NOTICE OF DECISION

CLASS 2 MINOR HISTORIC DESIGN REVIEW CASE NO.: HIS23-08

SUMMARY: A proposal to replace windows on the exterior of the Eder House (1918).

LOCATION: 1315 High St SE, Salem OR 97302

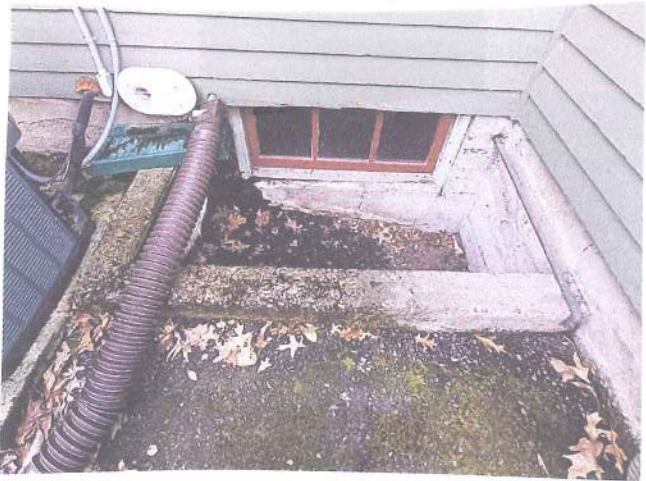
Location: <u>North Basement</u>
	Window Description: <u>Hopper Style Opens In. Sealed Shut. Single pane x 3</u>
	Sill: <u>Fair - Some Rot In Lower Corner</u> <input type="checkbox"/> Remove paint <input type="checkbox"/> Repair <input checked="" type="checkbox"/> Replace
	Frame/Trim: _____ <input type="checkbox"/> Remove paint <input type="checkbox"/> Repair <input type="checkbox"/> Replace
	Sash/Muntins/Leading: _____ <input type="checkbox"/> Remove paint <input type="checkbox"/> Repair <input type="checkbox"/> Replace
Glazing Putty: _____ % to repair _____ % to replace _____	
Dimensions of window: <u>47.5 x 21.5</u> Frame = <u>18.5 x 40</u> Each Pane = <u>11 x 13</u>	Glazing: _____ <input checked="" type="checkbox"/> Old <input type="checkbox"/> New <input type="checkbox"/> Broken
Remarks: <u>Water Comes in through This Window.</u>	Hardware Description: _____ <input type="checkbox"/> Remove paint <input type="checkbox"/> Missing

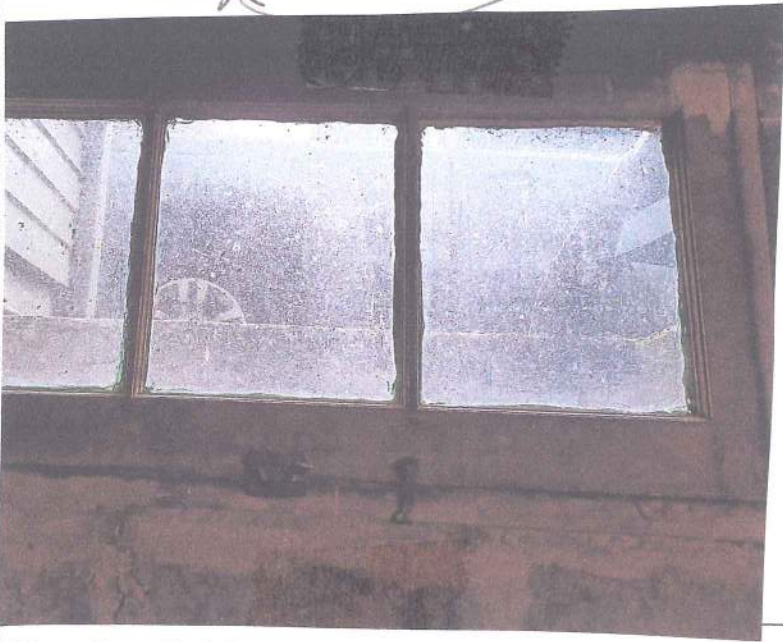
Water Intrusion between concrete and sill and between rail & Frame

Remarks: Change to Double pane sliding window. Replace Frame & Sill & Rails.

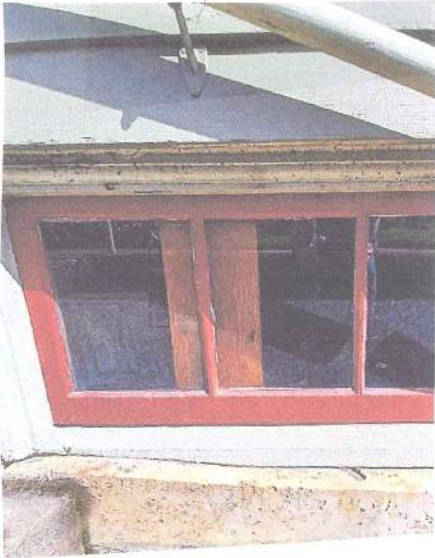
Location: Basement
West Side - Northern

Window Description: Wooden Hopper
sealed shut. 3 single panes
next to stairs.

Remarks: would like to replace with
tempered glass. Also change to
sliding window.

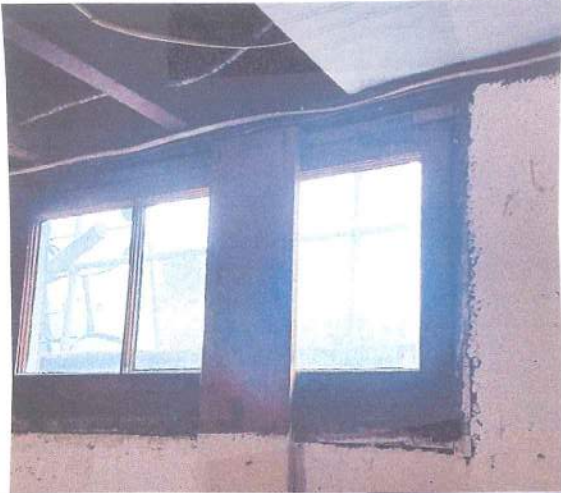
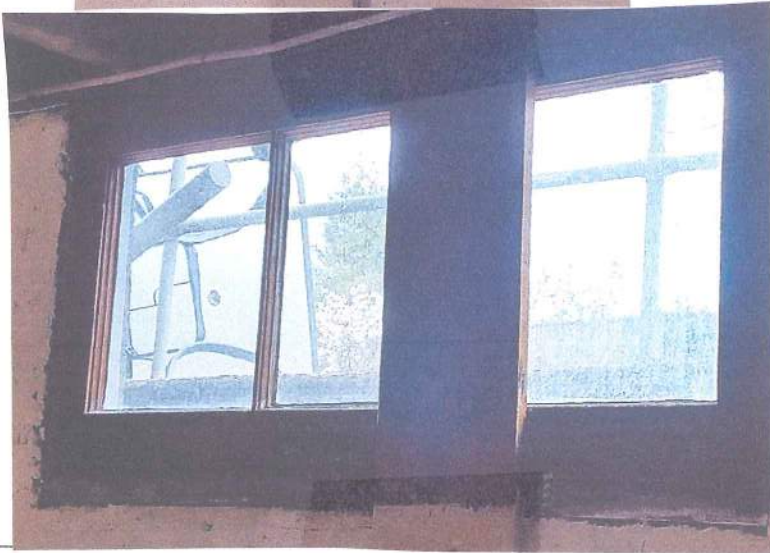
Location: Basement West side - North

Window Description: wooden 3 panes Hopper Style - Opens single pane In. Unpainted. Nailed & Blocked Shut

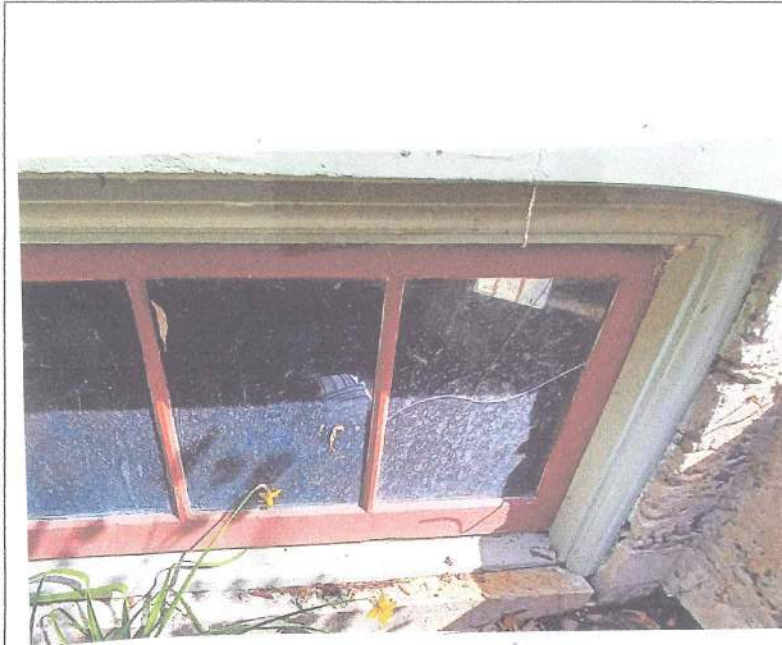
↑
cracked

Location: Basement
West Wall Southern

Window Description: Wooden Hopper
Sealed Shut.
3 Single panes - 1 cracked

Sash/Muntins/Leading: Cracked

Remarks: Replace with sliding window

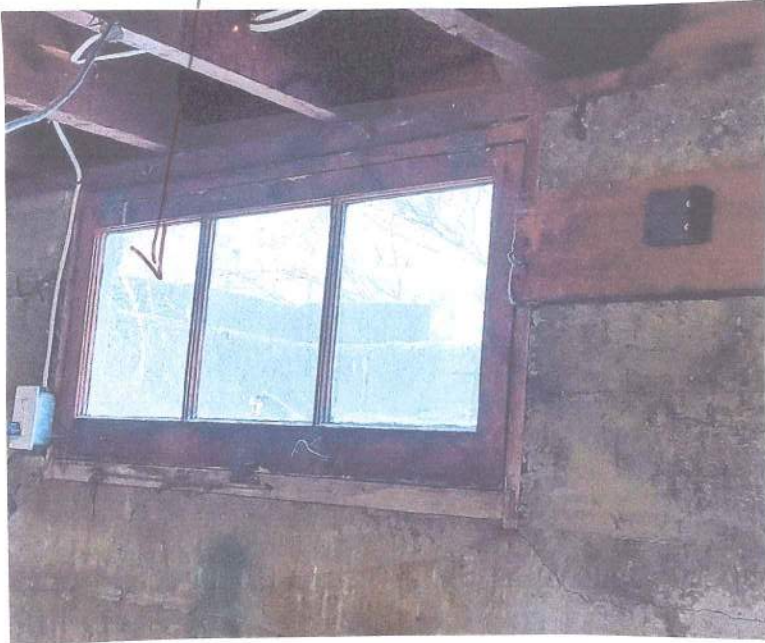
Window pane Cracked
in 2 directions

Location: Basement
West side South

Window Description: wooden
Hopper style Opens In
unpainted, Sealed Sput
3 panes - Single Paned

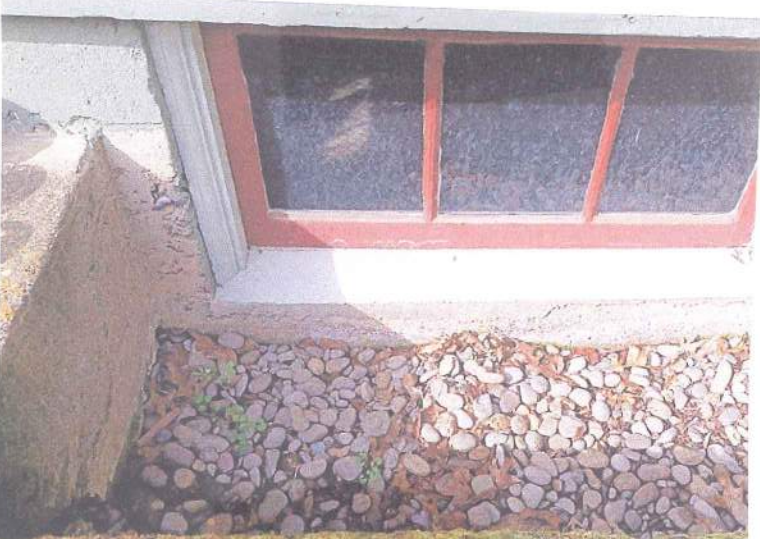
Location: <u>Basement</u> <u>South Wall West end</u>
	Window Description: <u>Wood Hopper</u> <u>Sealed Shut.</u> <u>3 single panes</u>
	Sill: <u>Poor</u> <input type="checkbox"/> Remove paint <input type="checkbox"/> Repair <input checked="" type="checkbox"/> Replace
	Frame/Trim: <u>Poor</u> <input type="checkbox"/> Remove paint <input type="checkbox"/> Repair <input checked="" type="checkbox"/> Replace
	Sash/Muntins/Leading: _____ <input type="checkbox"/> Remove paint <input type="checkbox"/> Repair <input checked="" type="checkbox"/> Replace
	Glazing Putty: _____ % to repair _____ % to replace _____
Dimensions of window: <u>Overall - 47.5 x 21.5</u> <u>Frame = 40 x 18.5</u> <u>Panes = 11 x 13</u>	Glazing: _____ <input checked="" type="checkbox"/> Old <input type="checkbox"/> New <input type="checkbox"/> Broken
Remarks: <u>Significant water intrusion</u> <u>between concrete & wood on</u> <u>both sides and sill.</u> <u>Replace with Sliding Window</u>	Hardware Description: _____ <input type="checkbox"/> Remove paint <input type="checkbox"/> Missing

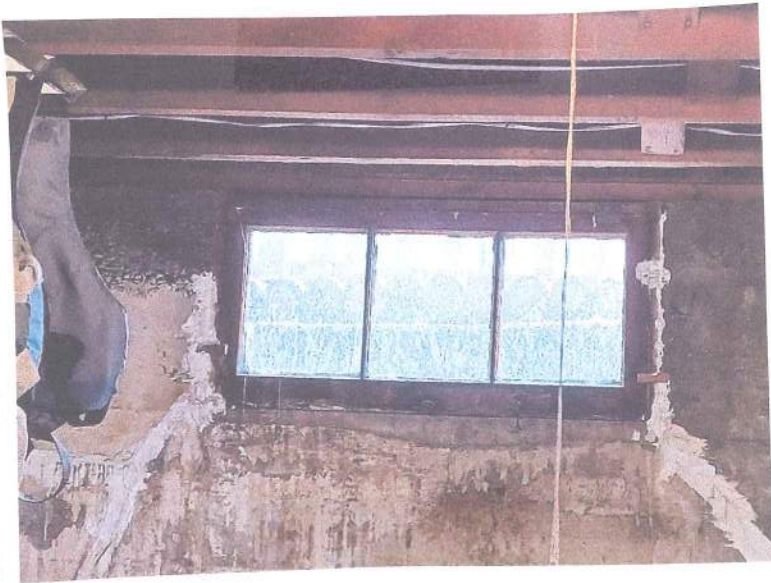
Significant Water
Intrusion between
Rails & Frame and sill
between Sill & Rails &
concrete

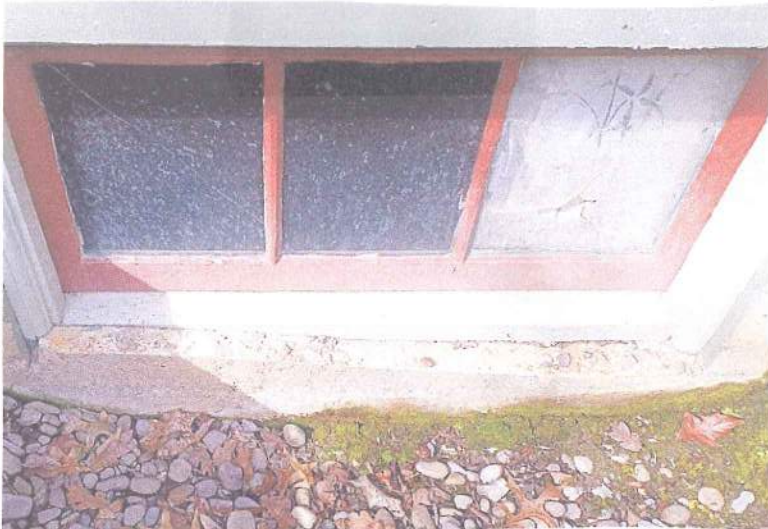
<p style="margin-top: 10px;"> ↑ Cracked ↑ Broken </p>	<p>Location: <u>Basement</u> <u>South Wall East End</u></p>
	<p>Window Description: <u>Wooden Hopper sealed shut.</u> <u>3 single panes</u></p>
	<p>Sill: <u>Poor</u></p> <p> <input type="checkbox"/> Remove paint <input type="checkbox"/> Repair <input checked="" type="checkbox"/> Replace </p>
	<p>Frame/Trim: <u>Poor</u></p> <p> <input type="checkbox"/> Remove paint <input type="checkbox"/> Repair <input checked="" type="checkbox"/> Replace </p>
	<p>Sash/Muntins/Leading: <u>Poor</u></p> <p> <input type="checkbox"/> Remove paint <input type="checkbox"/> Repair <input checked="" type="checkbox"/> Replace </p>
	<p>Glazing Putty: _____</p> <p>% to repair _____</p> <p>% to replace _____</p>
<p>Dimensions of window: <u>Overall - 47.5 x 21.5</u> <u>Frame = 40 x 18.5</u> <u>Panes = 11 x 13</u></p>	<p>Glazing: _____</p> <p> <input checked="" type="checkbox"/> Old <input type="checkbox"/> New <input checked="" type="checkbox"/> Broken </p>

<p>Remarks: <u>Significant water between sill & concrete.</u> <u>Replace with sliding window.</u></p>	<p>Hardware Description: _____</p> <p> <input type="checkbox"/> Remove paint <input type="checkbox"/> Missing </p>

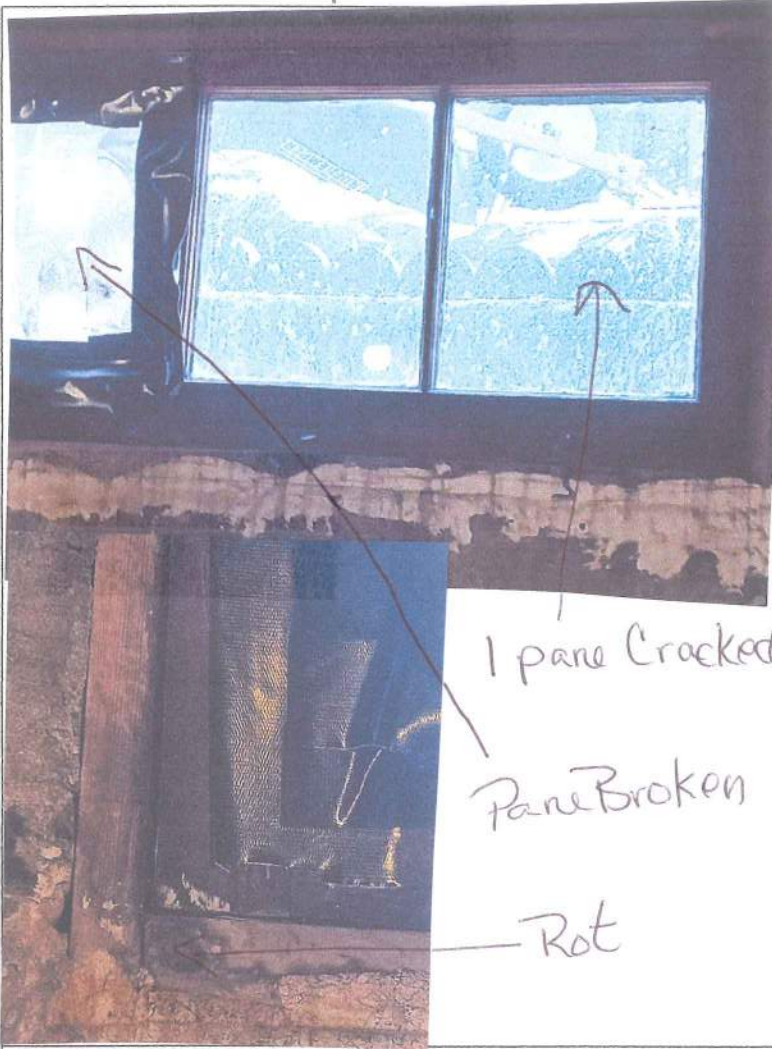
Location: Basement
West South Wall East End

Window Description: wood Hopper
style. Opens Inward - fixed
shut Unpainted
3 panes - Single Paned

Hardware Description: Hinge &
sash lock
Rusted

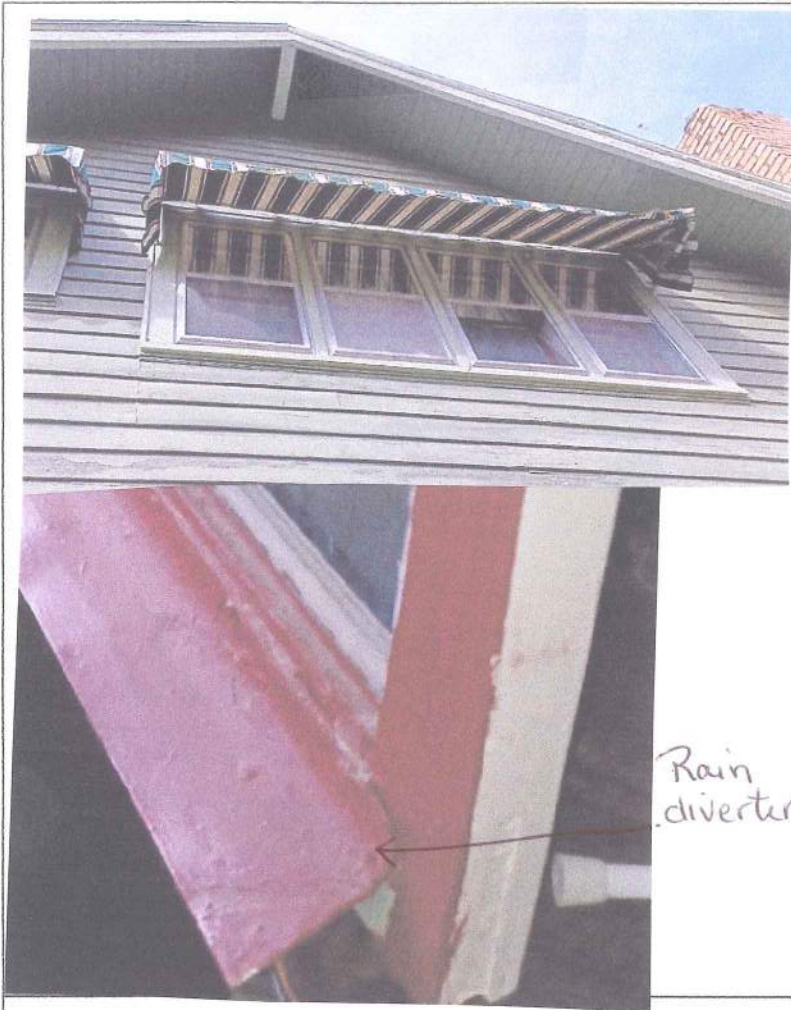
Location: 2nd story
South bedroom

Window Description: Single pane bank of 4 casements opening in. Aluminum frame screen & storm windows Rain diverter at base of frames

Remarks: 2 center windows are fixed shut. 2 outer ones wont shut, or the wind shakes the hardware until it falls out. water intrusion at some point caused dry rot below the Apron. Awning is rotting & has hole starting

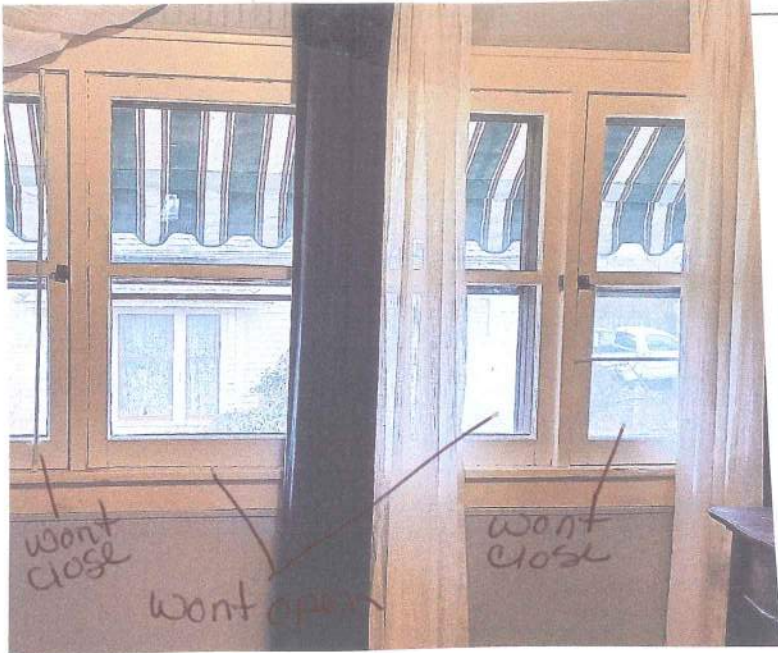
Location: 2nd Story
South bedroom

Window Description: Wood Casement
Open Inwards.
Bank of 4.
Single Pane. Alum. Frame Screens

Remarks: 2 outer windows do not latch
shut. Catch pulls out of wood when
windy. 2 inner windows are fixed shut.
water intrusion led to dry rot below Apron.

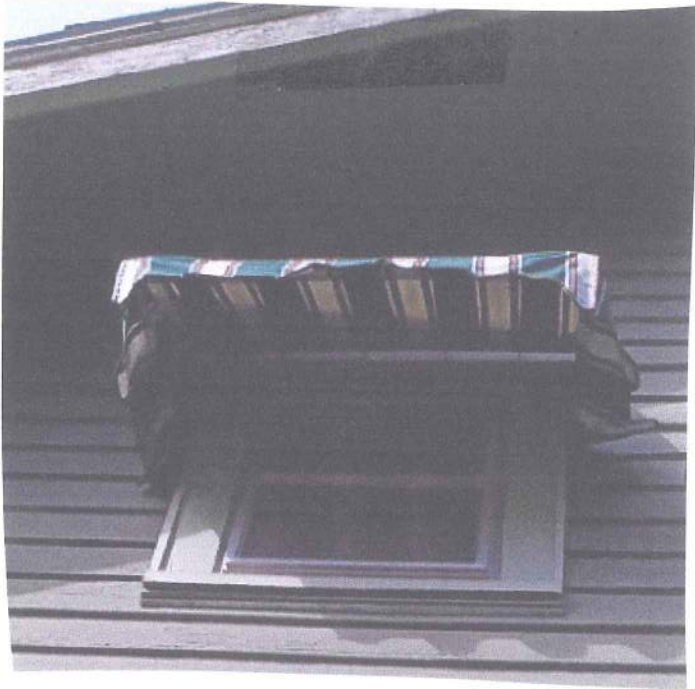
Location: 2nd story
Bath

Window Description: Single pane.
wood casement w/ Rain
diverter strip at Bottom
Aluminum Frame Screen

Remarks: would like to replace to be
consistent with age & materials
on this floor

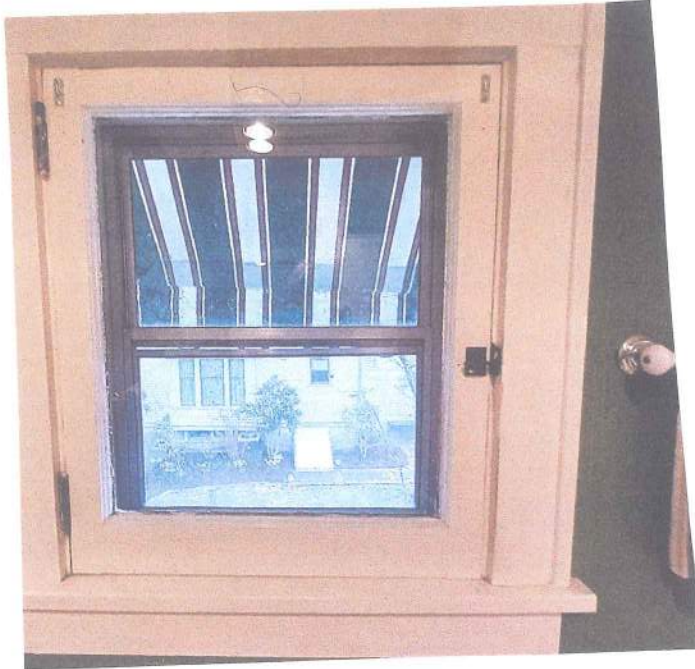
Location: South - Bath

Window Description: Wood Casement - opens inward Single pane

Remarks: window in good shape would replace to be consistent age & material on two floor.
Remove & Replace Aluminum Frame
Storm/Screen windows

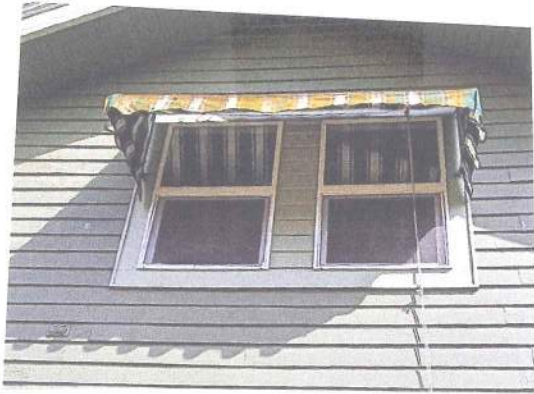
Location: 2nd story
west wall

Window Description: Double pane,
vinyl sash style. Aluminum
Frame Screens

Remarks: Replace to be consistent
with the rest of the house.
Remove Rotting Awning

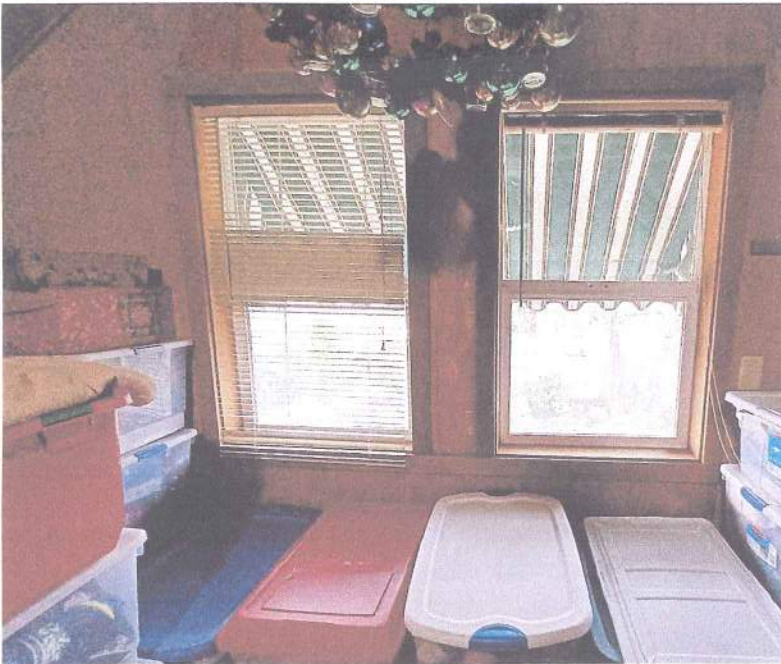
Double pane →

Location: 2nd story
West Wall

Window Description: Vinyl
Sash. Bank of 2.
Do not match anything in
the house. Alum. Screen

Remarks: Would like to replace
with an historically accurate
appearing window. consistent with the
rest of the house.

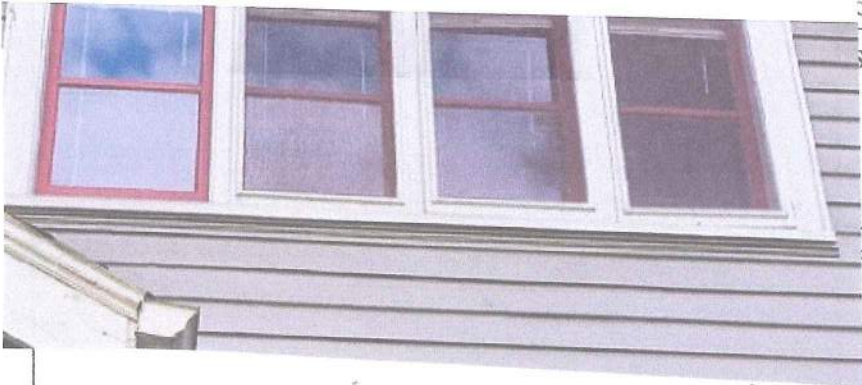
NO Awning on this window

Location: 2nd Story
North Bedroom

Remarks: 1 screen is missing, other frames in fair condition

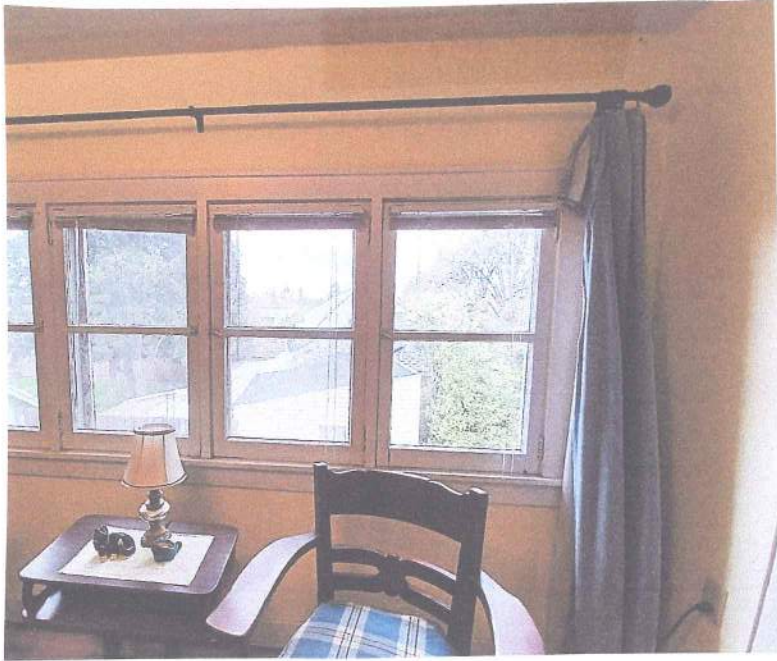
All extremely difficult to open during cool/wet weather.

Location: <u>2nd story North Bedroom</u>
Window Description: <u>Wood Casement open Inwards - Bank of 4 - Single paned 1 screen is missing</u>
Stool: <u>Good</u> <input type="checkbox"/> Remove paint <input type="checkbox"/> Repair <input type="checkbox"/> Replace
Frame/Pulley/Stiles: <u>Good</u> <input type="checkbox"/> Remove paint <input type="checkbox"/> Repair <input type="checkbox"/> Replace
Sash/Muntins/Leading: <u>Good</u> <input type="checkbox"/> Remove paint <input type="checkbox"/> Repair <input type="checkbox"/> Replace
Trim: <u>Good</u> <input type="checkbox"/> Remove paint <input type="checkbox"/> Repair <input type="checkbox"/> Replace
Hardware Description: <u>Good</u> <input type="checkbox"/> Remove paint <u>Sash Lock</u> <input type="checkbox"/> Missing <u>Screens have hook & eye.</u>
Ropes/Chains: <u>None</u> <input type="checkbox"/> Replace
Weatherstripping: <u>None</u> <input type="checkbox"/> Replace

Remarks: Would Replace these so all upstairs are the same age & materials. Screens would also be replaced.
