SEISMIC RESILIENCY ANALYSIS REPORT

B&V PROJECT NO. 406828

City of Salem

AUGUST 2023

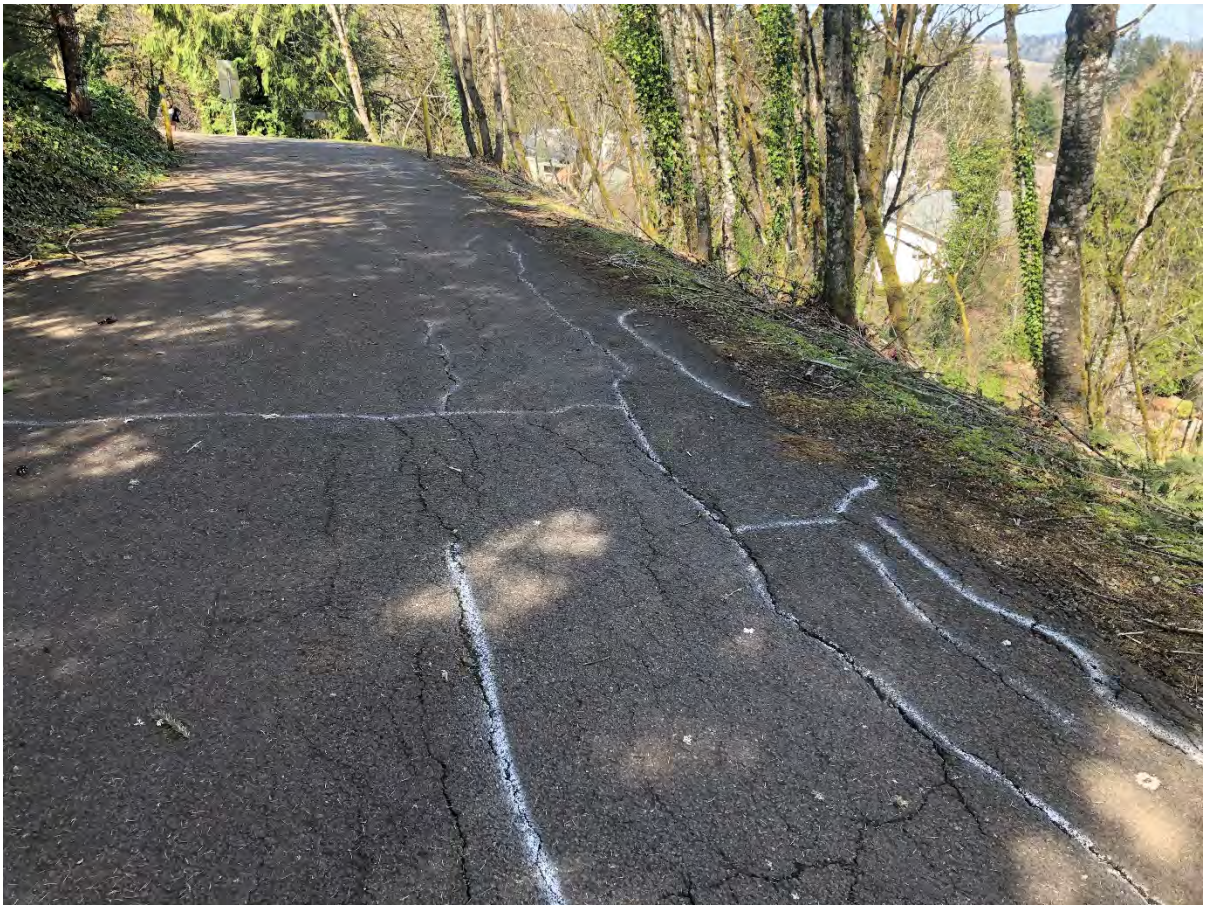
Exhibit 3-10: Photo of Cracking Observed in Driveway During Site Visit

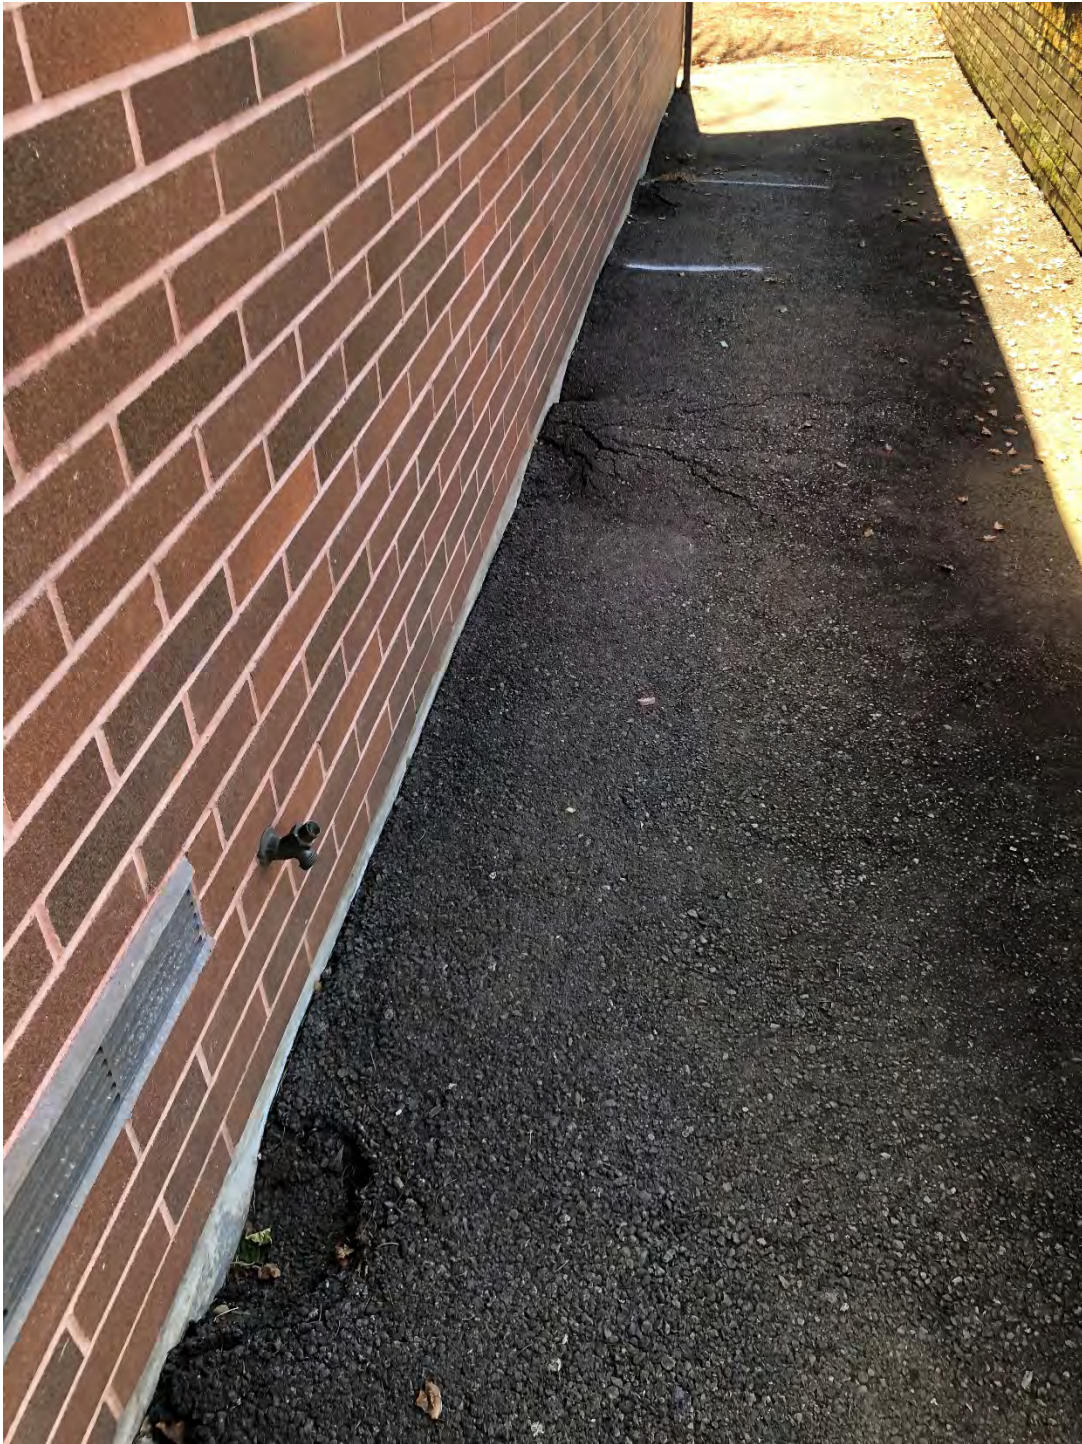
Because the predicted settlements in the HAZUS model are based on the assumption that the pump station is underlain by gravel which appears not to be correct based on the closest available well log, the hazard may not be adequately defined by the hazard mapping. The actual potential for liquefaction and movement to the nearby creek would be a function of the plasticity of the fine-grained material above the gravel. If the fine-grained material has consistent medium or high plasticity the liquefaction potential may be low. However, if layers of saturated, low plasticity silt or loose sand are also present, a liquefaction hazard may be present. Additionally, portions of the subgrade in the pavement next to the building appear to be negatively affected by past uncontrolled water releases at the pump station. If the areas of disturbed soil or voids extend below the building foundations, then portions of the foundations may have significantly less subgrade support than at locations where undisturbed native soil is present during both seismic and static conditions. Due to uncertainties associated with the liquefaction potential and subgrade we consider the potential for permanent ground deformation to be moderate to high during a seismic event.

Exhibit 3-12: Photo of Cracking and Settlement along Edwards Pump Station West Wall During Site Visit

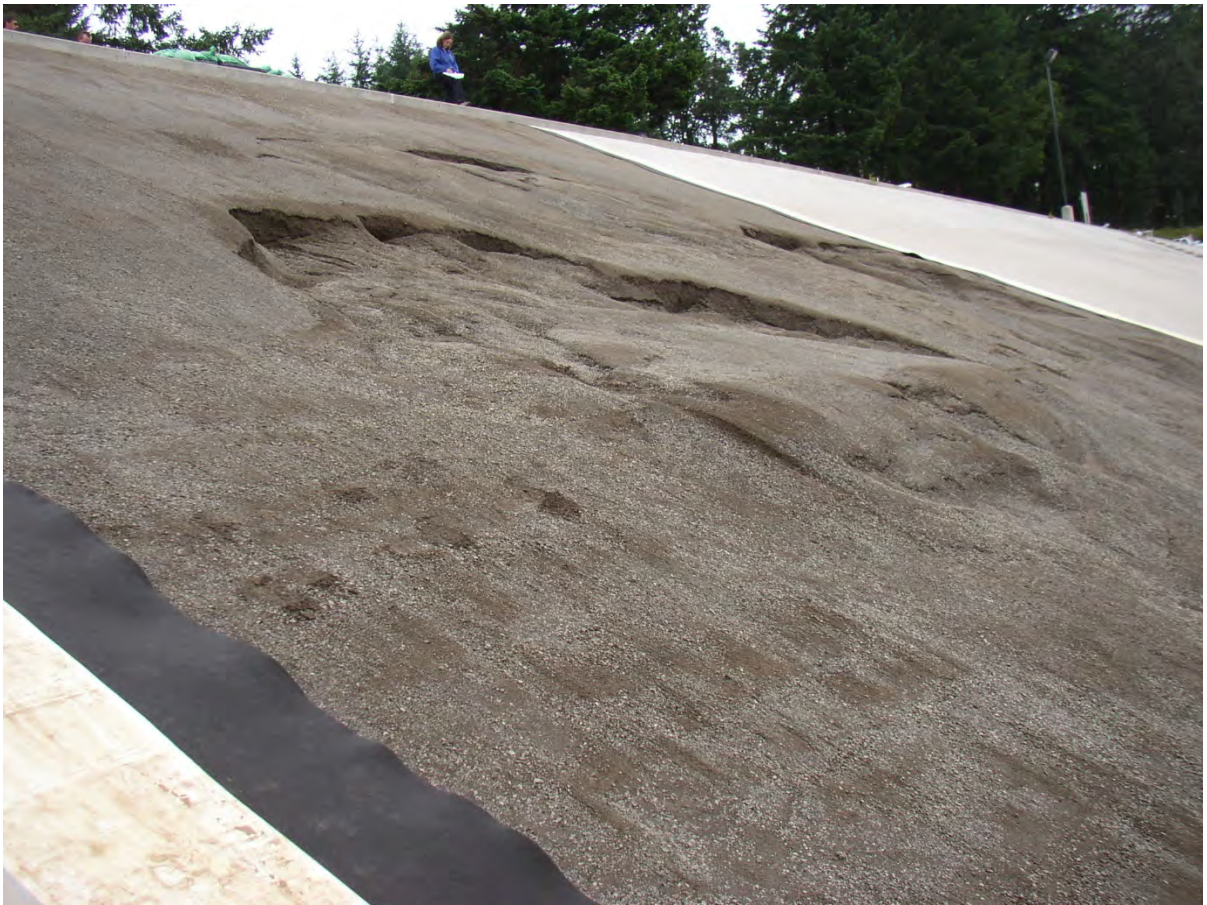
for seismic slope instability of the embankment may be moderate to high.

Exhibit 3-21: Photo of Slump Failure along Cut Slope of West Cell from 2008 (Photo Provided by the City of Salem)

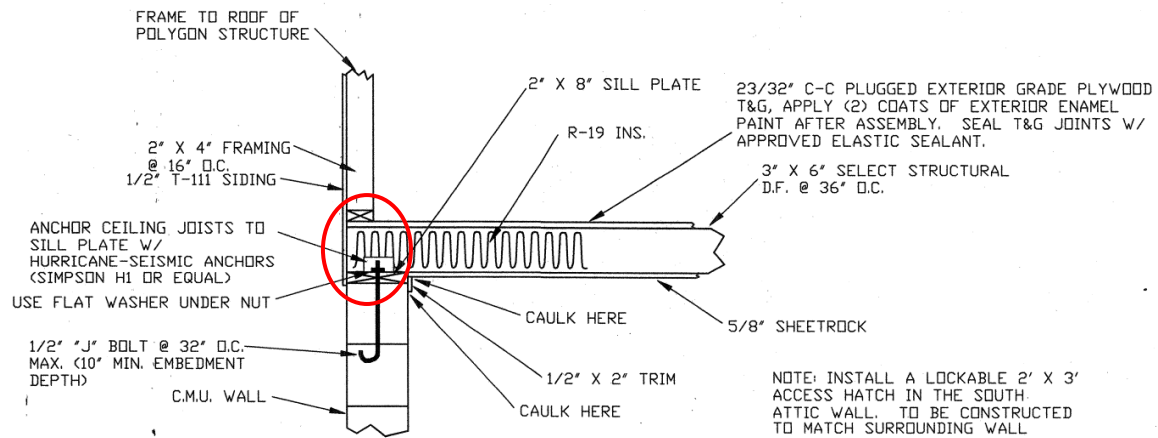
Figure 3.21 Inadequate Blocking and Masonry Wall Out-of-Plane Anchorage
(Source: Detail 5 on Sheet A3 of 1997 design drawings by Stettler Company)

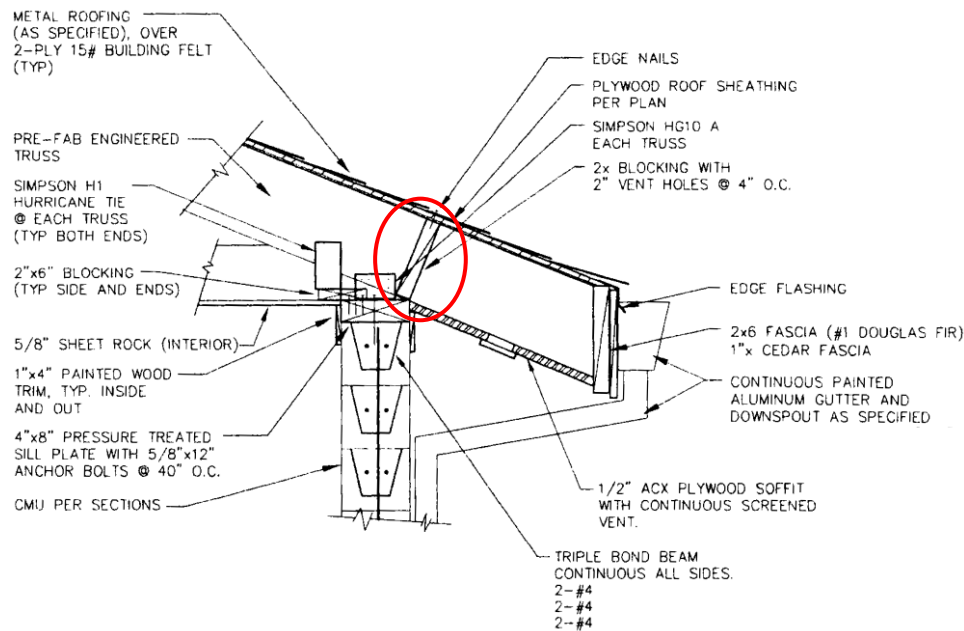
Figure 3.132 Inadequate Connection between Blocking and Masonry Wall Top Plate
(Source: Detail 6 on Sheet S13 of 2005 design drawings by Westech Engineering)

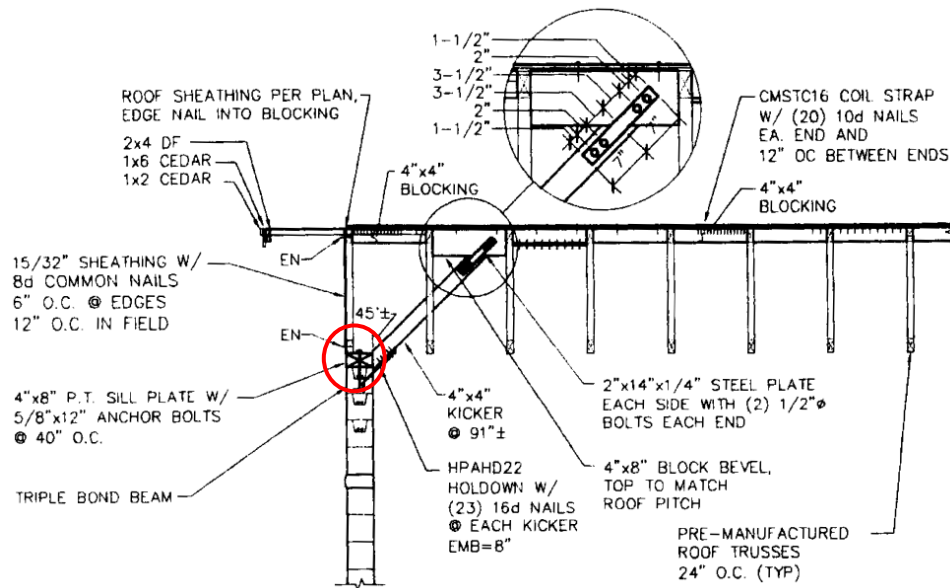
Figure 3.133 Inadequate Connection between Sheathing and Masonry Wall Top Plate
(Source: Detail 4 on Sheet S13 of 2005 design drawings by Westech Engineering)

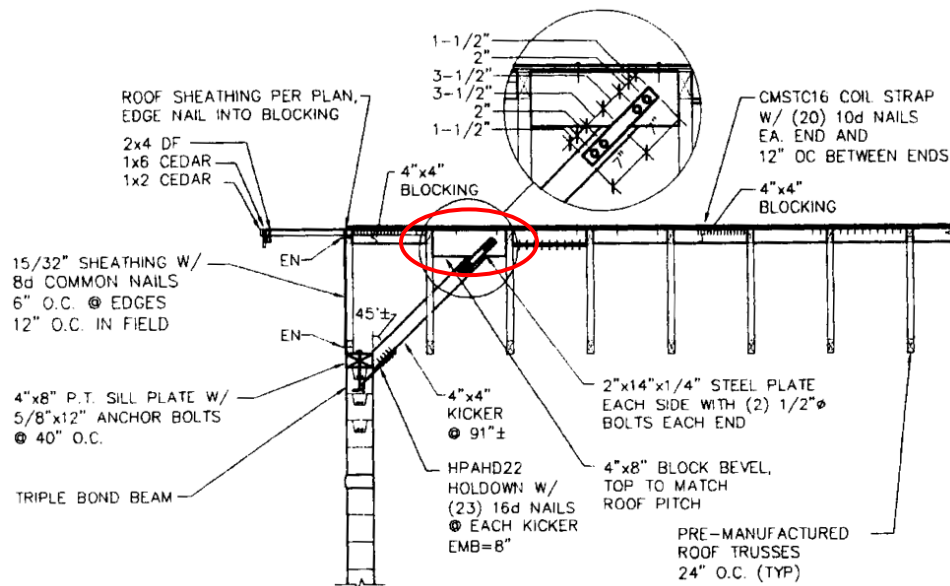
Figure 3.134 Inadequate Connection between Blocking and Roof Truss
(Source: Detail 4 on Sheet S13 of 2005 design drawings by Westech Engineering)

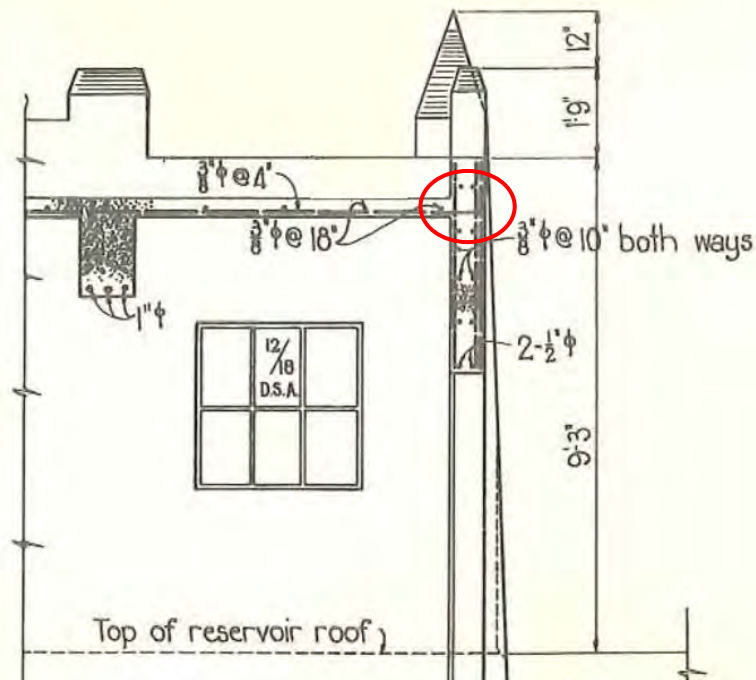
Figure 3.153 Inadequate Shear Wall to Diaphragm Connection
(Source: Section a-a on Sheet 16 of 1936 design drawings by Stevens & Koon)

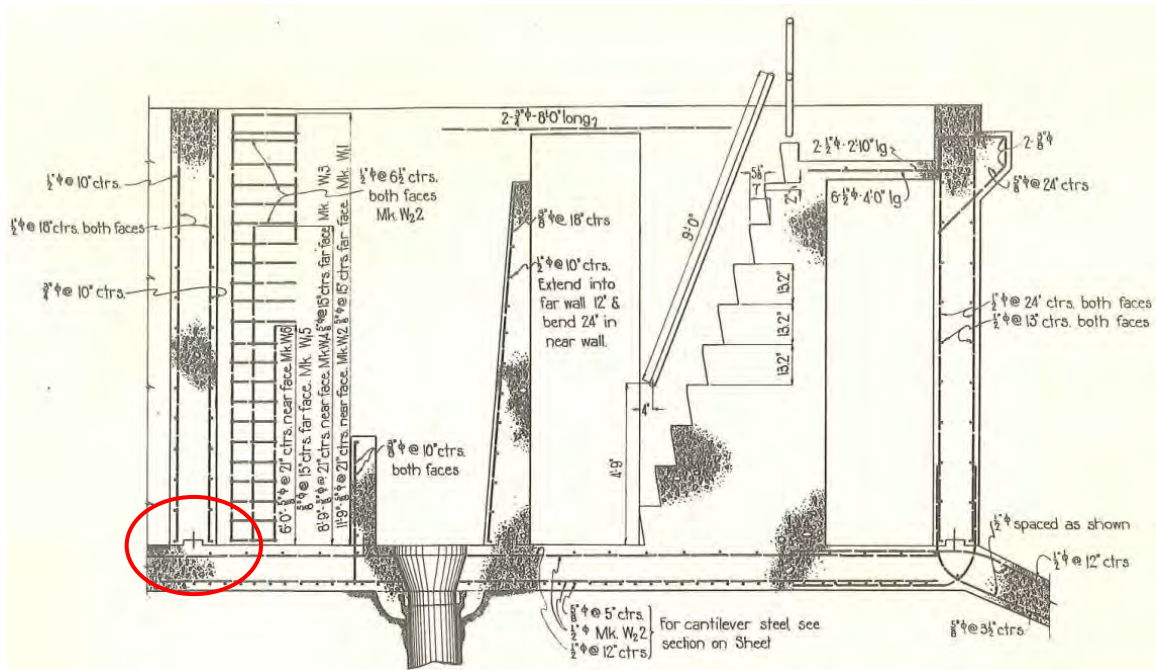
Figure 3.154 Inadequate Shear Wall to Foundation Connection
(Source: Section J-J on Sheet 12 of 1936 design drawings by Stevens & Koon)

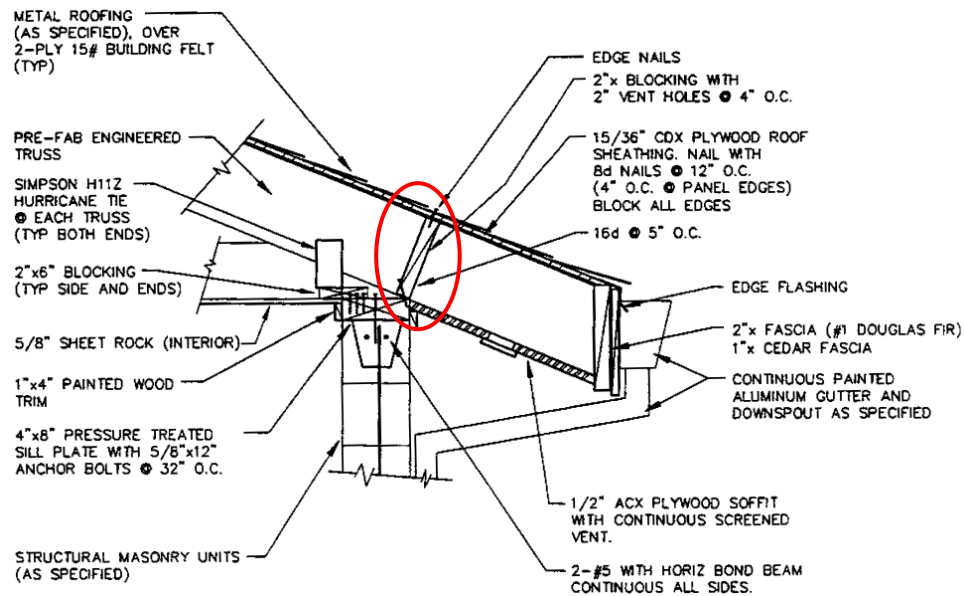
Figure 3.170 Inadequate Connection between Blocking and Masonry Wall Top Plate
(Source: Detail 6 on Sheet B-5 of 2001 design drawings by Westech Engineering)

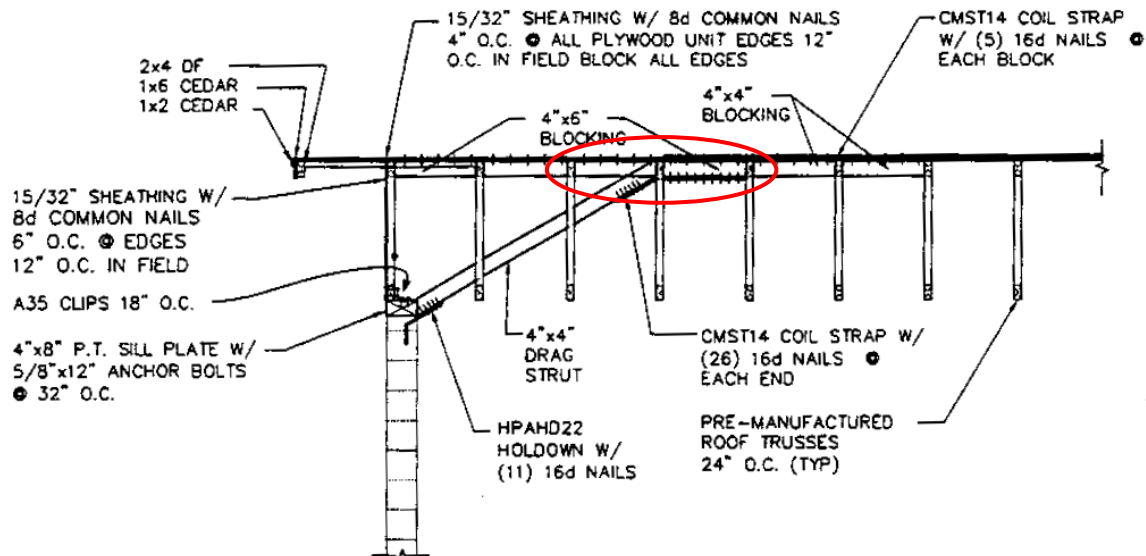
Figure 3.171 Inadequate Connection between Blocking and Roof Truss
(Source: Detail 4 on Sheet B-5 of 2001 design drawings by Westech Engineering)

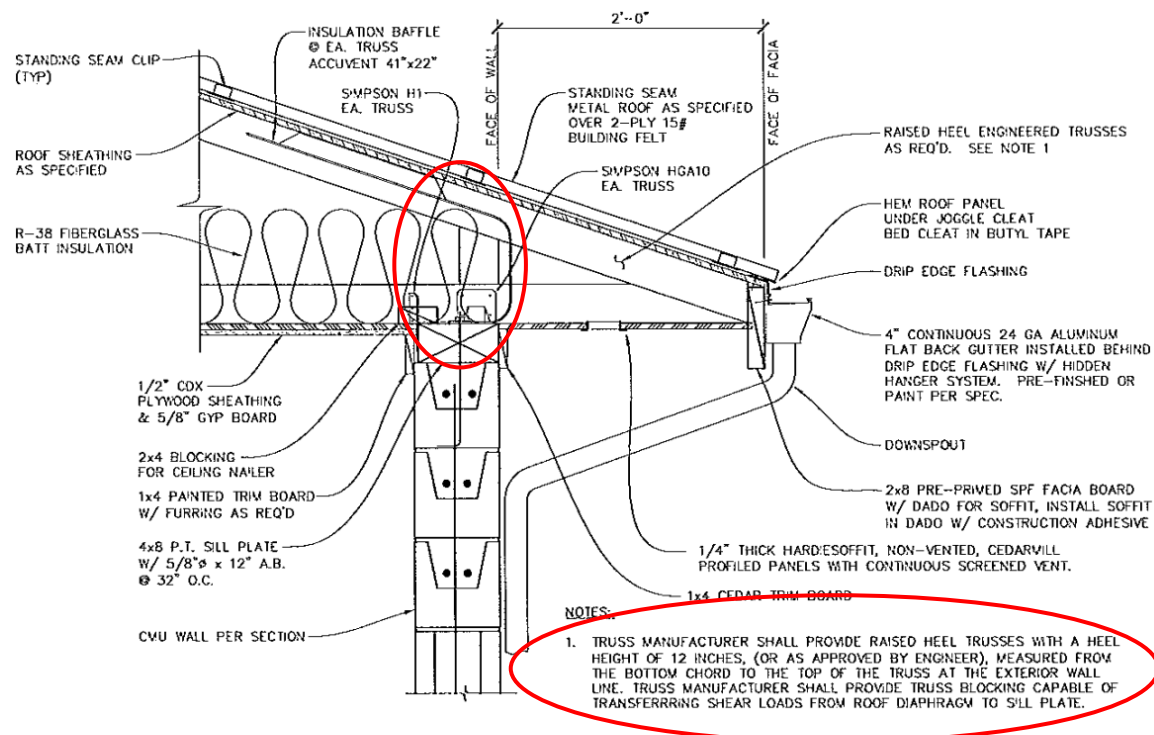
Figure 3.198 Inadequate Connection between Blocking and Masonry Wall Top Plate
(Source: Detail 5 on Sheet S-20 of 2014 design drawings by Westech Engineering)
