# NOTICE OF DECISION

## ADMINISTRATIVE DECISION - MINOR HISTORIC REVIEW

CASE NO.: Historic Review Case 17-21 / Amanda No. 17-109230-DR

**SUMMARY:** A proposal to repair a sidewalk panel, install a new heat pump and replace windows on the Webb House (1930).

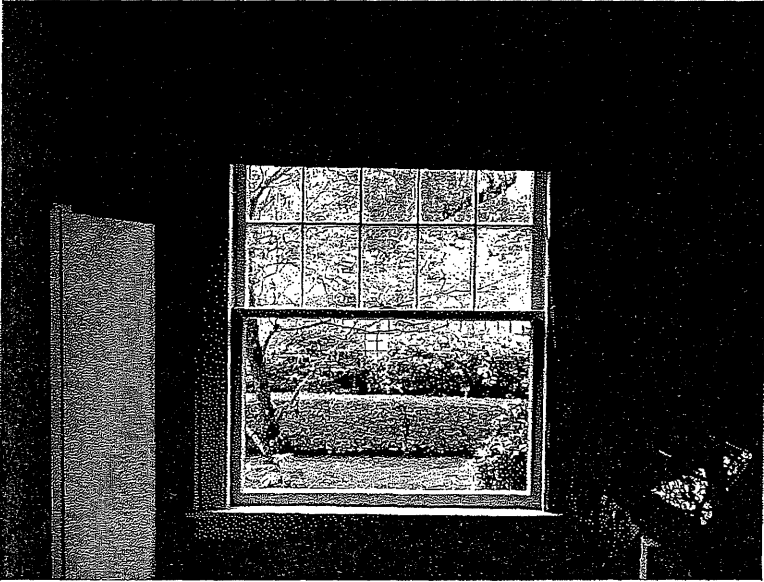
Location: Living room
	Window Description: Double Hung window
	Stool: <u>Wood stool</u> <input type="checkbox"/> Remove paint <input type="checkbox"/> Repair <input type="checkbox"/> Replace
	Frame/Pulley/Stiles: <u>Frame/Stiles</u> <input type="checkbox"/> Remove paint <input type="checkbox"/> Repair <input checked="" type="checkbox"/> Replace      Need to be replaced
	Sash/Muntins/Leading: _____ <input type="checkbox"/> Remove paint <input type="checkbox"/> Repair <input checked="" type="checkbox"/> Replace      Need to be replaced
	Trim: <u>Wood</u> <input type="checkbox"/> Remove paint <input checked="" type="checkbox"/> Repair      Needs to be painted <input type="checkbox"/> Replace
Dimensions of window: 1- 28 x 52	Hardware Description: _____ <input type="checkbox"/> Remove paint <input type="checkbox"/> Missing
	Ropes/Chains: _____ <input type="checkbox"/> Replace
Remarks:	Weatherstripping: <u>does not currently exist</u> <input checked="" type="checkbox"/> Replace      Needs to be replaced

Overall Condition: Fair

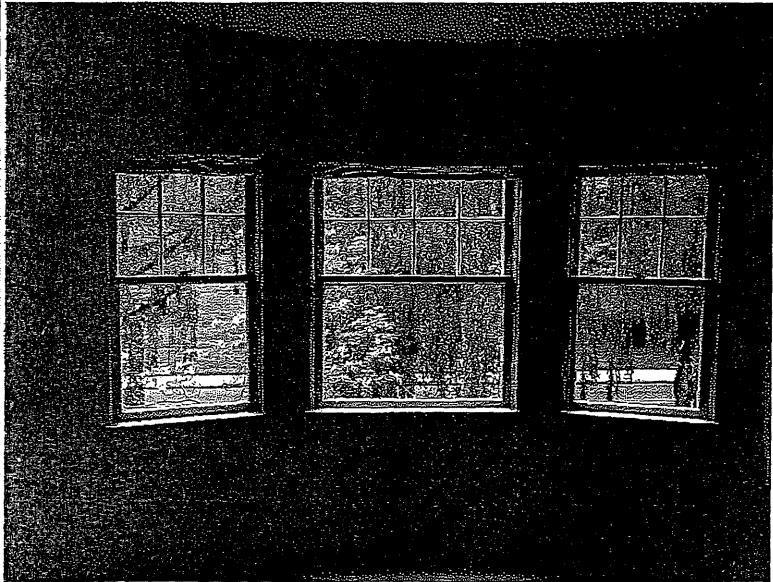
Location: Master Bedroom
	Window Description: Double Hung window
	Stool: <u>Wood stool</u> <input type="checkbox"/> Remove paint <input type="checkbox"/> Repair <input type="checkbox"/> Replace
	Frame/Pulley/Stiles: <u>Frame/Stiles</u> <input type="checkbox"/> Remove paint <input type="checkbox"/> Repair <input checked="" type="checkbox"/> Replace      Need to be replaced
	Sash/Muntins/Leading: _____ <input type="checkbox"/> Remove paint <input type="checkbox"/> Repair <input checked="" type="checkbox"/> Replace      Need to be replaced
	Trim: <u>Wood</u> <input type="checkbox"/> Remove paint <input checked="" type="checkbox"/> Repair      Needs to be painted <input type="checkbox"/> Replace
Dimensions of window: 1- 26 x 48 2- 38 x 48 3- 26 x 48	Hardware Description: _____ <input type="checkbox"/> Remove paint <input type="checkbox"/> Missing
	Ropes/Chains: _____ <input type="checkbox"/> Replace

Weatherstripping: <u>does not currently exist</u> <input checked="" type="checkbox"/> Replace      Needs to be replaced
Remarks:

Overall Condition: Fair

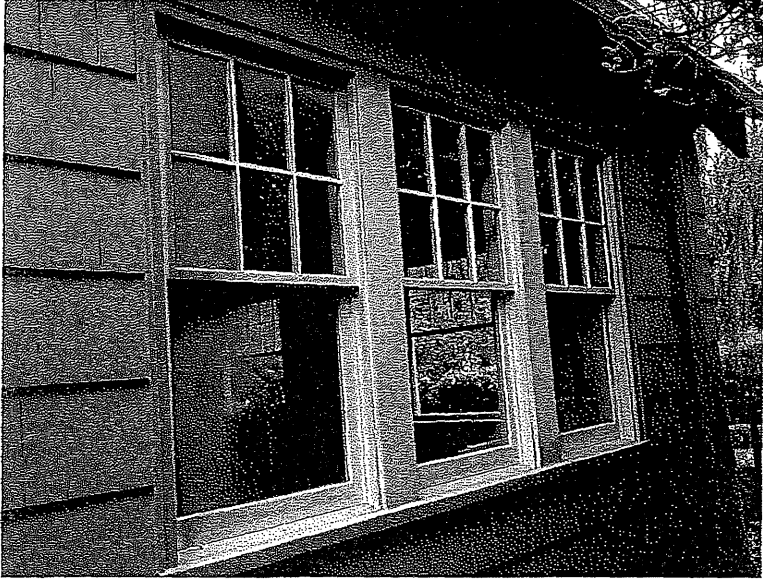
Location: Living room
	Window Description: Double Hung window
	Sill: <u>Wood</u> <input type="checkbox"/> Remove paint <input checked="" type="checkbox"/> Repair      Needs to be painted <input type="checkbox"/> Replace
	Frame/Trim: <u>Wood</u> <input type="checkbox"/> Remove paint <input checked="" type="checkbox"/> Repair      Needs to be painted <input type="checkbox"/> Replace
	Sash/Muntins/Leading: <u>Sash &amp; Muntins</u> <input type="checkbox"/> Remove paint <input type="checkbox"/> Repair <input checked="" type="checkbox"/> Replace      Needs to be replaced
	Glazing Putty: _____ % to repair _____ % to replace _____
Dimensions of window: 1- 28 x 52 2- 28 x 52 3- 28 x 52	Glazing: <u>Single Pane</u> <input checked="" type="checkbox"/> Old      Needs to be replaced <input type="checkbox"/> New <input type="checkbox"/> Broken
Remarks:	Hardware Description: _____ <input type="checkbox"/> Remove paint <input type="checkbox"/> Missing

Overall Condition: Fair

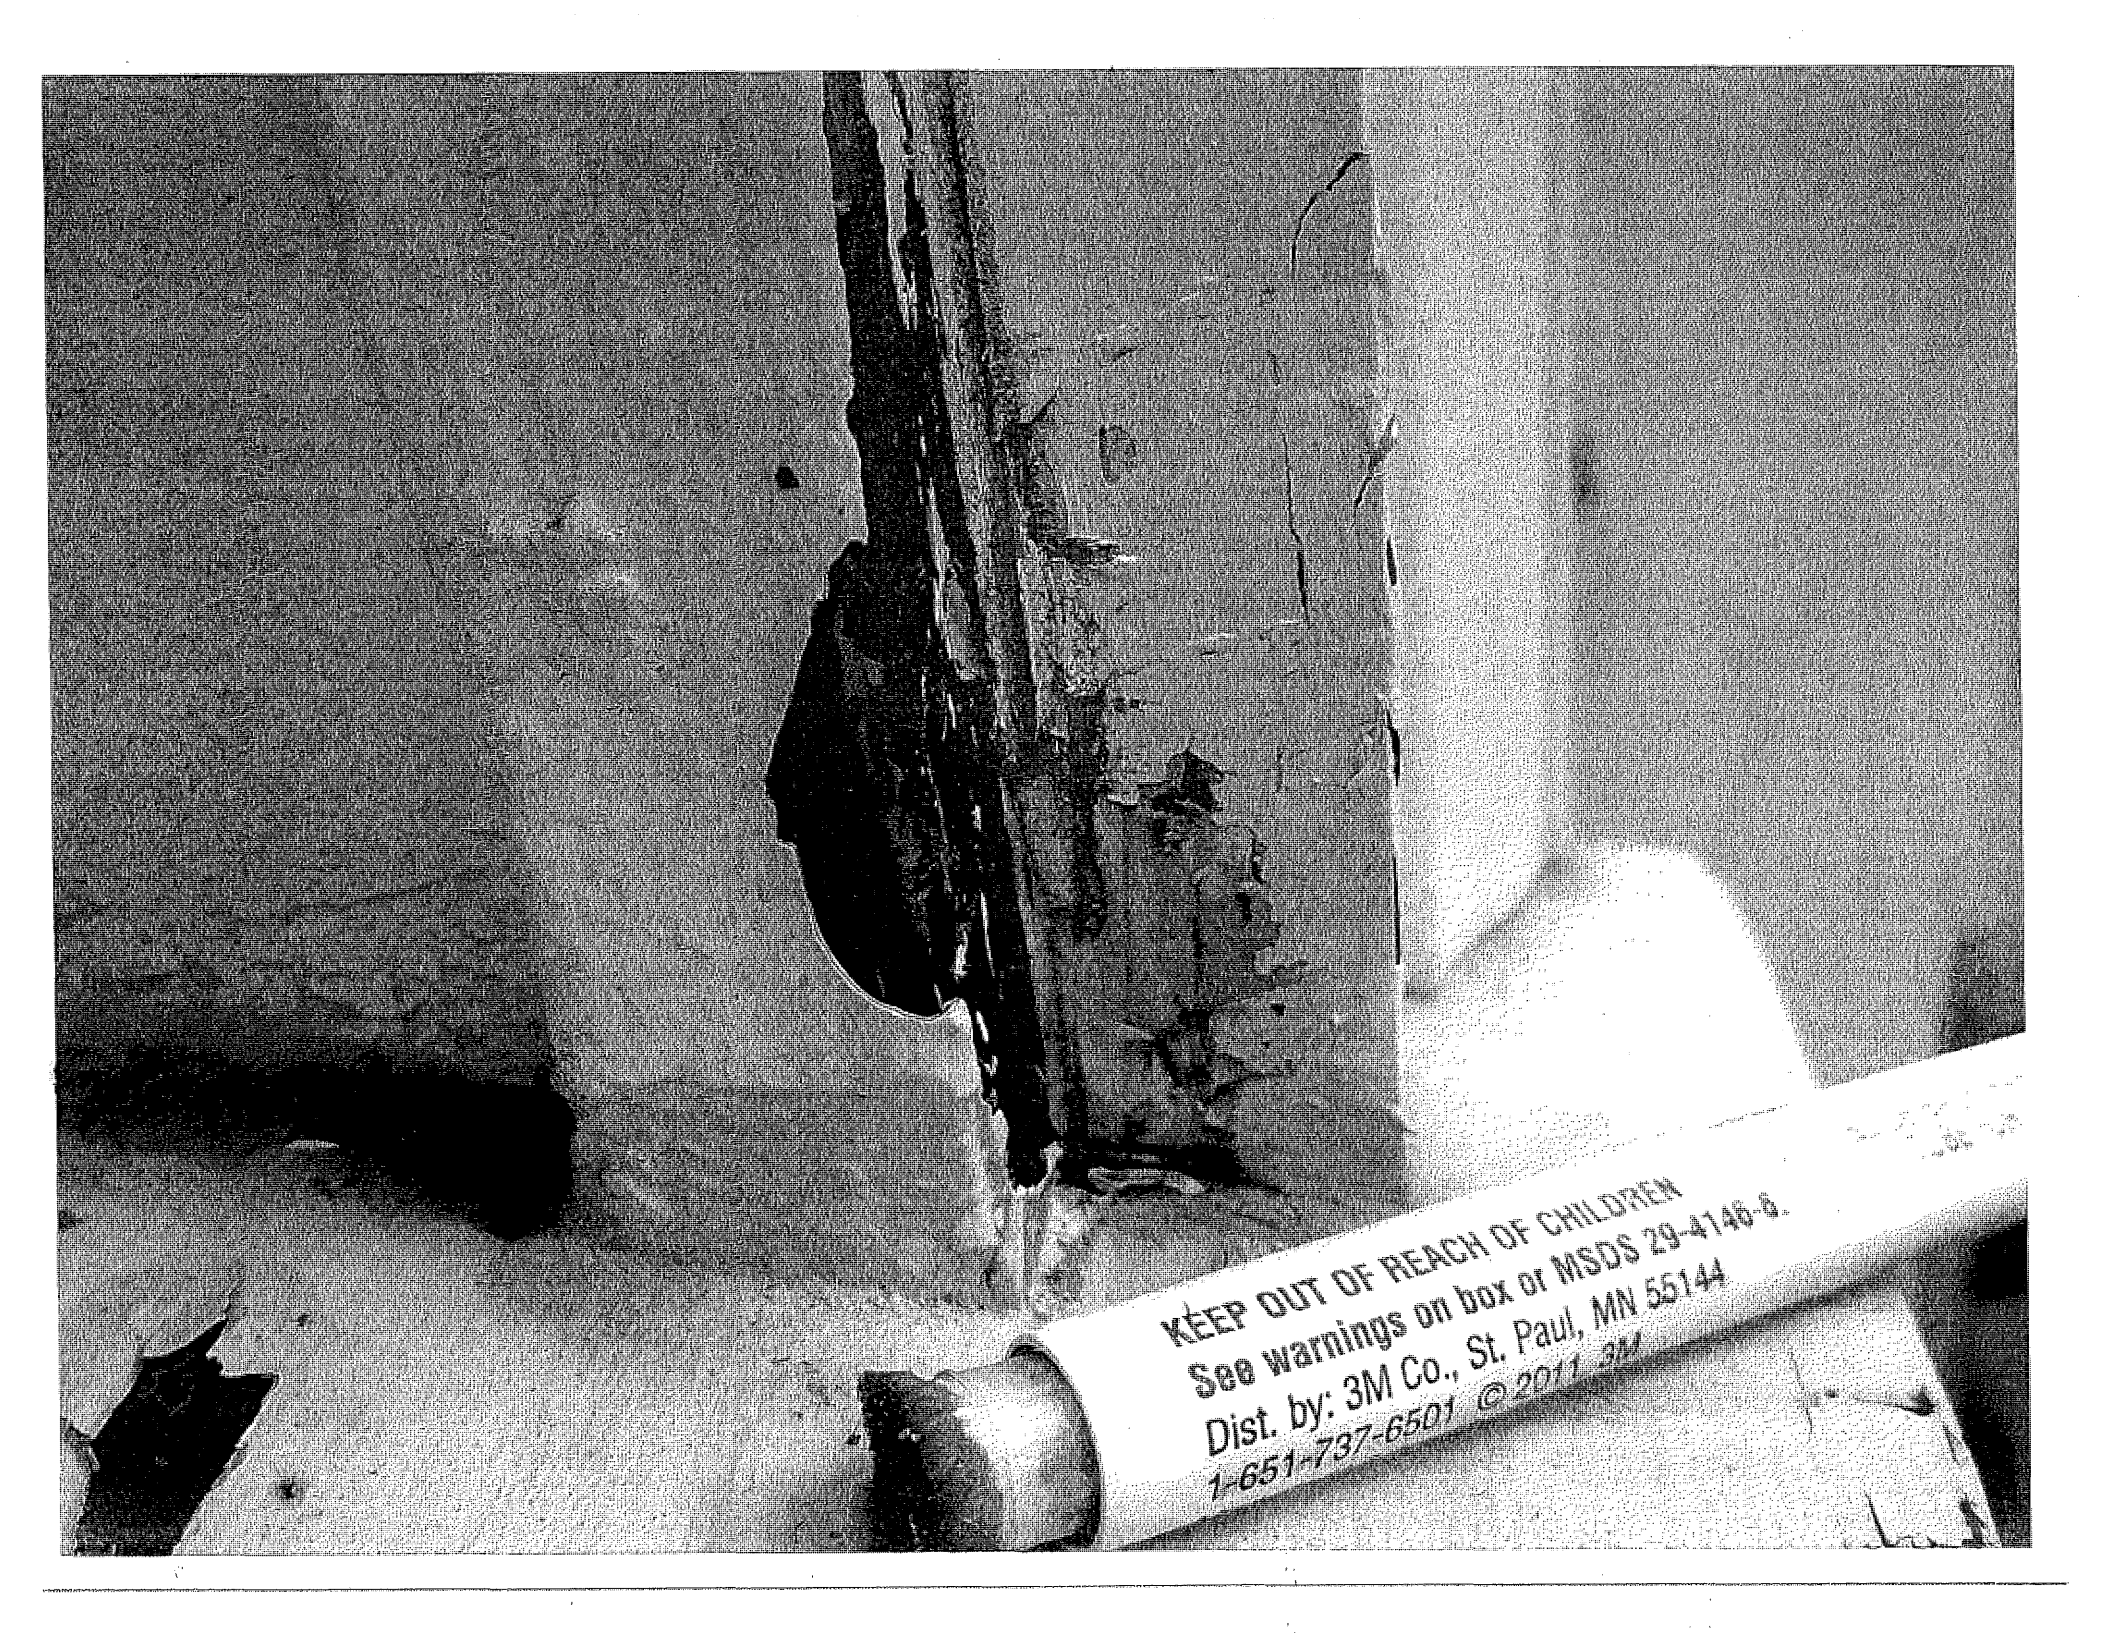
**Finding:** The applicant is proposing to replace eight windows throughout the Webb House with paintable wood composite Renewal double hung windows by Andersen. The proposed windows will duplicate the multi-pane design on the top sash of each of the windows, and have a single pane undivided light on the lower sash. The existing windows are currently in poor condition, suffering from varying degrees of dry-rot and water and air intrusion, and are currently inoperable.

Window (typical) in Poor Condition

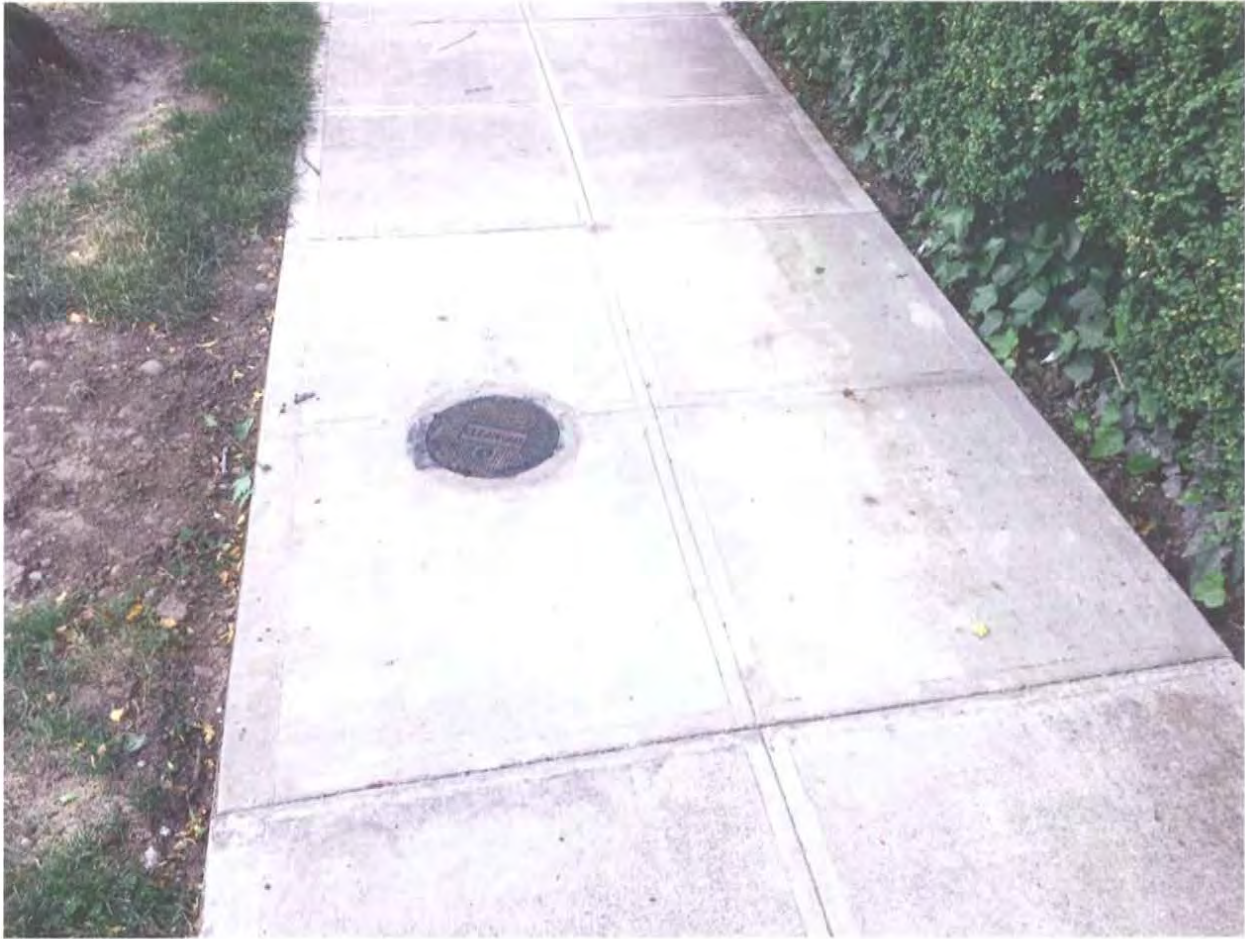
Sidewalk Panel

The applicant was required to remove the sidewalk panel in front of the resource prior to obtaining historic design review because the sewer line was failing. The applicant coordinated with the Public Works Department to ensure that the sidewalk panel was restored to its previous condition, including the four square tooled joints.

The applicant has replaced the 5' x 5' sidewalk panel with a concrete mix that replicates the color, texture and finish of the sidewalk materials found throughout the Gaiety-Hill/Bush's Pasture Park Historic District. Staff finds that 230.075(a)(1) has been met.

**Finding:** The applicant has replaced the sidewalk panels to meet the City's acceptable condition standards including replicating the historic "four square" tooled joints in all new sidewalk panels thereby meeting SRC 230.075(2)(b)(5).

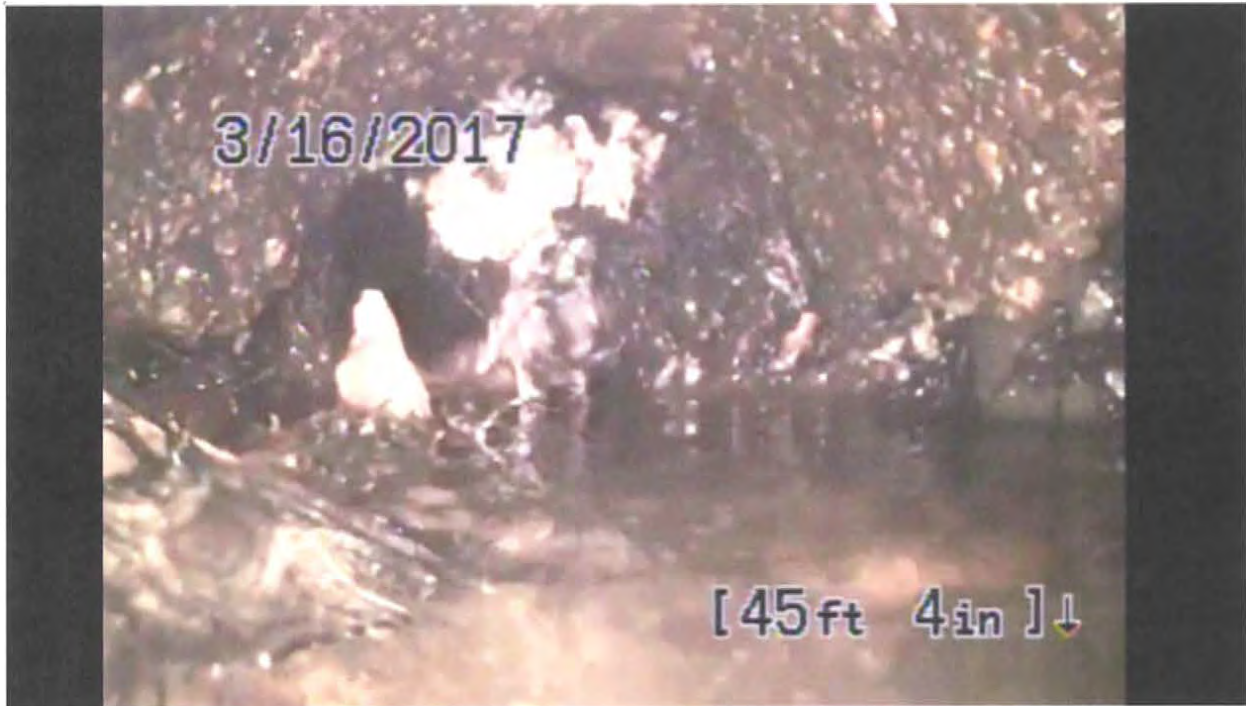
Failed Sewer line

**Finding:** The applicant only proposed to replace portions of the sidewalk adjacent to the site that were damaged as part of the necessary sewer line repair, thereby meeting SRC 230.075(2)(b)(7).

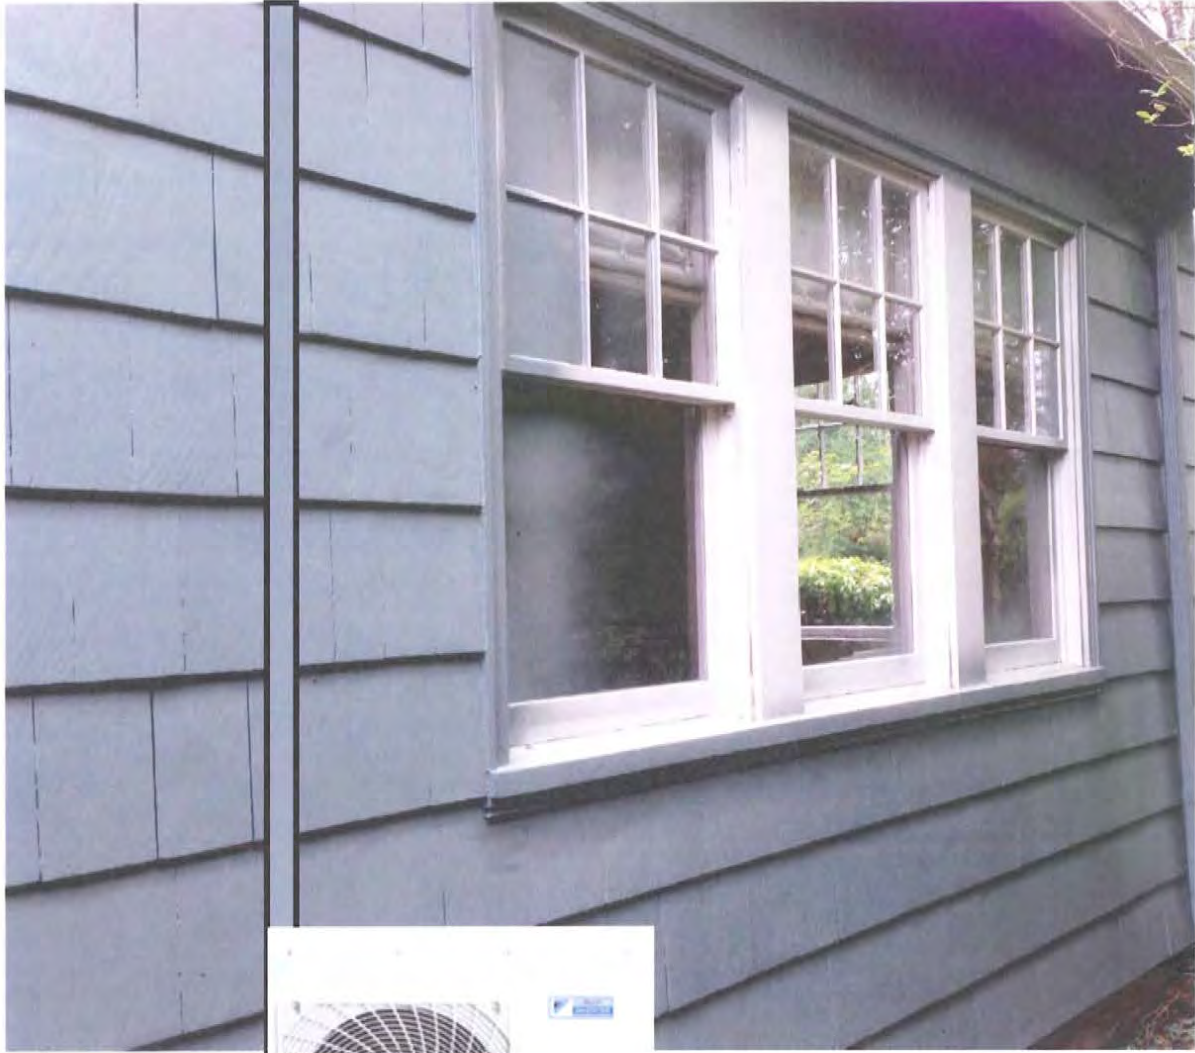
West side of house.

Daikin Ductless heat pump  
24,000 BTU's 3MXS24LVJU

The proposed new HVAC unit will be 32" wide x 12" deep x 29" high and will sit on a 14x34 cement pad. The 1/2" refrigeration line coming from the unit will be hidden in a metal "line hide" that is 4" wide and 1" deep and attached to the house using 1" screws. This "line hide" will extend from the HVAC unit up the exterior wall 10'6" to the soffit. The 1/2" refrigeration line will penetrate the soffit through a 1/2" hole that will be hidden by the "line hide".
