FOR THE MEETING OF: October 15, 2020
AGENDA ITEM: 5.a

CASE NO.: Historic Design Review Case No. HIS20-24

APPLICATION SUMMARY: A proposal to rehabilitate the front porch and replace the stairs, siding and non-original windows on the front facade of the Denison House (1910).

LOCATION: 1705 Court Street NE

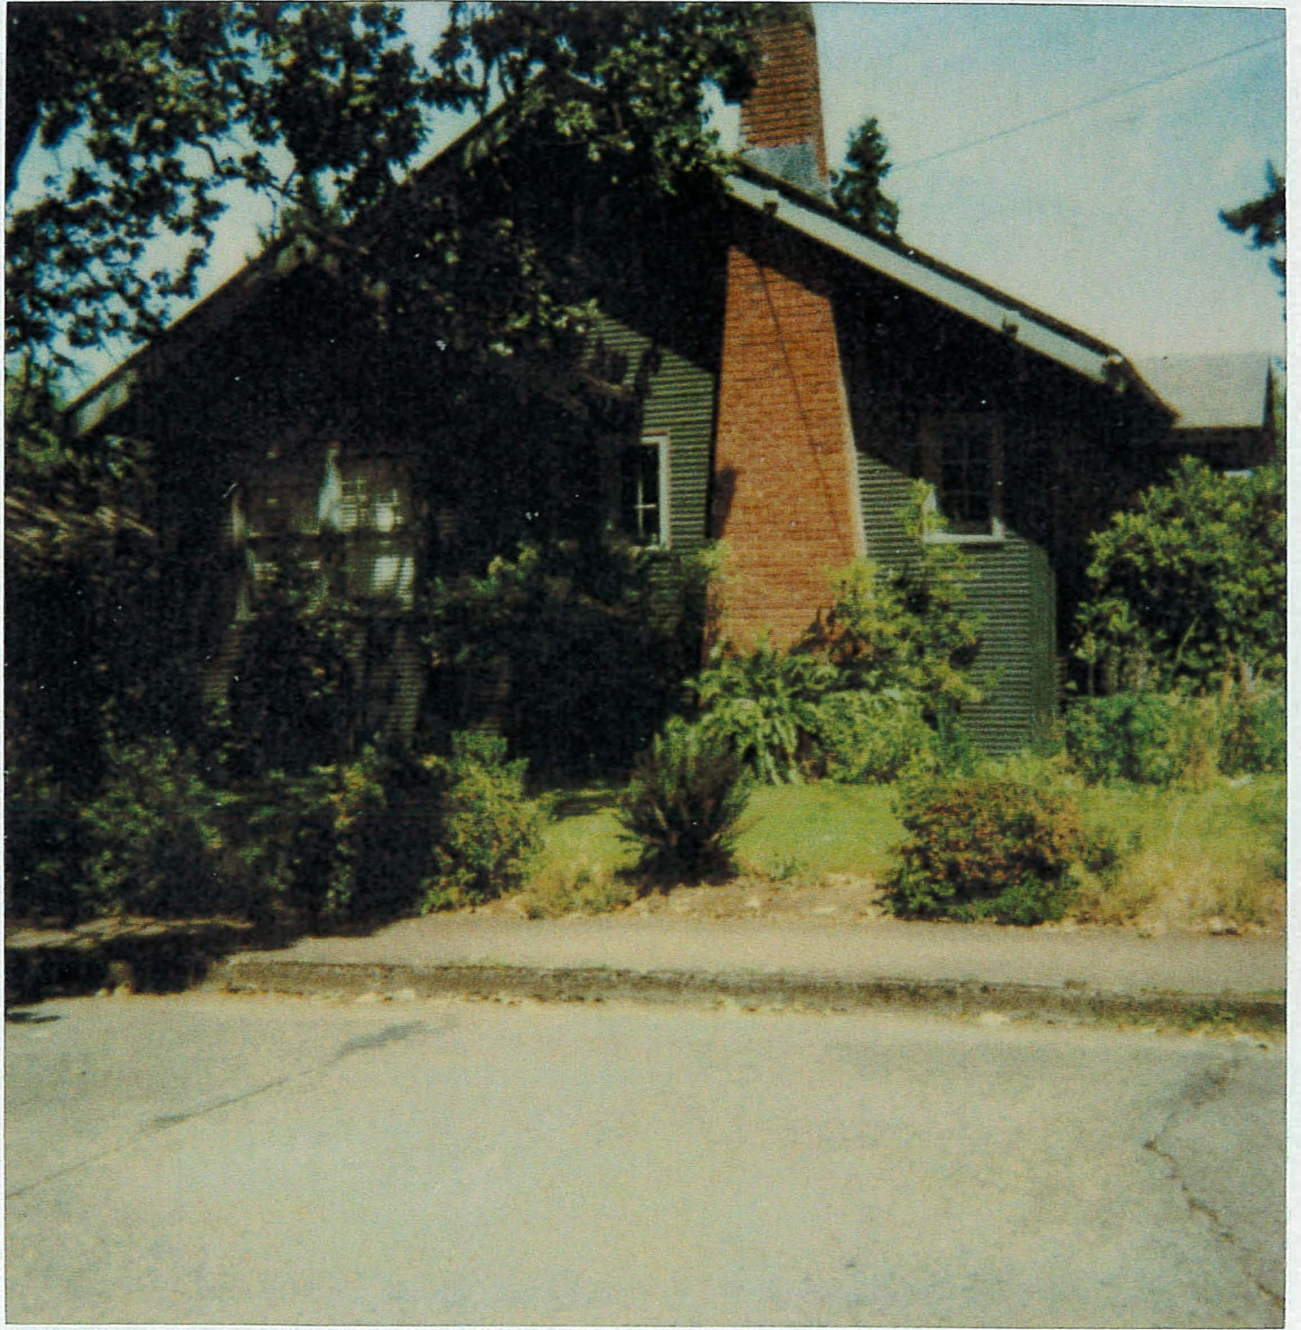
1705 Court Street pre-1915

the porch is not an original part of my home. A very early photo shows my house had only a gable covered stoop on the east side of the house. This stoop has been removed and replaced by the current porch roof at some point. A copy of this picture is named 1705 Court Street pre 1915.

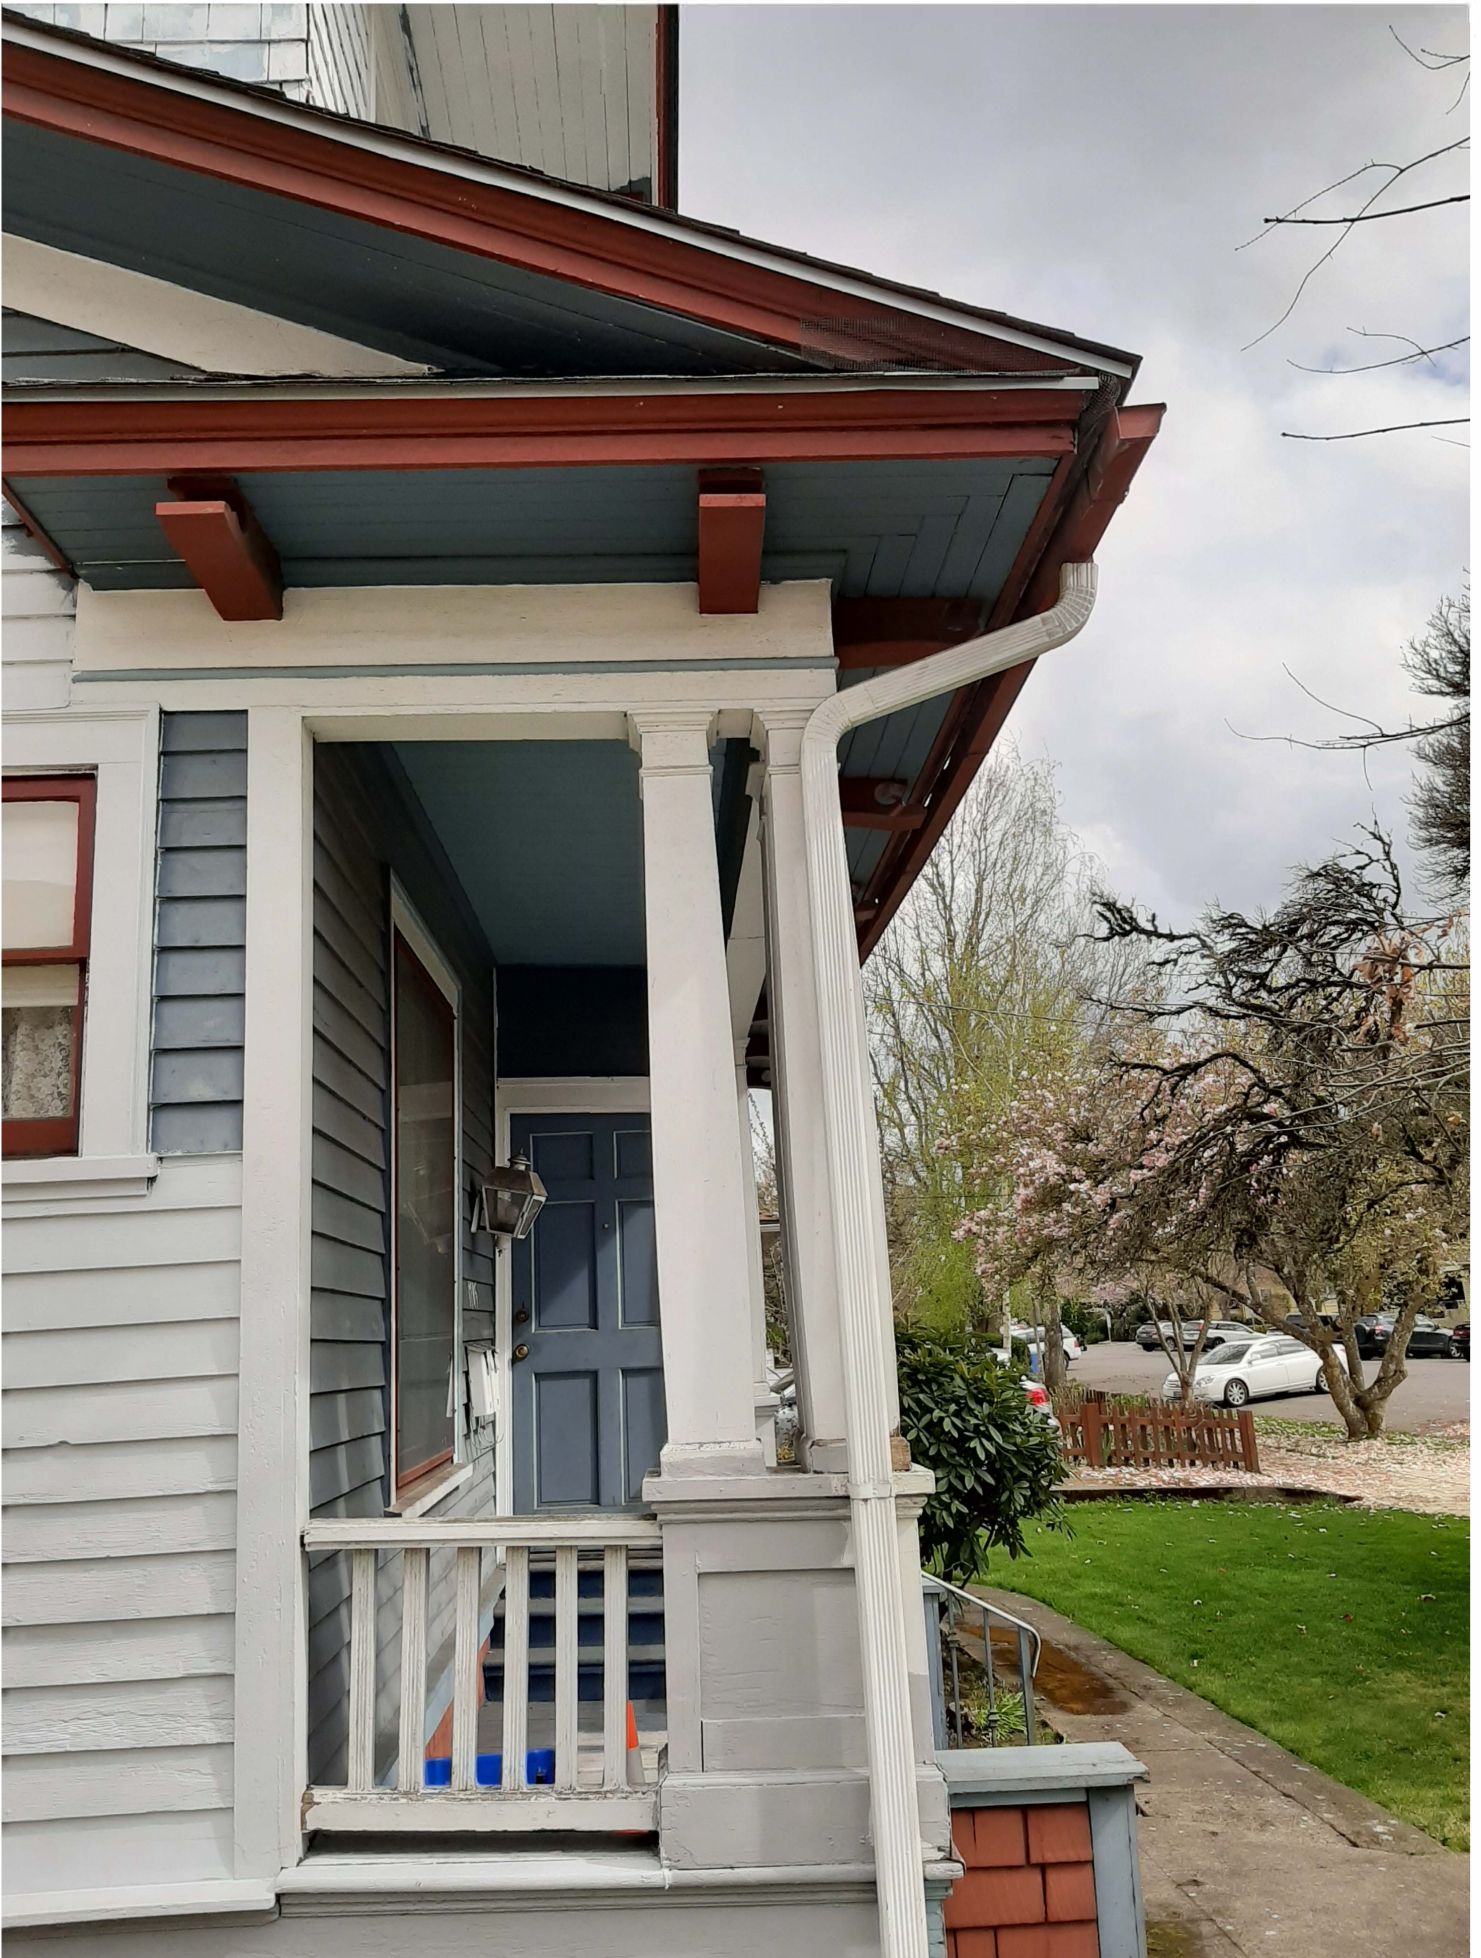
westside of 1705 porch

My porch needs to be repaired due to dry rot and water damage that occurred over the years. Some of the damage is due to water intrusion through the horizontal fenestrations or surfaces projections.

Outside porch: The floor and the steps of the open porch is slightly lower on the eastern portion than the western portion. This is an indication there may be deterioration.

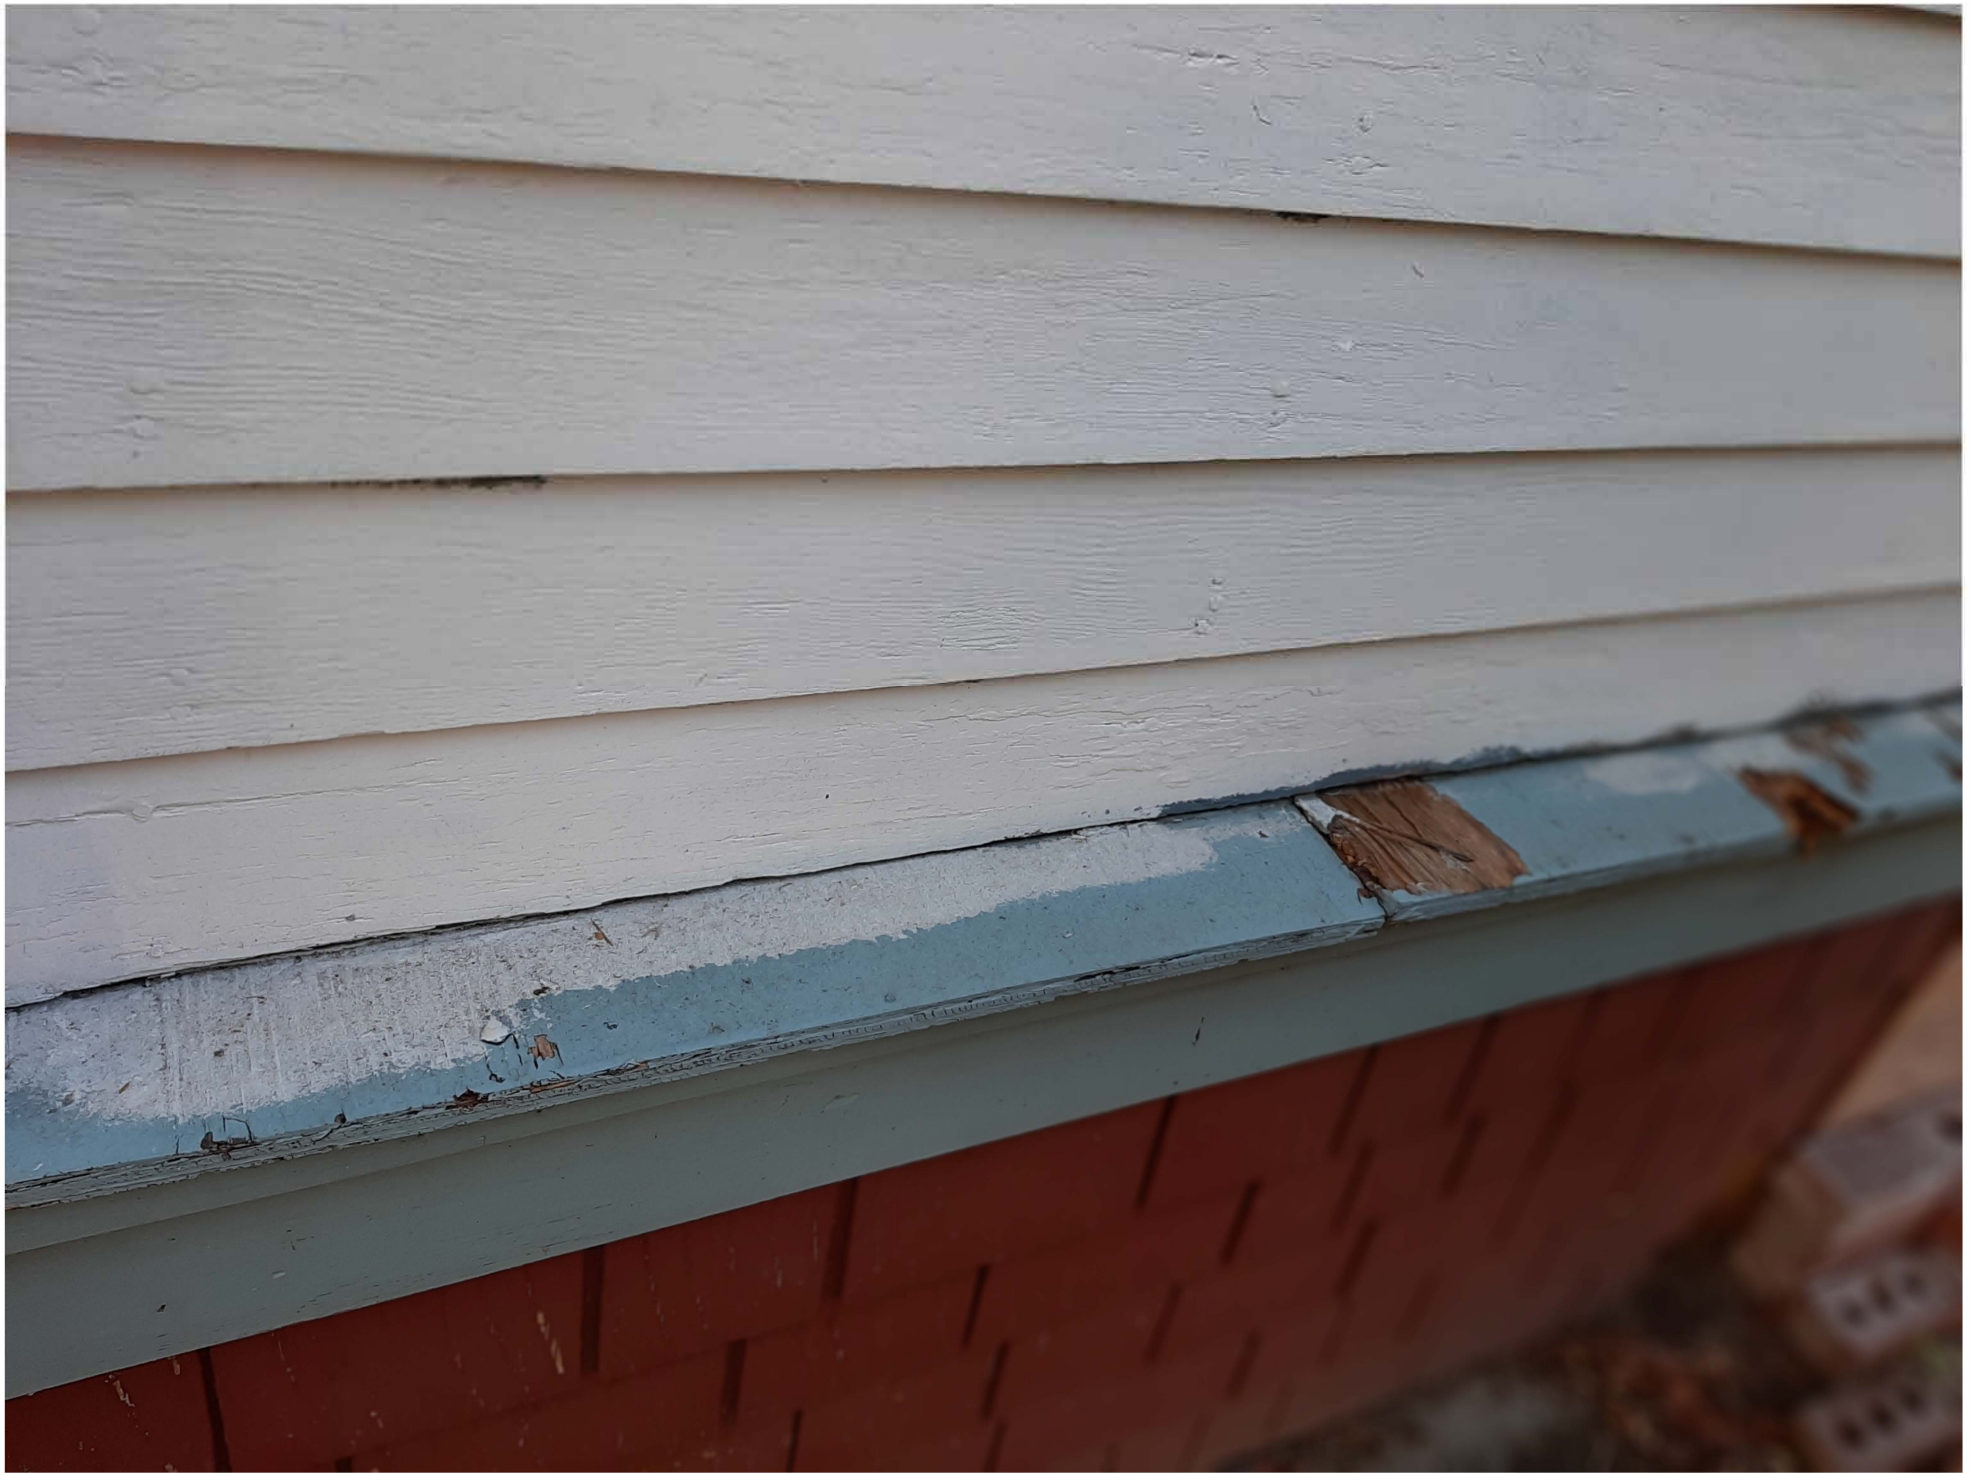
porch subfloor projection

South and east walls: The lap siding portion of the wall under the windows is currently set back approximately 2 inches from the apron of the porch, and the plywood subfloor projects out approximately 4 inches from the lap siding. Two inches of this is due to the lap siding wall being set back from the apron and the other two inches consists of a 1 inch covering a trim board and a 1 inch overhang. This part of the plywood is exposed on the exterior and has water damage.

The subfloor material, which was originally all tongue and groove wood, projects out into the exterior space. This is different from the open part of porch on the west side. The outer 16 inches of the tongue and groove floor was replaced with plywood in the western 80% of the floor, and the remaining tongue and groove flooring material is separating due to deterioration or settlement. Having the plinth boxes sitting on top of the subfloor is change that was not present originally and different from the western part of the porch.

The floor framing of the porch includes plywood sheathing at the perimeter that projects beyond the sill of the windows and captured moisture which is dryrotten and needs replacement. The original subfloor is 2x decking that is largely intact but will be disrupted when construction proceeds. The perimeter of the stoop is supported off a 6" concrete stem wall and footing perimeter that appears stable but the slope in the stoop to the south suggests that settlement may have occurred over the years. It is not necessary to elevate or modify the footing or stem wall. We would suggest that the 2x4 cripple wall be reconstructed and the floor joists elevated to moderate this slope to a minimum to deflect water (1/2") and not so steep to be awkward such as presently(1.25"). Furthermore the 4x4 posts in the crawlspace under the corner columns are dryrotten on the ends near the base. These posts should be replaced with pressure treated material resilient to future moisture absorption. The steps are in particularly poor condition at this time and need to be rebuilt to match with new material.
