FOR THE MEETING OF: October 17, 2019
AGENDA ITEM: 5.a

CASE NO.: Historic Design Review Case No. HIS19-37

APPLICATION SUMMARY: A proposal to restore and repair the exterior of the Sweetland-Peck House, c1895.

LOCATION: 1552 Court Street NE

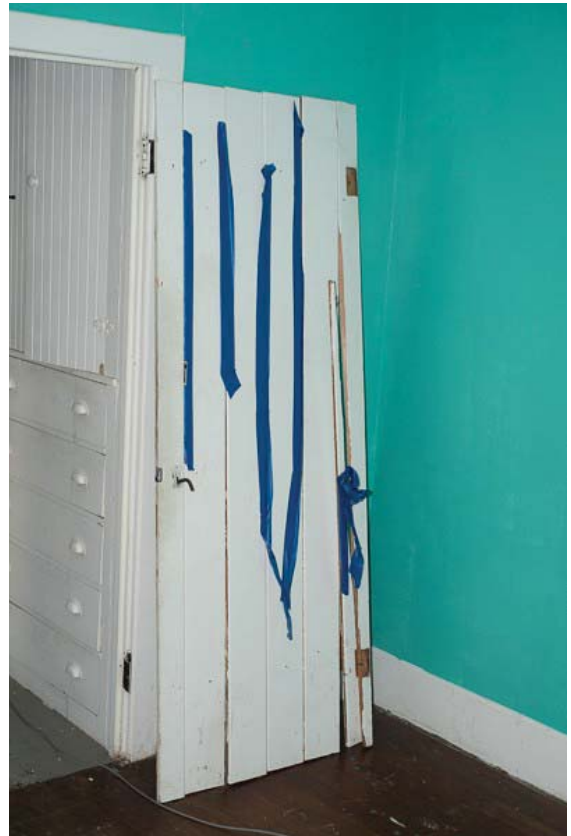
Figure 3: Smashed Interior Door from Tenant Rampage

During the violent episodes, crashing of doors and heaving of furniture were heard at the next door house at 1566 Court Street. Evidence of the rampages is evidenced by the broken interior doors found in the house. See Figure 3: Smashed Interior Door from Tenant Rampage. Earlier anecdotes from neighbors are that the property attracted vagrants who would congregate among piles of junk and within the neglected landscape that obscured their presence in the large front yard.

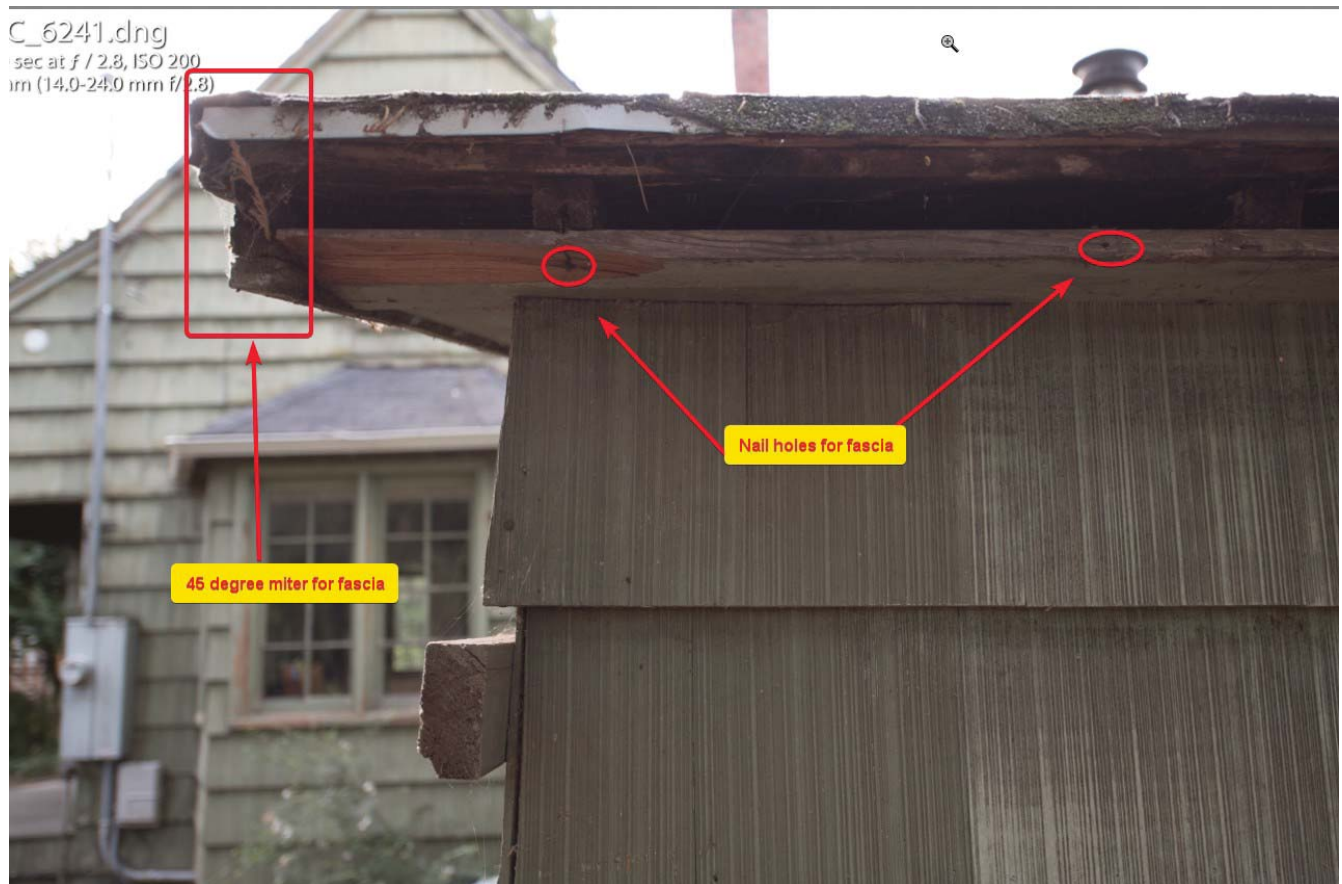
There is missing a fascia board on the end of the west, a wood fascia will be affixed.

Figure 8: Northwest Corner of Garage Depicting Missing Fascia

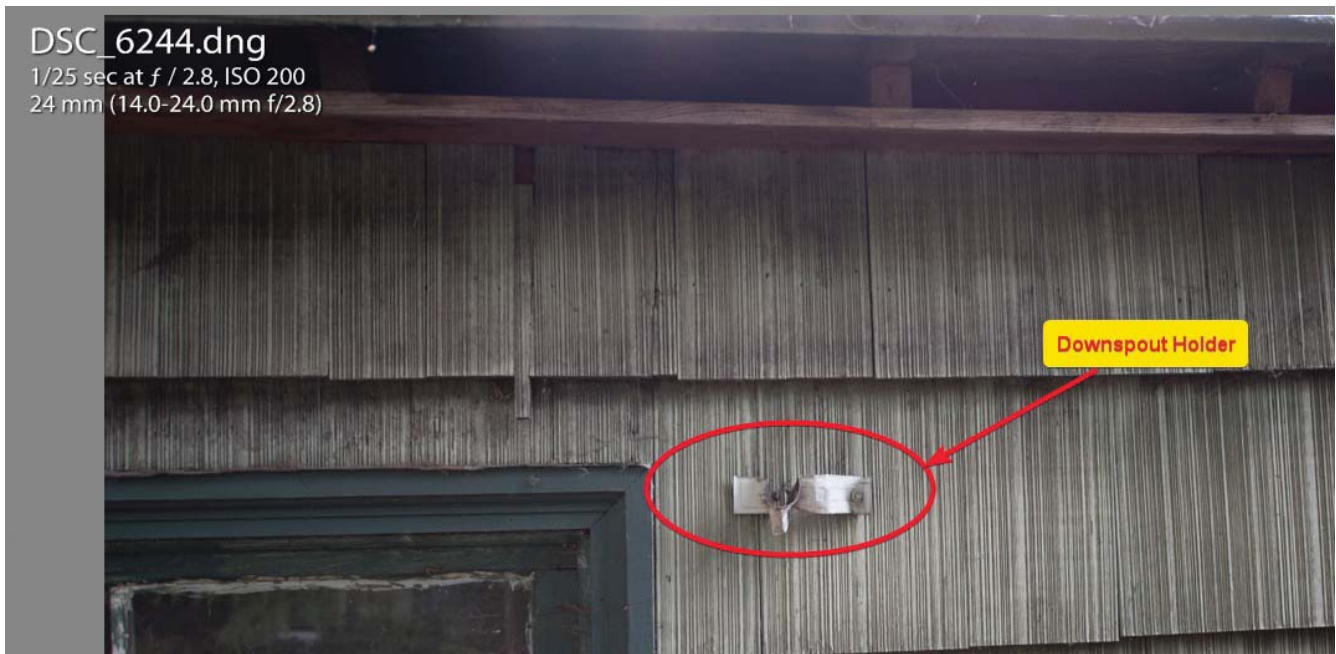
There are no gutters on the garage roof, so all the water falling on the garage is deposited along the west side of the garage. There is physical evidence of a downspout by the presence of a downspout holder. It is submitted that there had been a fascia with a gutter and downspout and those elements were removed and not replaced.

Figure 9: Garage Downspout Holder Remnant

The intensified collection of rain water along the shed roofed porch and garage roof creates problems for the structure. A gutter and downspout will be installed to divert rain water away from the structure. The gutters will be half round, approximately 3" in diameter. The material will be either copper, raw galvanized steel, or painted galvanized steel. If copper, the copper will be treated to appear aged – a process the applicant mastered for a significant historical home that had copper flashing, vents, gutters and downspouts.

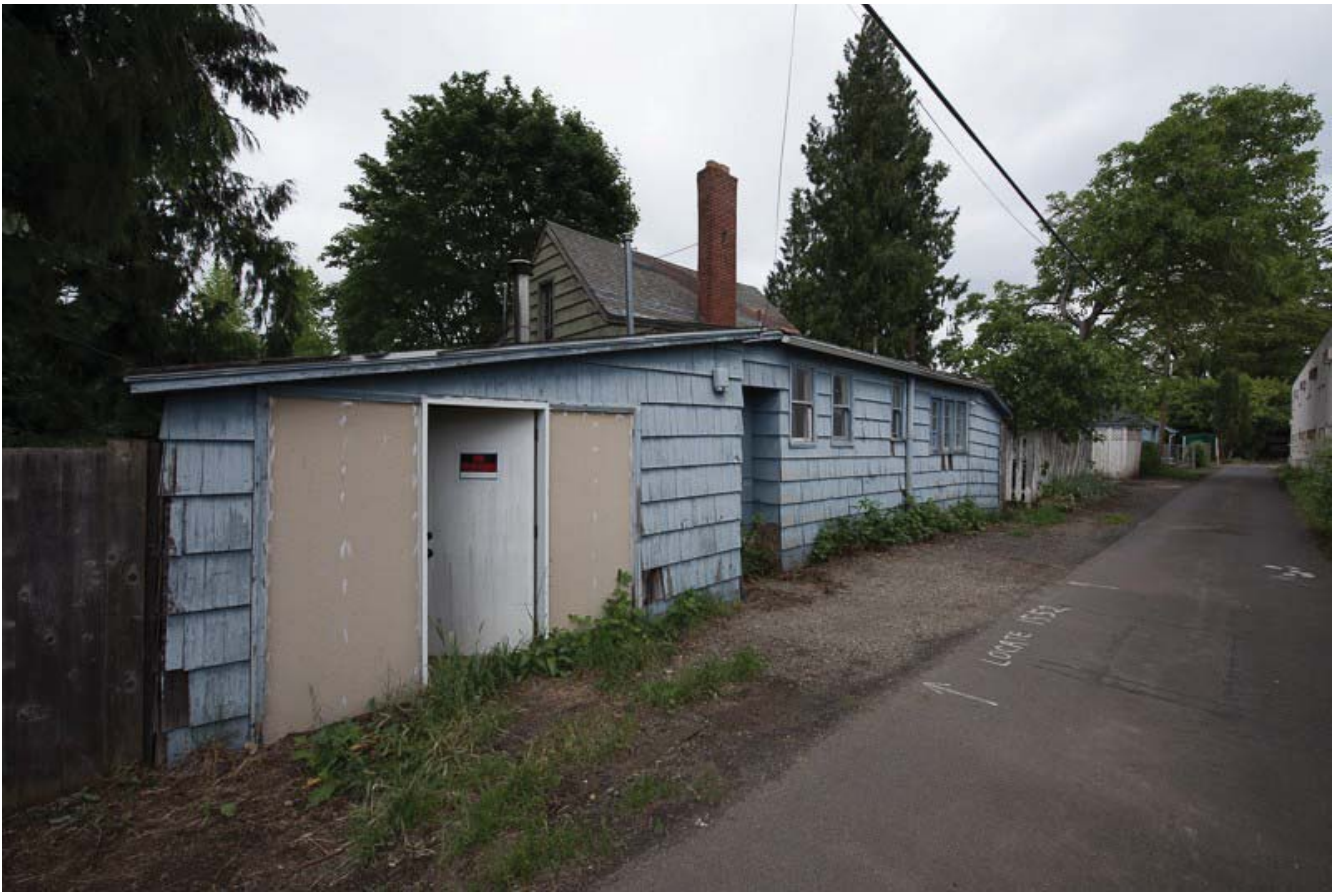
During prior ownership, the garage door had been removed and a fixed wall with a regular doorway inserted. An administrative application to replace the infill with temporary working garage doors so the garage could be utilized for storage of a vehicle pending this hearing was approved on July 11, 2019. There currently are plywood doors on strap hinges that serve as garage doors for vehicle access.

Figure 11: Garage Door Infill as of May 27, 2019

The garage is an extension of the western porch. The joists of the garage roof are attached to the rafter tails of the porch. We propose to keep the exterior of the garage the same, but pour footing on either side of the current garage door to support a door system that will not sag or rack. The new garage doors will be 3 panels in order to minimize the outward swing. The garage flooring is about four inches below the current asphalt surface in the alley and full swinging door.

The new garage doors will be Port Orford cedar and either left natural with an oil finish or painted. There will be glazing with opaque glass or security glass of four lites for each window. The exterior "brick mould" trim will be replaced with wood trim that matches the

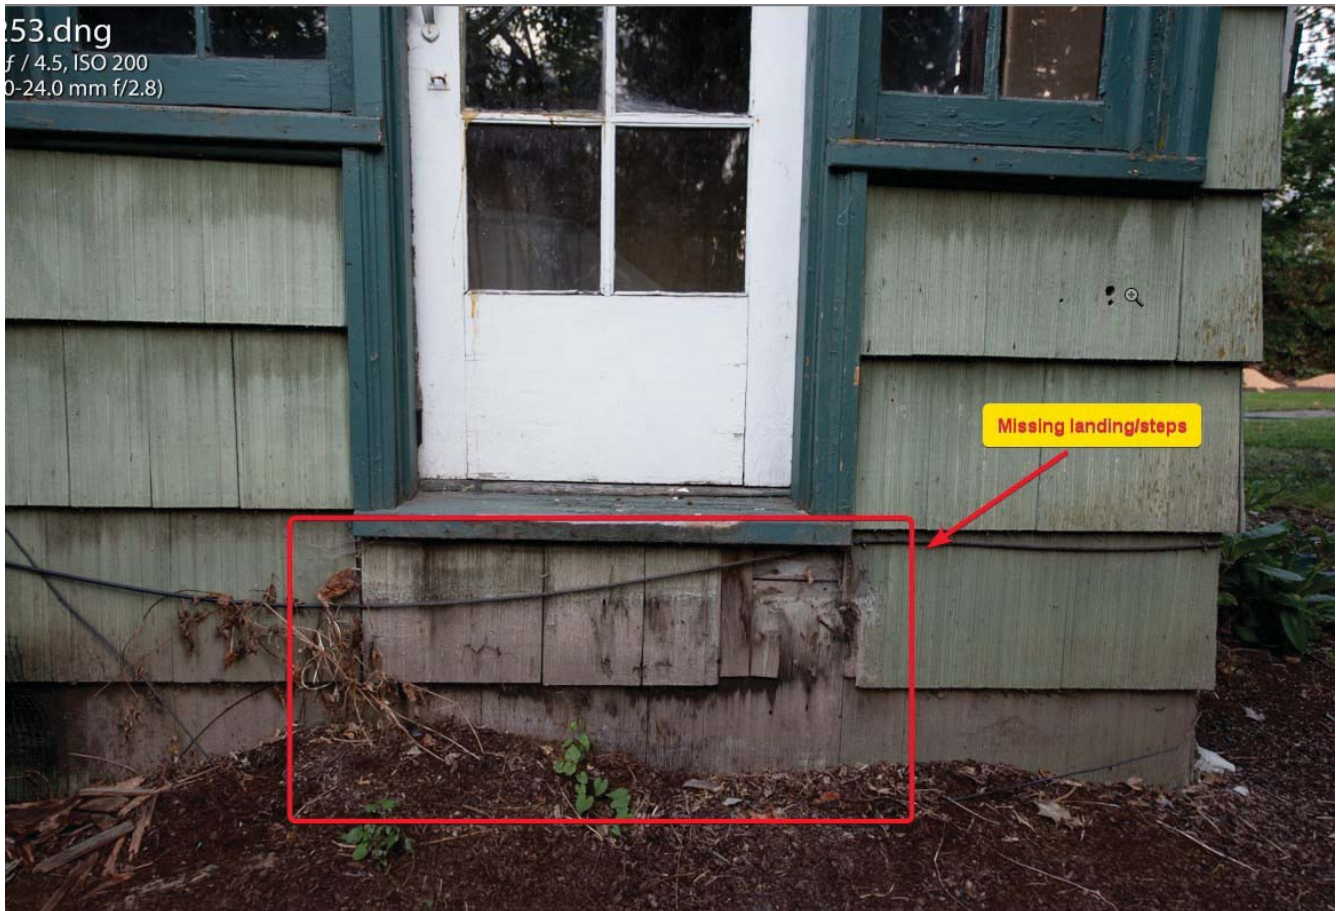
Figure 13: Eastern Facade Showing Missing Landing

The house facades will remain the same, except that the eastern facade from the living room and sun room will have a new wooden landing extending 36" eastward with two steps to the ground. The material will be wood and kept to the minimum required by code, e.g. 36" in direction of travel.

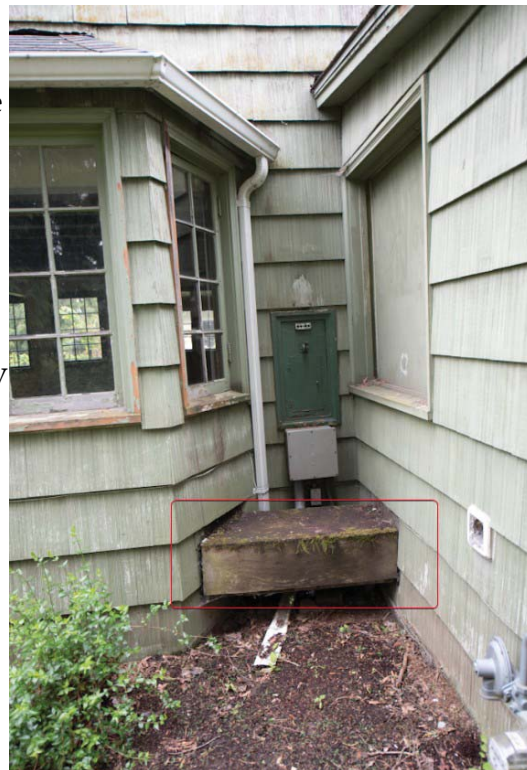
Figure 16: Exterior Heating Duct Serving Bay Window

Remove wood-encased heating duct serving the bay window. See Figure 16: Exterior Heating Duct Serving Bay Window. There is a heating grate installed in the floor of the Bay Window. The duct serving the floor grate runs through the bay window wall and then through the east porch wall where it connects to a main duct running into the gas heater in the garage. This was a short-cut taken by the heating installer and impairs the visual facade, although the treatment of the duct with a wood casement softens the blow. When foundation work is undertaken, we may opt to reroute the ducting keeping the ducting under the house thereby making this transition superfluous.

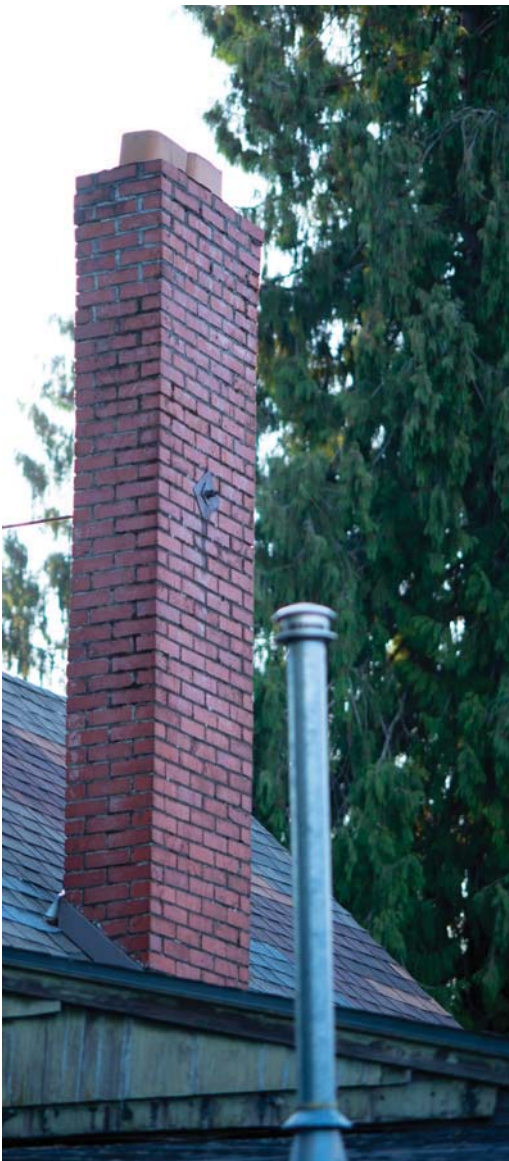
The current chimney is not seismically safe and poses a hazard to the bedroom and rooms below it. We propose to remove it and replace with a chimney of the same size and dimensions using light gauge steel or wooden framing with a veneer of brick of similar color so that the replacement structure appears the same. There will be a spark arrestor at the top.

Figure 21: Chimney View At Back Looking Northeast

The firebox within the house may also be replaced, the decision to replace will be based upon our findings about the foundation as well as the worthiness of the firebox and smoke shelf once we remove the chimney.

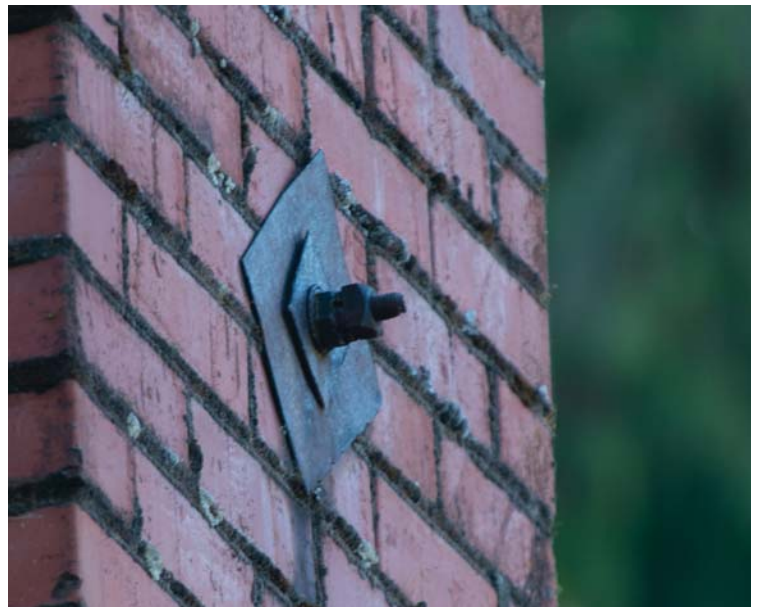
Figure 22: Chimney Brace Plate Detail

The plate tying in the brace will be re-used and a supporting bar of similar dimensions and patina from the roof will appear for aesthetic purposes.

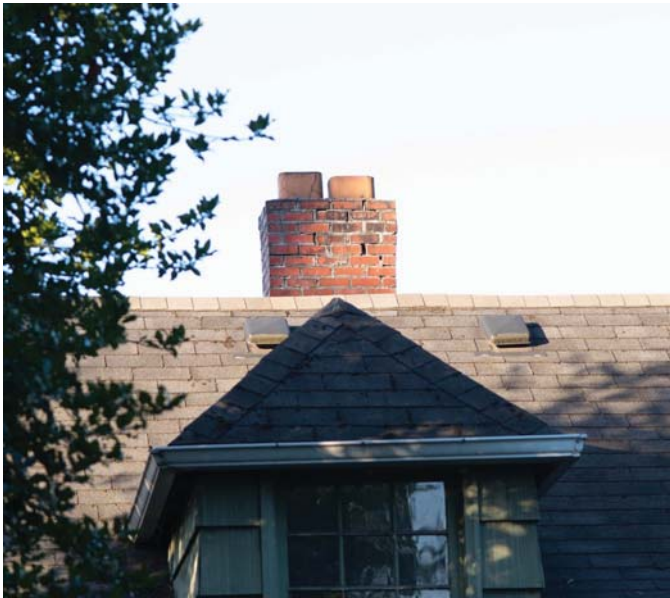
Figure 23: Chimney View Looking South Towards Front of Cottage

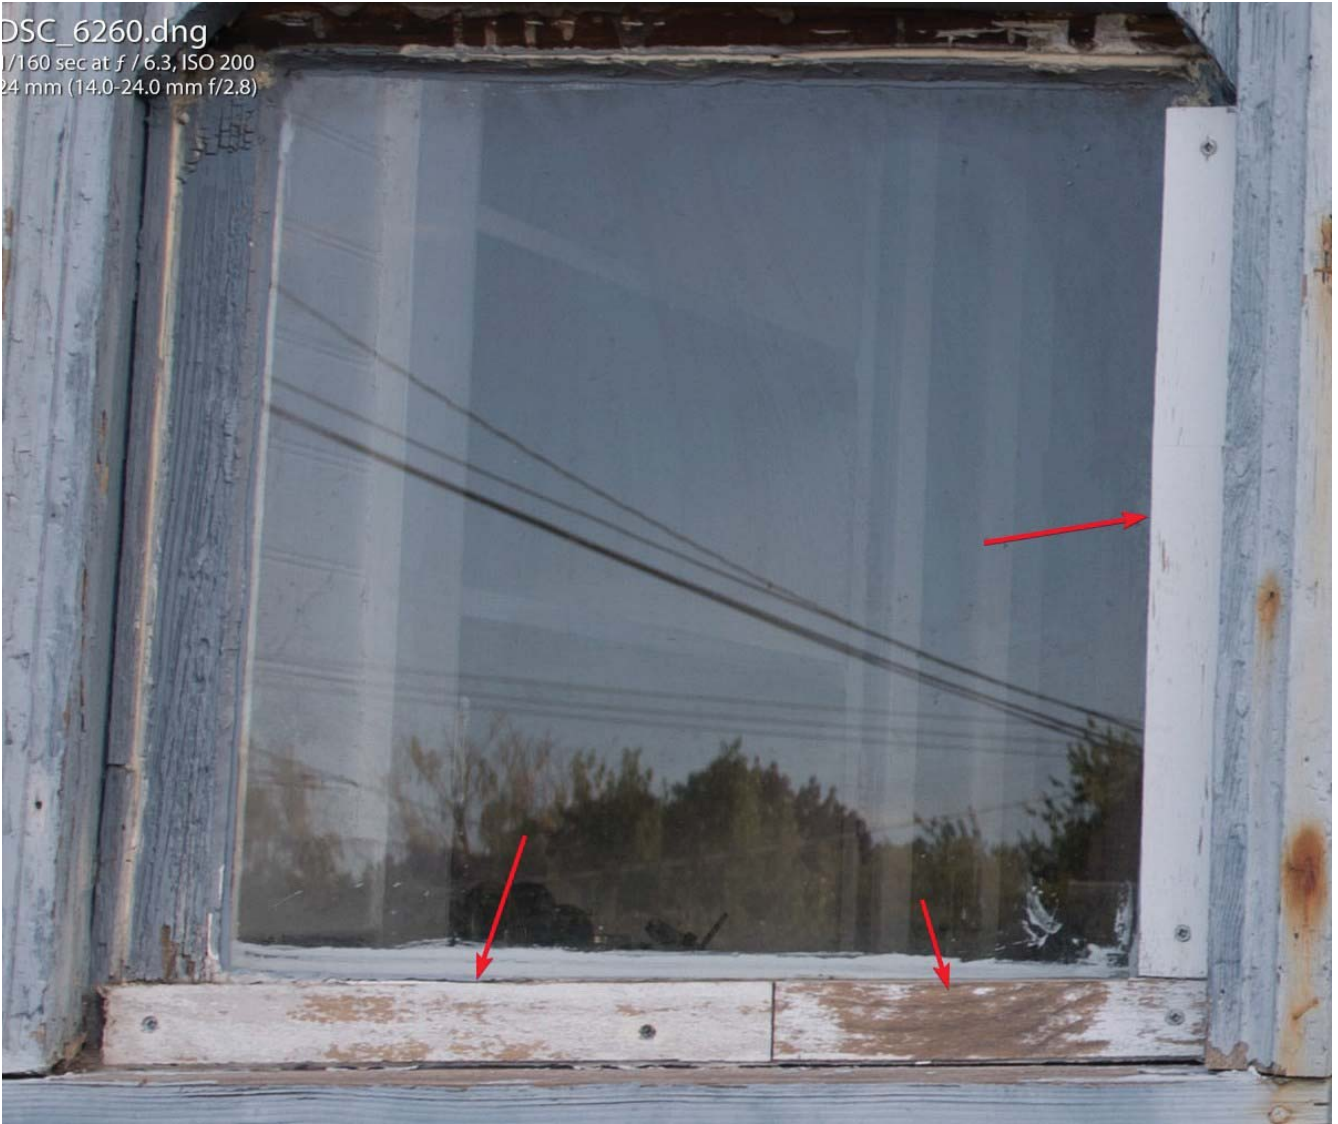
- 1) Kitchen Window – double hung with gypsum board screws holding sleeper boards, see Figure 32: Kitchen Window With Sleeper Support.
- 2) Bedroom Window – casement with a crank, missing mullion, see Figure 34: Bedroom Window With Faux Mullion.
- 3) East Porch Windows – currently fixed glass, possibly matched other casements with screens. On September 4, 2019, a woman introduced herself to Juliana Inman saying she lived in the Peck Cottage over a decade ago and her quarters were the two porch rooms. She shared the house with several other renters. See Figure 33: East Porch Windows.

Figure 32: Kitchen Window With Sleeper Support

I want to be able to leverage any ToolBox grants and tax incentives, applications for which will require thorough documentation. My intent is to “repair rather than replace” or “replace in kind” depending on the severity of the damage.

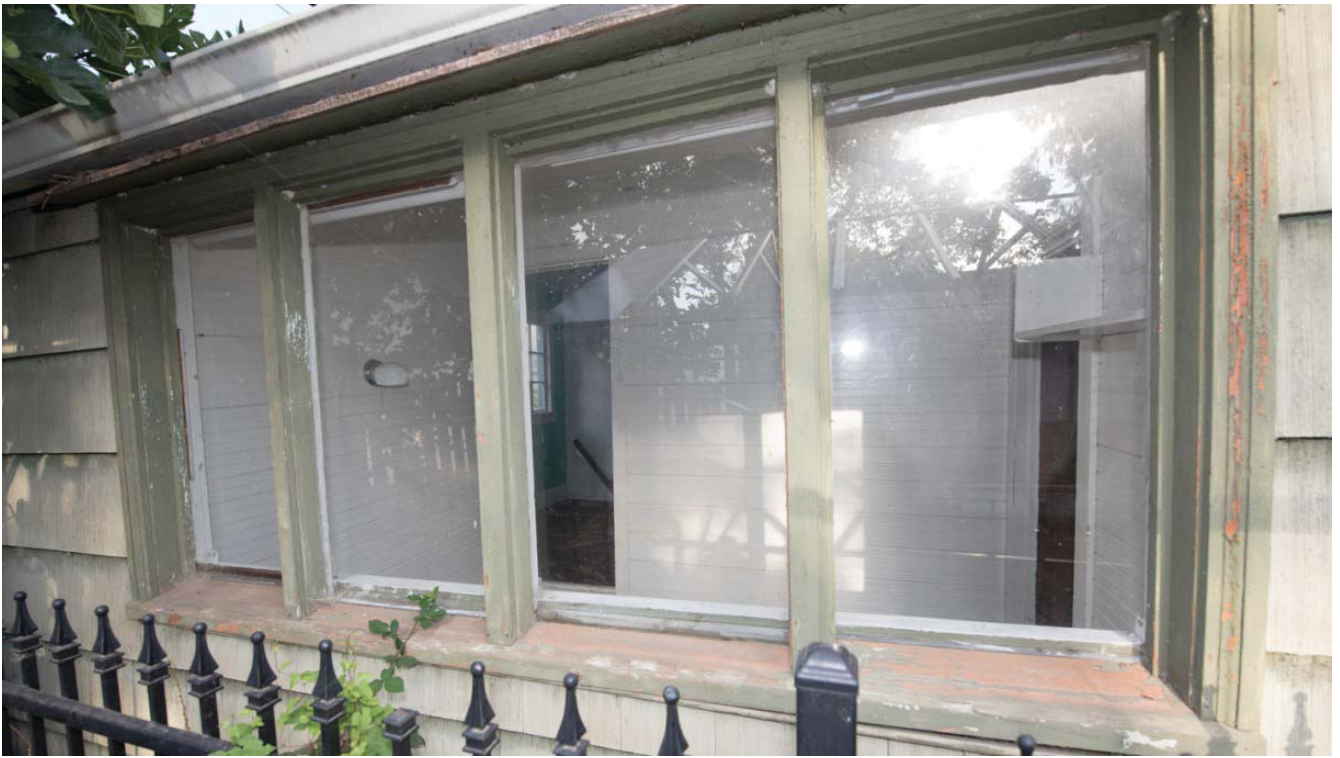
Figure 33: East Porch Windows

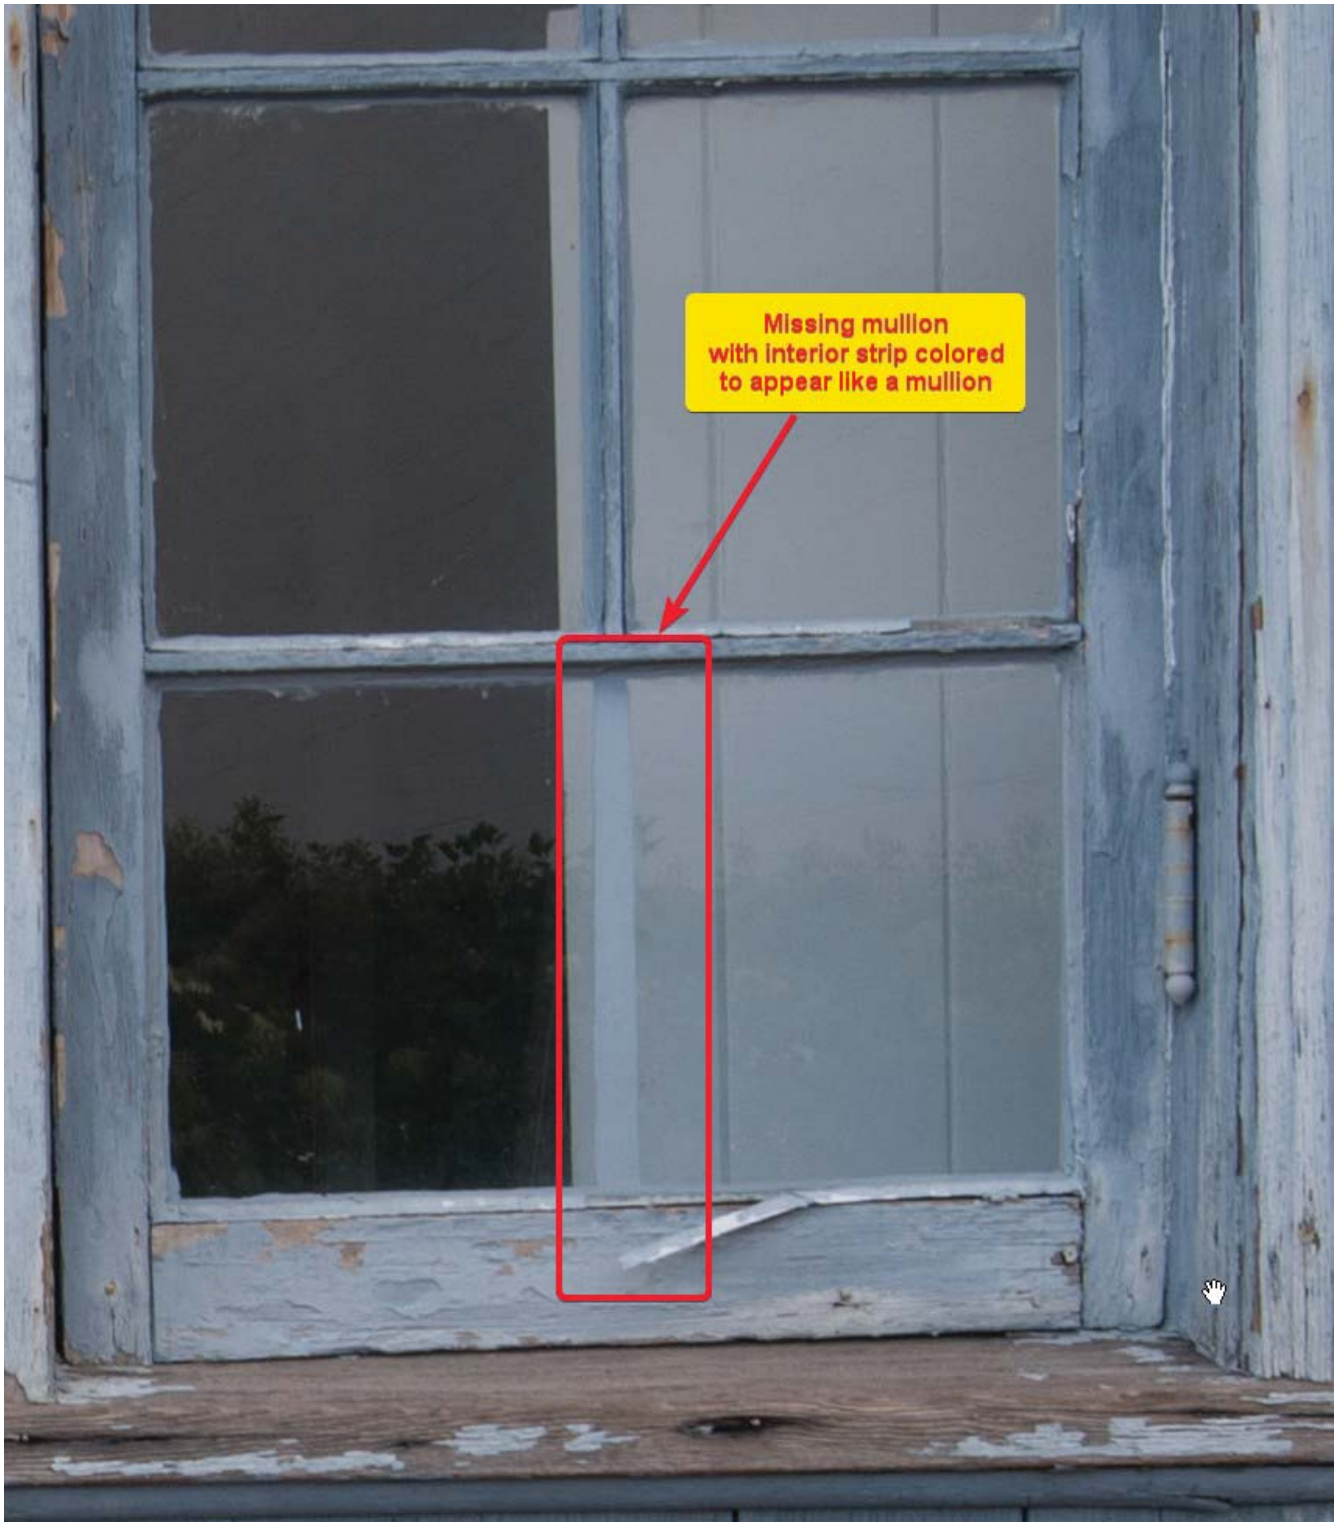
Figure 34: Bedroom Window With Faux Mullion

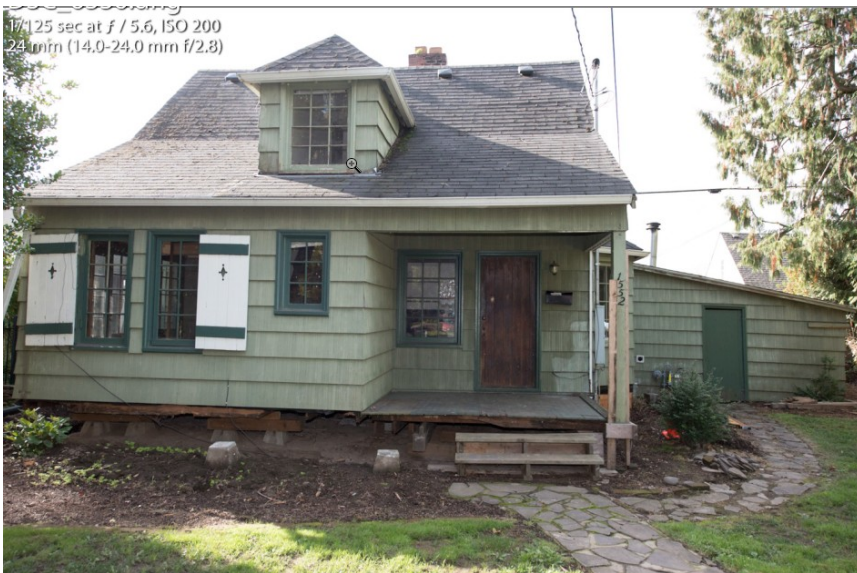
The front porch has two major problems. First, the corner support has a rotted base and currently is supported by *sistered* 2x4s. The post from the floor level up is sound, the supporting and separate post underneath is it rotted out. The second problem is the replaced floor boards that do not match the existing flooring; there is a difference in thickness and poses a tripping hazard. We propose to remove the replacement boards and replace those with appropriate thickness flooring so there is no difference in thickness. At the same time, concern was

Figure 2: Front Porch -- October 2019

expressed by City of Salem Senior Building Inspector, Ken Eatwell, that the porch may not be properly tied into the foundation of the house. This hidden floor framing will be repaired as foundation repairs are accomplished.
