CASE NO.: Historic Design Review Case No. HIS18-04

APPLICATION SUMMARY: A proposal to replace the failing front porch and bay window foundation, porch and steps; replace the non-historic rear upper deck and lower sunporch steps, hand railing and balustrades; and replace 24 windows on the Daniel S. Yoder House (c.1891).

LOCATION: 1811 Chemeketa Street NE

Daniel S Yoder House
1811 Chemeketa St NE
Salem, OR 97301

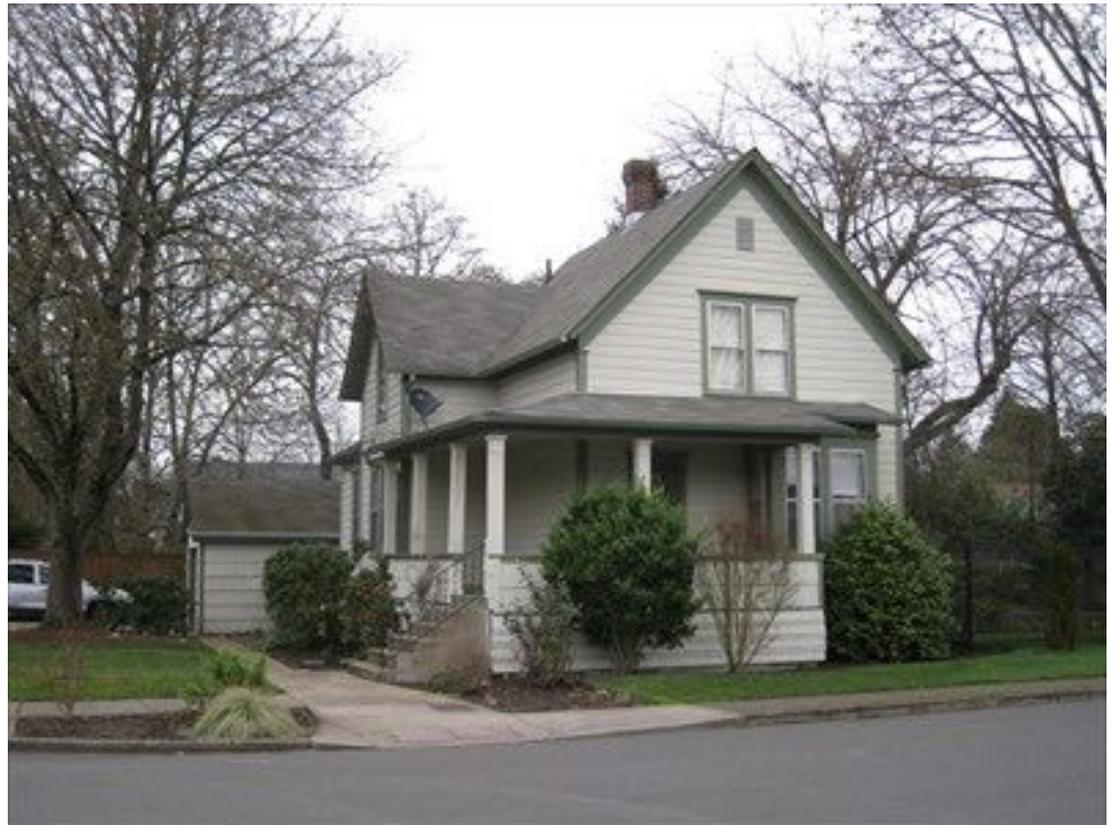
This is the area in the worst condition. The front porch appears to have had a foundation replacement sometime that was done in a substandard manner.

The porch and bay window foundation is dry stack cinderblock with no concrete or other stabilizing materials except chicken wire. The footing that the block rest on is not sufficient to prevent settling.

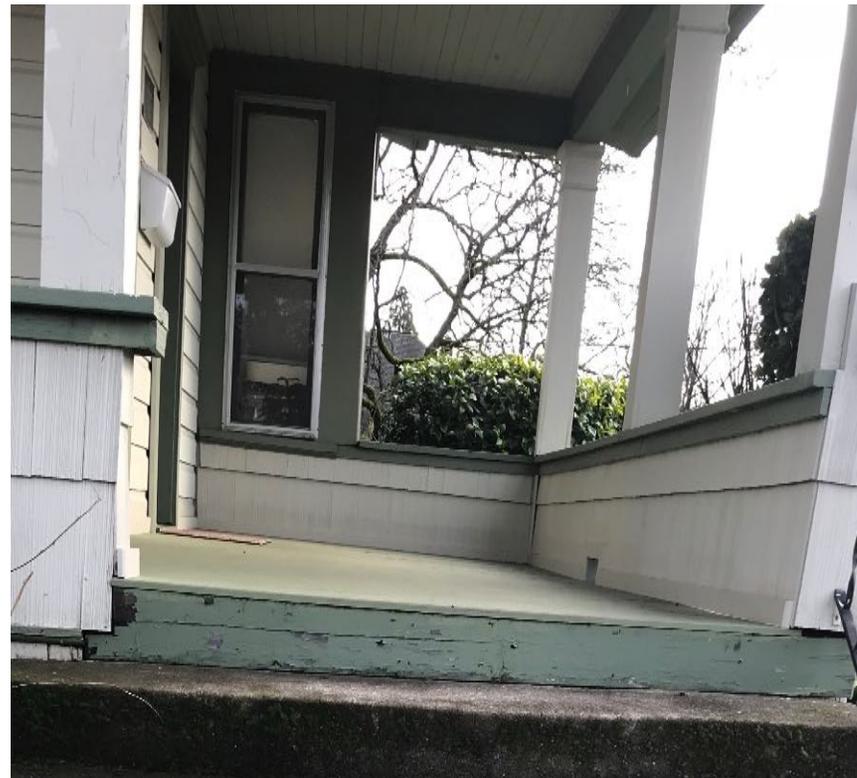
Porch View From Entry Steps

This a view from the stair side of the porch. The slope is a little exaggerated by the photograph, but it does show that the drop of the porch from square relative to the post in the foreground and the exterior wall of the bay window. To provide perspective, the far right corner of the porch is supported by the slipping foundation we just saw.

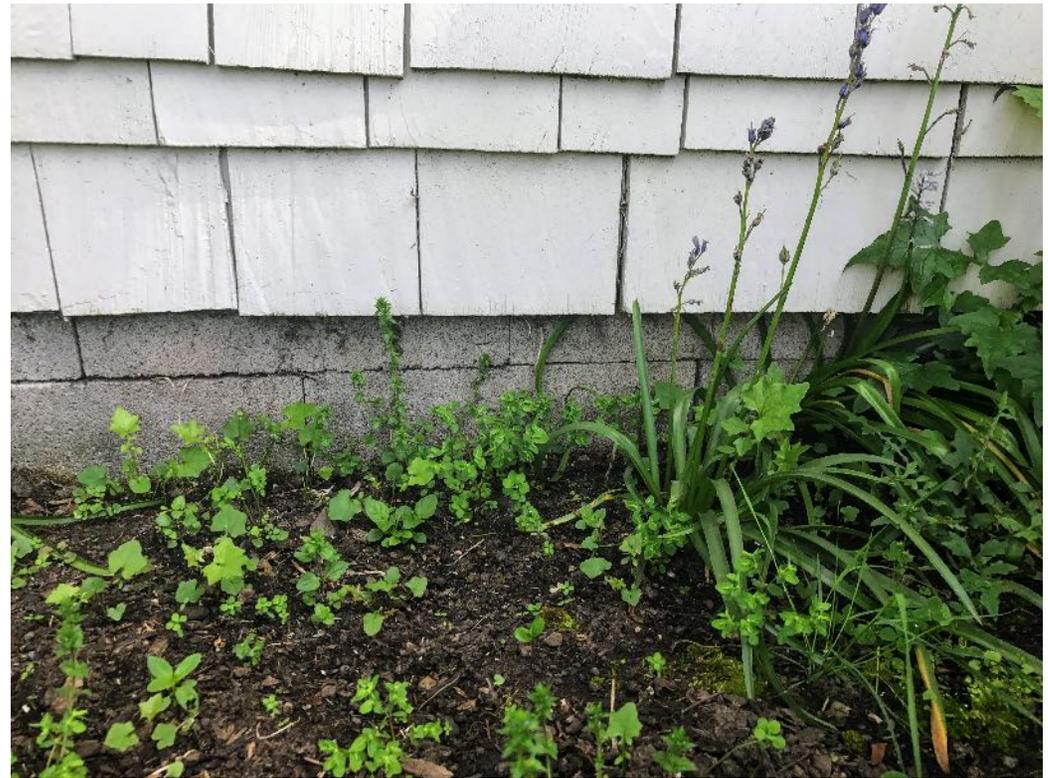
Exterior Photos

The photos from the exterior show that very little if any of the actual foundation shows from the exterior of the house. It also shows something more disturbing – upon close examination you will see there is no mortar, concrete or other binding material. These are hollow blocks filled with loose rock for stability.

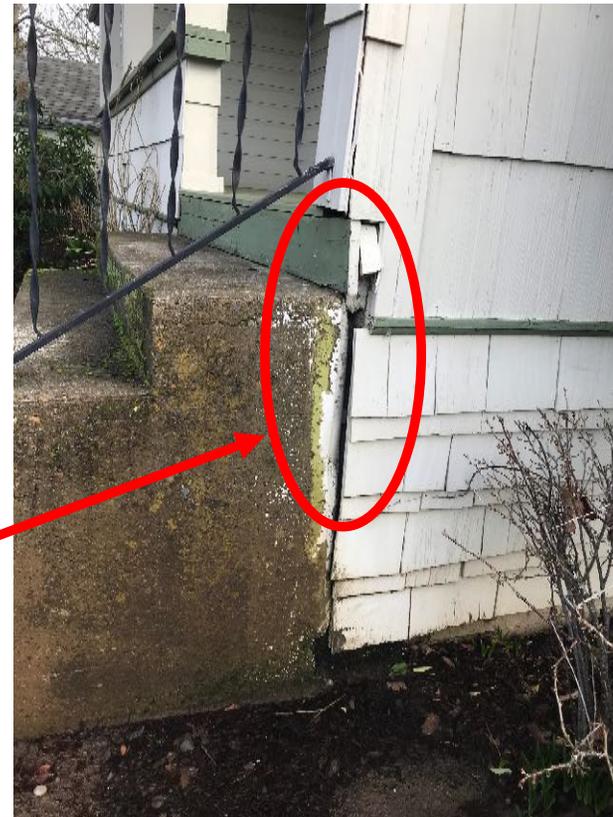
Contributing Factors –
Improperly Designed
Stairs - No Supporting
Foundation.

Looking at the stairs themselves, not only are they weathered they are very unattractive and not in keeping with the character of the house.

The design of the stairs is a contributing factor to the ongoing damage to the porch. There is no continuous foundation behind the stairs. The stairs themselves are used as unattached support for the front porch. This picture shows the porch sliding away from the concrete stairs.

- Demo and remove existing concrete stairs
- Form and pour new concrete landing at base of stairs to matching the style of the current walkway
- Frame and build new stairs with railing on both sides. Primary materials for the new stairs will be clear cedar supports and railings with Doug-fir treads.
- Stairs will be trimmed out and ready for paint.
- Painting to be done by when the job is complete.

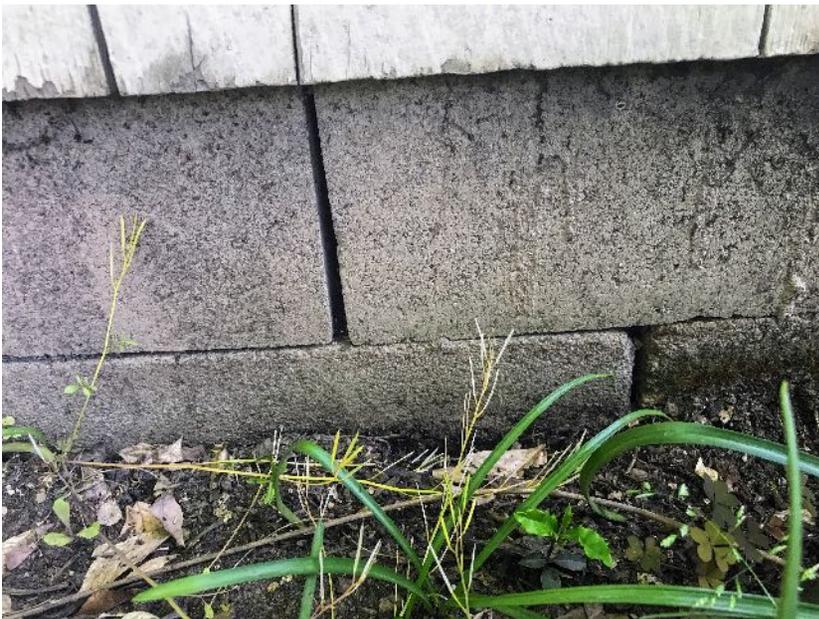
Close-up Exterior Photos

Close up showing no mortar or cement of any kind. This photo shows that the foundation is slipping apart

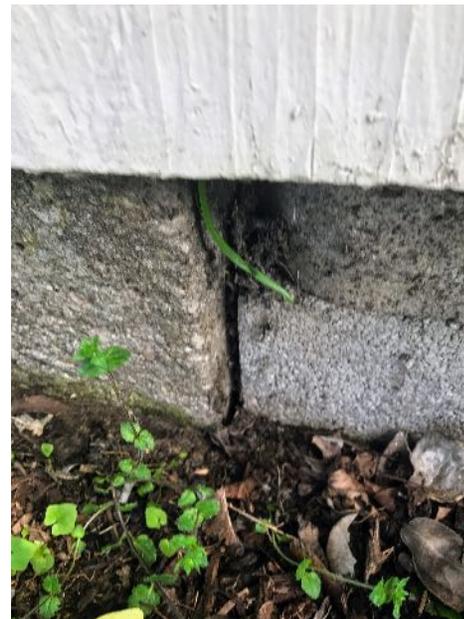
This photo shows that there are plants beginning to grow in the cracks.

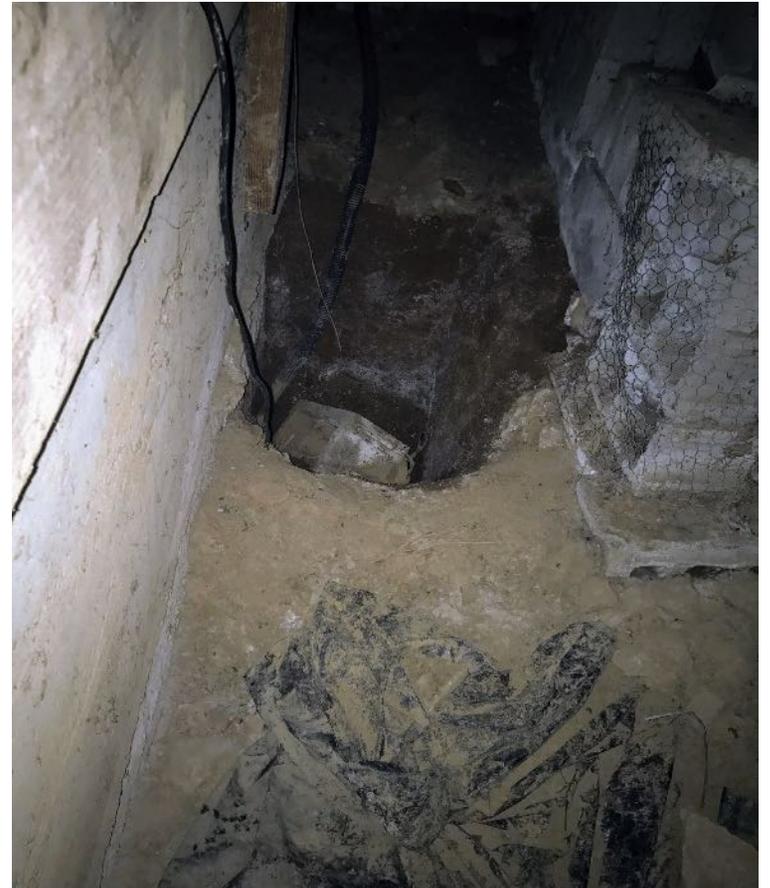
View Underneath Bay Window

The bay window seen on the right in the street view photo on the second slide and is supported by the cinderblock stack to the right in this photo. The edge of the plastic tarp is evident in the foreground. On the left of the photo is the concrete foundation of the main house. Straight ahead is a hole dug between the house foundation and the foundation of the bay window where a sump pump was placed. The dry stack cinderblocks secured with chicken wire on the right face Chemeketa St NE.

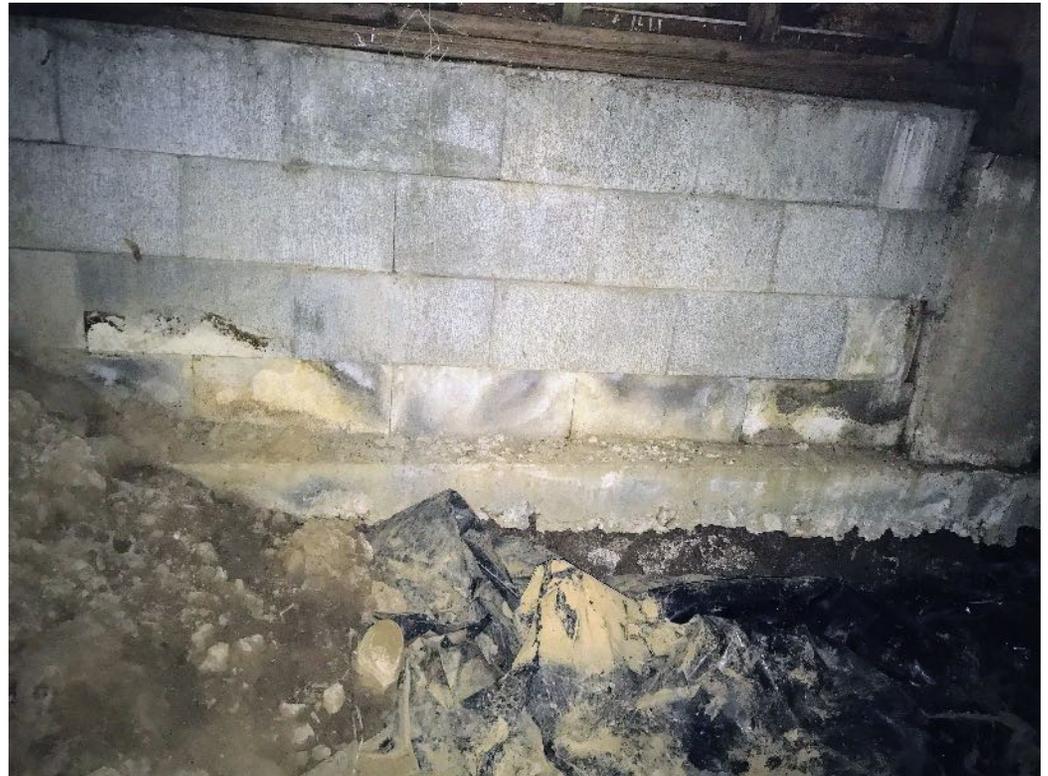
Interior View Underneath Porch

The severity of the problem is seen from a crawl space accessed through the basement. The top course of block is the course above ground in the previous photo. The wood header in the photo is where the deck and the foundation attach. The footing below is the only concrete in this foundation section. This concrete runs about 8" deep. The cinderblocks are dry stacked upon one another.

The watermark on the blocks below show that the water has been seeping in for years. A previous owner covered the dirt with a plastic tarp to control the moisture level under the deck.

- Level front porch and construct new foundation
- Hang 4X6 beams no more than a span of 6' through the crawl space under the front porch
- Level the soil and install precast 18" pads with adjustable brackets under the beams
- Set 4X6 posts in the adjustable brackets
- Mechanically connect the posts to the beam and the post to the adjustable brackets
- Attempt to lift and level
- Once we have lifted to the maximum we will hand excavate the exterior soil around the foundation
- Cut and remove Concrete steps to the front porch
- Remove the dry stacked block, we will leave the solid concrete pillars
- Drill and set steel into the existing footing and the concrete pillars to help bind new concrete
- Build and set forms flush with existing pillars
- Set a steel grid inside new concrete foundation
- Pour Concrete and let set, remove the forms
- Back fill excavated soil

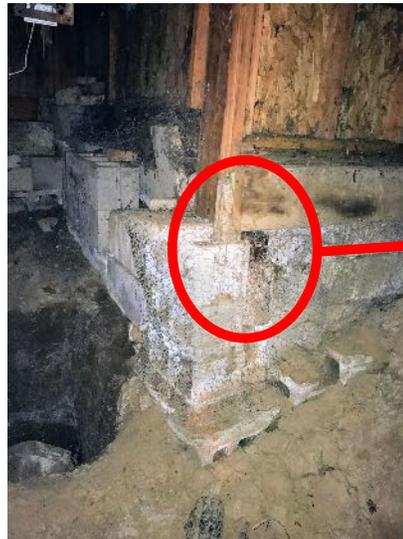
Foundation Wall Close Up

These photos are from underneath the porch, facing east.

The dark spot identified with the red circle shows a large gap due to shifting of the foundation. Above the dark gap to the left shows that the load of this corner is supported by about 2.5 inches of cinderblock.

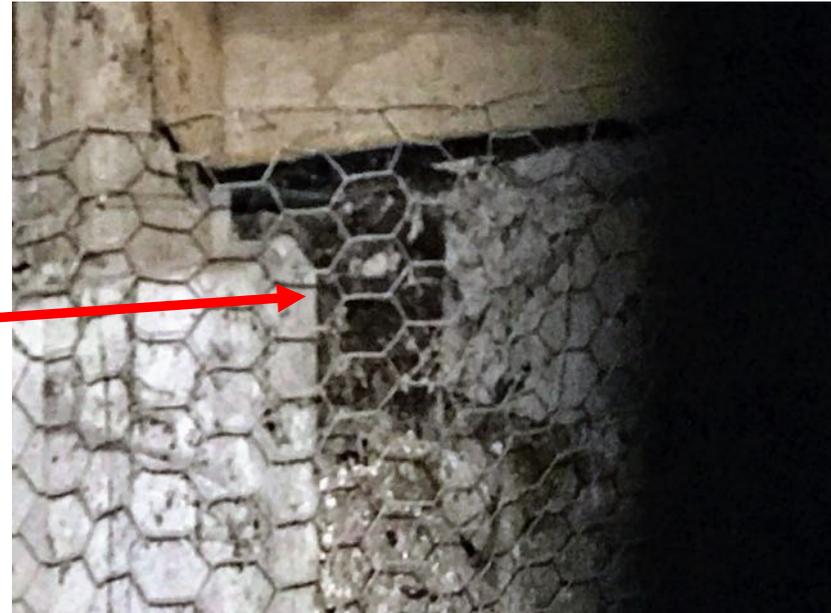
The chicken wire is stapled to the underside of the bay window structure in the hopes of keeping the foundation blocks in place.

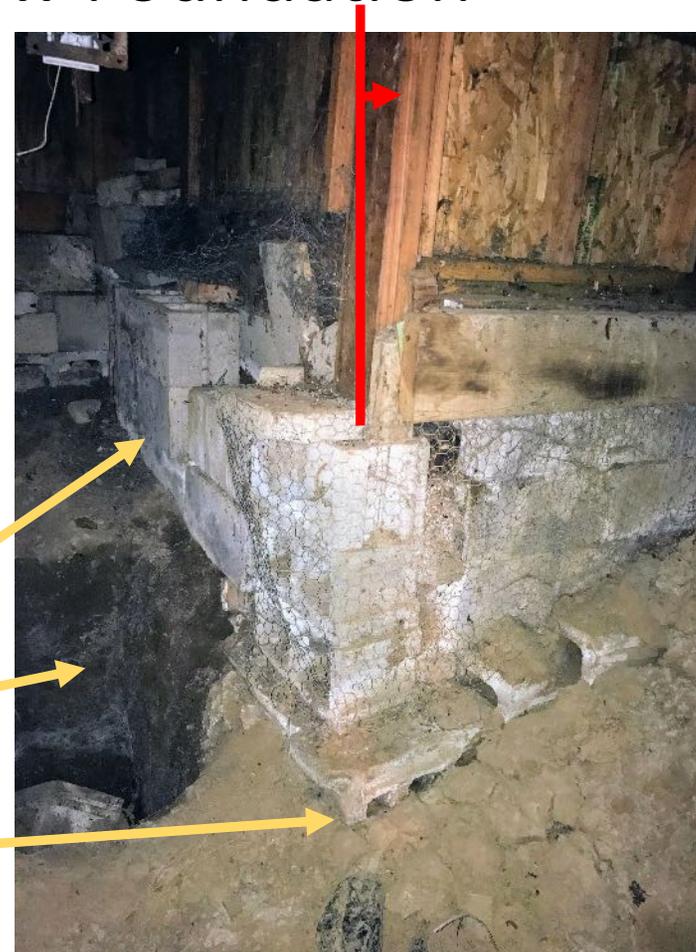
Additional Detail on Foundation Closeup

In this enlarged picture, several reasons for the shifting of the foundation are apparent.

- 1) There is no fill at all in many of the cinderblocks.
- 2) The foundation is slipping into the large hole created by the improperly installed sump pump.
- 3) The unfilled cinderblocks used as footers can not bear the weight of the structure.

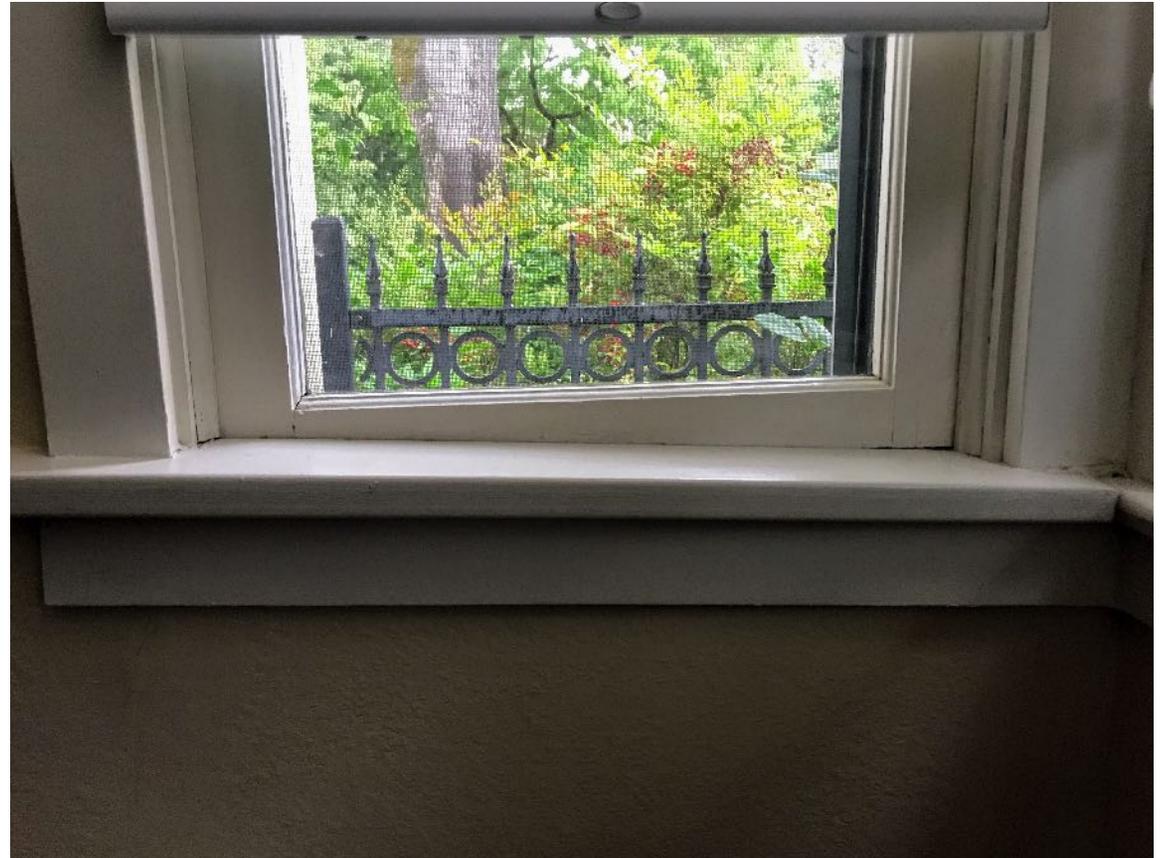
Porch Settling Impacts Visible Inside the House

The view out this window looking toward 19th Street shows how far the floor has sunk in that area. The line of the window is about even with the line of the fence, but the floor has dropped nearly three inches as shown by the slope of the windowsill.

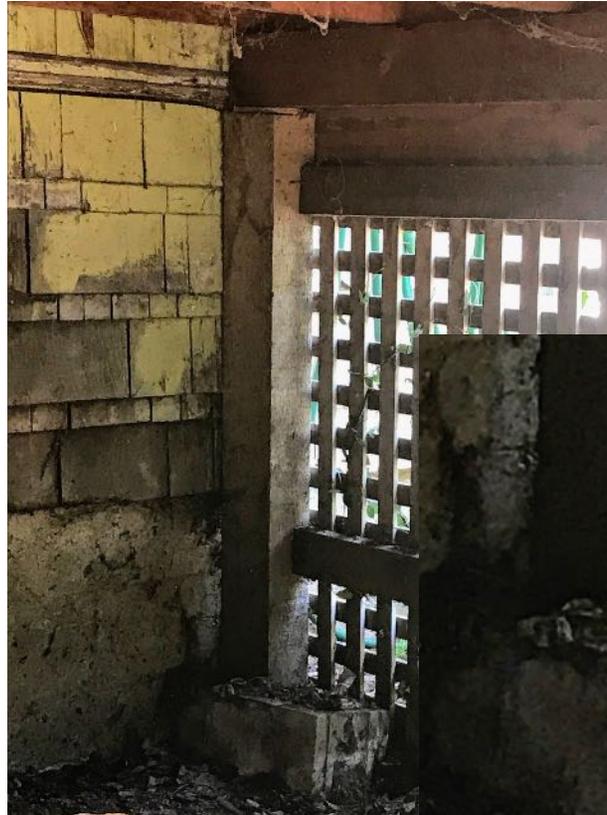
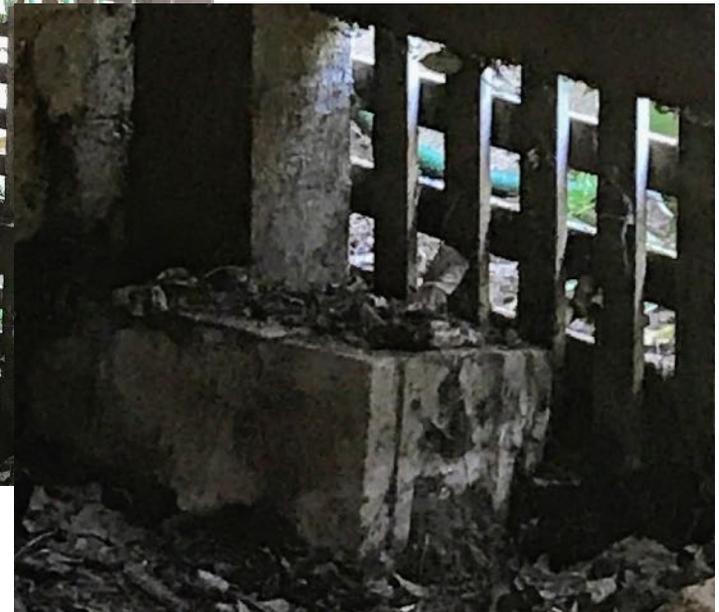
Sunporch Footings and Posts

The close up of the footing shows that it is a single concrete block with no foundation or structure underneath it. It is sitting on bare earth. Close examination shows that this footing is not sitting square to the ground but is angled toward the lath covering.

- Set temporary posts
- Attempt to lift and level area
- Excavate soil, form and pour new footings
- Set and plumb new pressure treated 4X6 posts
- Mechanically connect the posts to the beams and to the footings
- Rebuild stairs and upper deck using the same style and materials proposed for the front stairs, specifically clear cedar supports and railings with Doug-fir treads

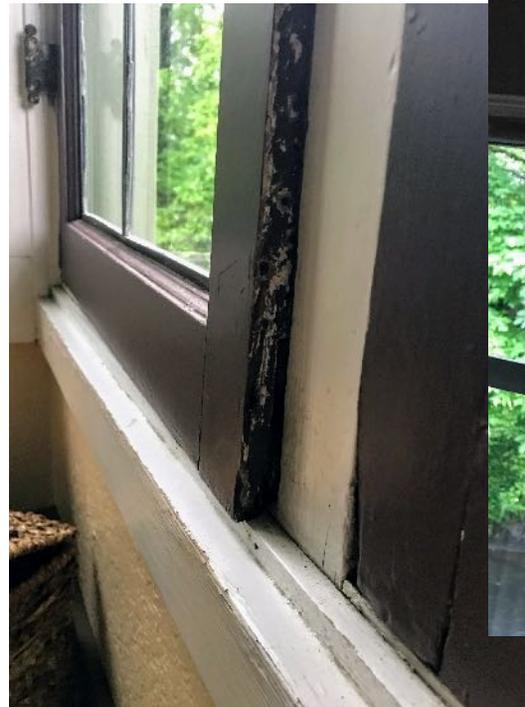
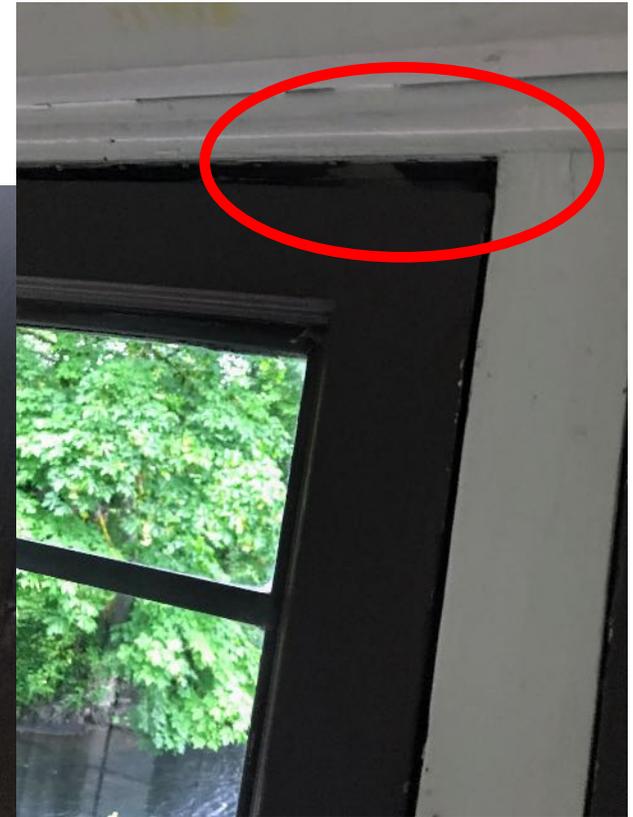
Impacts of Settling of Sunporch

The windows of the sunporch are lovely, but they are being bent and pushed out of the frame as the sunporch sinks and shifts due to the lack of proper foundational structure.

That outside corner of the sun porch (which is the left side in the photos) is sinking. Though difficult to see against the dark trim in the photo, the upper corner of that same window shows a gap of greater than ½ inch.

This shifting sunporch is literally pulling the house in its direction. Many kitchen cupboard doors no longer close properly, and there is a noticeable shift which can be felt when walking on the upstairs area near this side of the house.

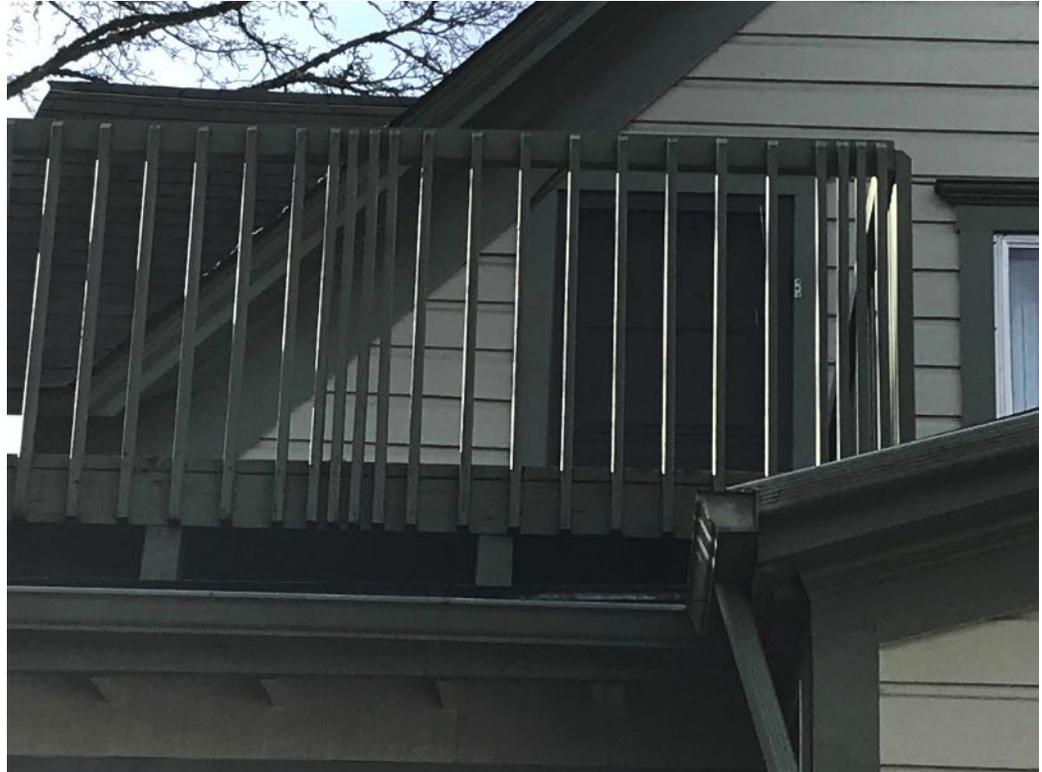
Needed Deck Replacement

During the 1980s (estimated) remodel, the railing of the deck was replaced with a style common at that time, diminishing the historic look and feel of the deck.

Additionally, the wood decking is not historic, but instead is common painted lumber. That deck now has rotted and soft areas making it a serious safety issue.

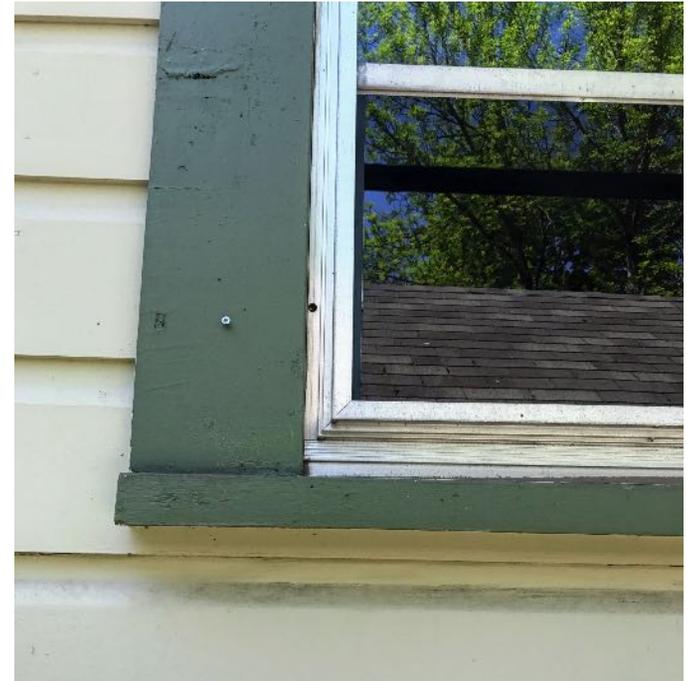
Needed Window Reconstruction

The issues with the sunporch foundation combined with the foundation issues under the front porch have literally been slowly twisting the house. Many of the windows have been shaved or altered a little at a time over the years to accommodate the shifting of the house. Virtually every window in the house must be rebuilt or replaced. The only thing that keeps rain and wind from entering the house are 80's vintage exterior aluminum storm windows.

Additionally, a contractor who looked at the house and examined the basement of the main structure indicated that while the foundation of the main structure of the house is level and sound, lifting the sun porch and bay/front deck area is likely to cause cracks in the lath and plaster, window breakage and the inability to open or close doors. It is likely nearly every door and doorframe, every window and window frame will have to be removed, rebuilt or re-squared or worst case replaced. He went so far as to say that he would not allow his team to do this work with the windows in place due to the risk of breakage and flying glass.

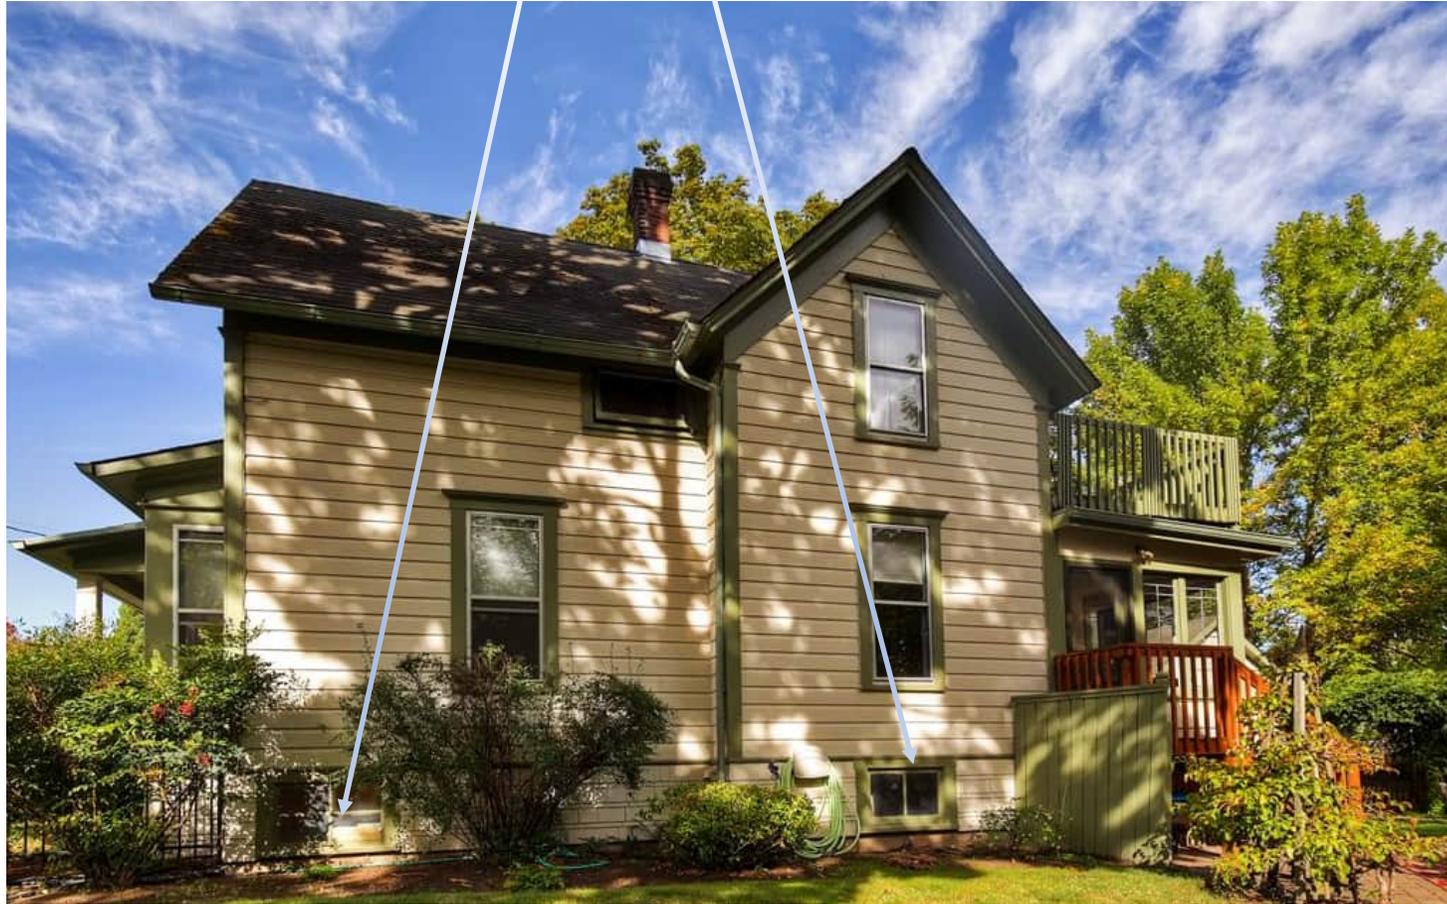
Basement windows 24, 25

- Currently nailed shut. Need to be replaced for safety reasons
