REVISED DECISION OF THE HISTORIC PRESERVATION OFFICER

MINOR HISTORIC DESIGN REVIEW CASE NO.: HIS22-08

SUMMARY: A proposal to demolish an accessory structure at the rear of the Leland and Mildred Geer House (1927).

Re: **1815 Commercial St.**
Structural Observation
MSC Job #220121

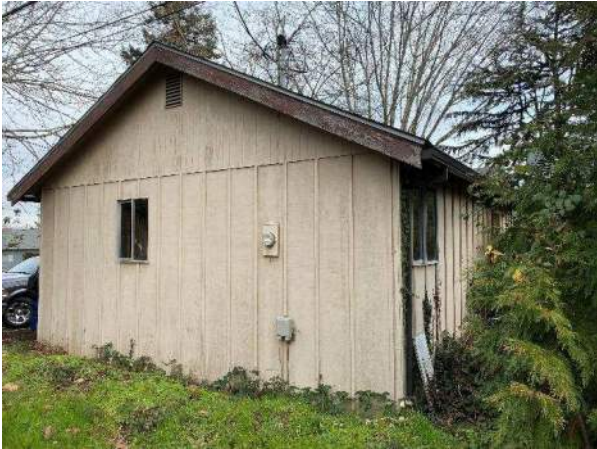
Photo 1: West Elevation

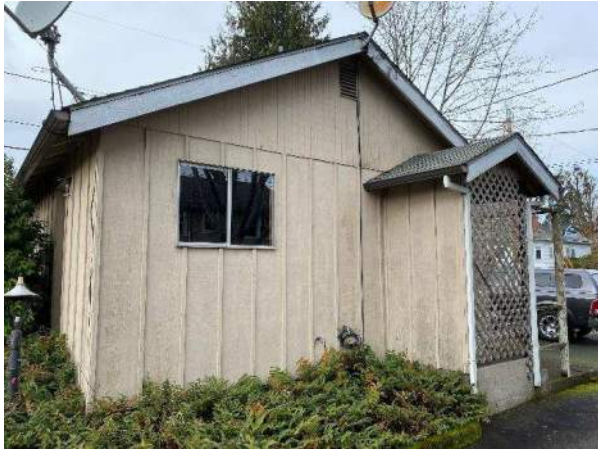
Photo 2: East Elevation

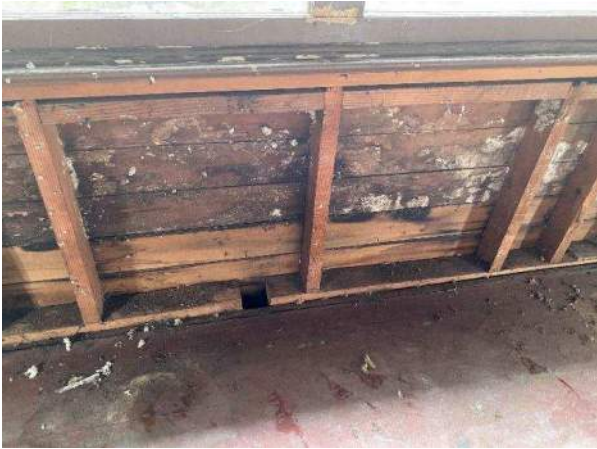
Water damage was also observed at the floor on east and south sides of the structure. A significant portion of the floor sheathing has been compromised in this area and will need to be replaced. Lastly, horizontal sheathing on all (4) walls has areas of water damage and will need to be replaced.

Photo 3: Sheathing Damage

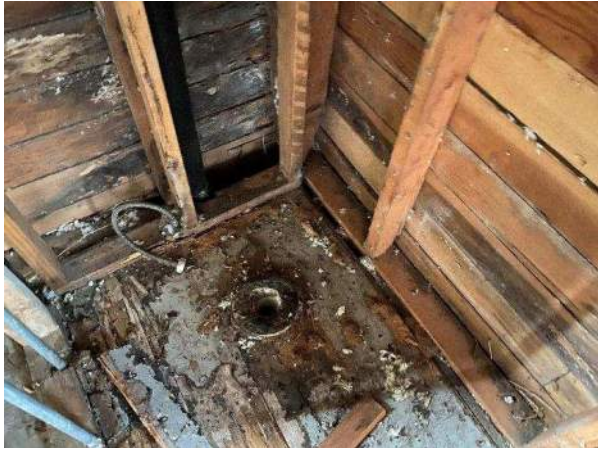
While on site multiple areas of rot and wood deterioration were observed. The restroom was previously located at the northwest corner of the structure and water damage was observed on the wall sheathing, studs, sole plate, floor sheathing and floor joists. At least (1) floor joist was completely deteriorated and no longer present. The joists on either side have also been severely compromised.

Photo 4: Water Damage

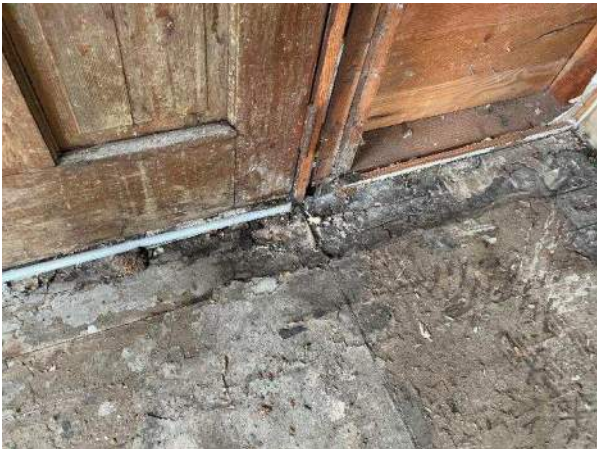
Photo 5: Floor Deterioration

In our opinion, the deterioration and decay of the floor system will require replacement of almost half the existing floor deck and substantial reframing of the supports. Similarly, damage to the horizontal sheathing on the walls is extensive enough that substantial replacement will be required. It may be possible to treat the existing wood sheathing and replace the strength of the horizontal sheathing with plywood. However, the rotten sill plate and studs will definitely need to be removed and replaced and either scenario represents a substantial investment.

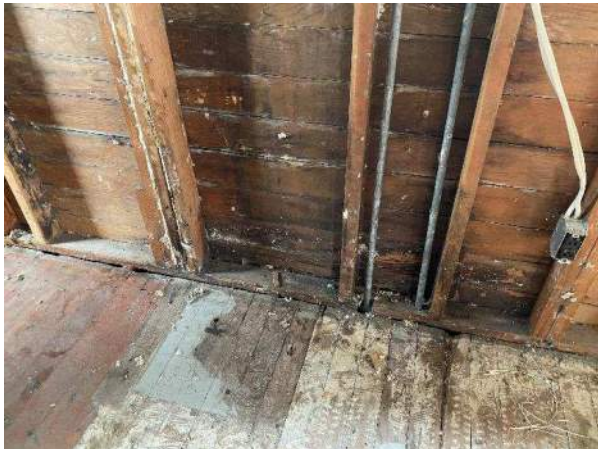
Photo 6: Floor Deterioration

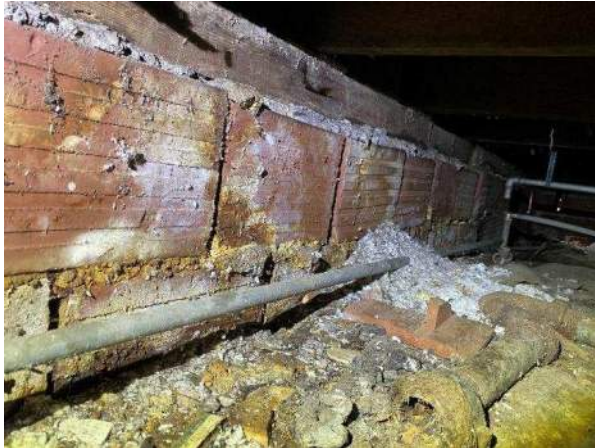
The foundation of the exterior walls consists of a 4x4 sleeper beam on top of hollow clay bricks laid in a running bond. Aside from the mortar between the sleeper beam and brick, no other connection was observed. Interior posts are supported on concrete pads or rocks and also do not have a positive connection between the post and foundation.

Lastly, the structure, similar to other structures of this age, is not compliant with any seismic codes. In our opinion, it will not be feasible to bring this structure into compliance with the current clay tile foundation. Any elective or mandatory seismic upgrade should take this into account.

Photo 7: Brick Stemwall

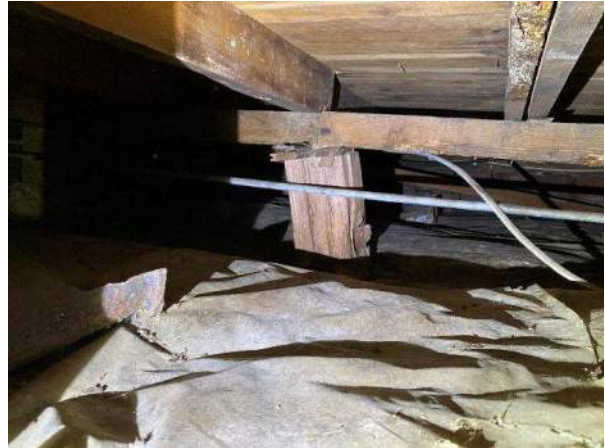
While on site, we also observed several structural modifications that have compromised the original structure's capacity. Ceiling joists have been haphazardly cored and in at least (2) instances, completely cut in two. In an attempt to level the floor, floor beams have been shimmed and propped up using all manner of material including decking, wood veneer strips and logs.

Photo 8: Misc. Shoring

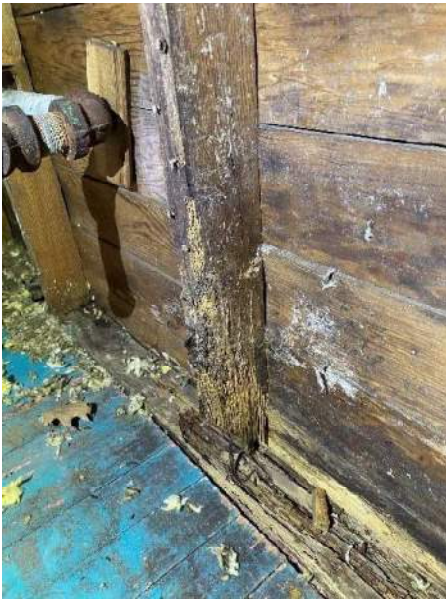
Photo 9: Stud Damage

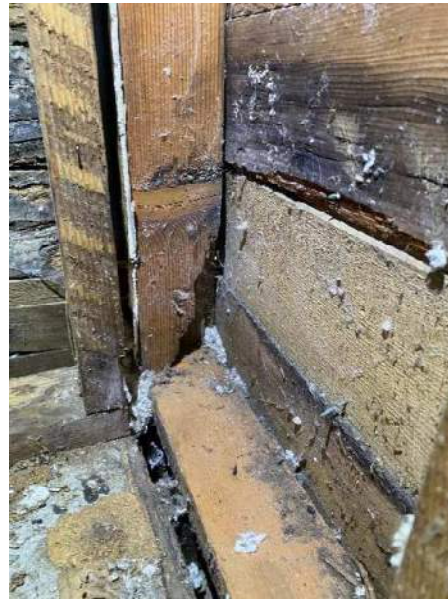
Photo 10: Wall Damage

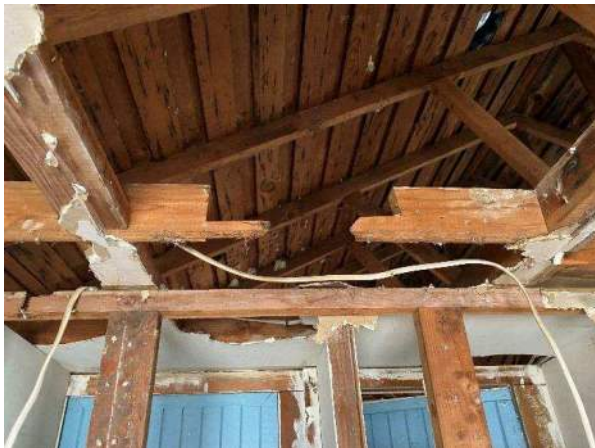
Photo 11: Cut Ceiling Joist

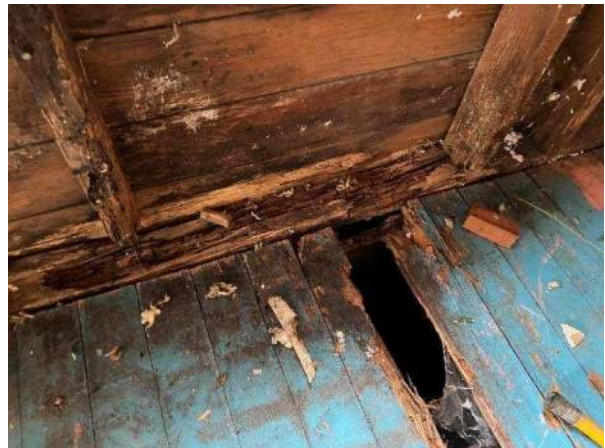
Photo 12: Floor Deterioration
