NOTICE OF DECISION

CLASS 1 MINOR HISTORIC DESIGN REVIEW CASE NO.: HIS22-35

SUMMARY: A proposal to restore doors and windows and replace exterior lighting on Buildings 24 (the Horse Stadium) and 28 (the Poultry Building) and install a new walkway at the Oregon State Fair.

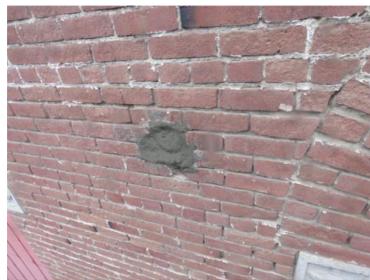
BR-2 - BRICK REPAIR 2

- CONDITION: HEAVILY DAMAGED OR MISSING BRICK, PREVIOUSLY REPLACED BRICK USING NON-ORIGINAL MATERIALS.
- REPAIR: SAWCUT AND REMOVE DAMAGED OR OTHER MATERIALS FROM REPAIR AREA, AND REPLACE WITH IN-KIND BRICK UNIT.
- REPOINT MORTAR JOINTS
- SCHEDULE QUANTITY BY UNIT COUNT

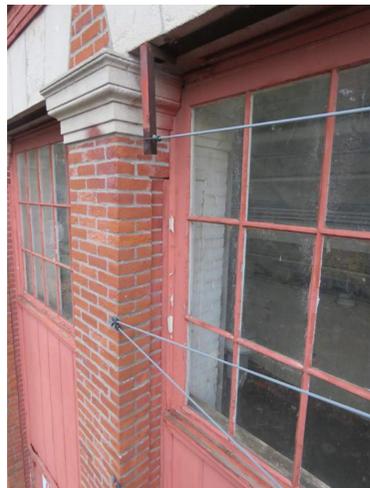
BR-3 - BRICK REPAIR 3

- CONDITION: CABLES FOR BANNERS & ASSOCIATED ANCHORS AT BRICK & CAST STONE
- REPAIR: REMOVE CABLES, ARMATURE, & UNUSED ANCHORS & PROVIDE MORTAR TO MATCH ADJACENT SURFACE
- SCHEDULE QUANTITY BY UNIT COUNT

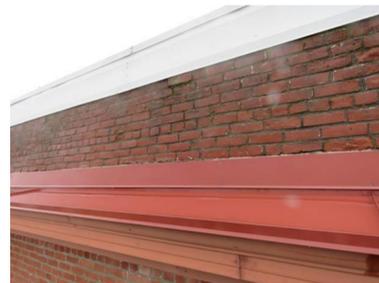
BR-4 - BRICK REPAIR 4

- CONDITION: DISPLACED BRICK UNIT.
- REPAIR: SAWCUT AND REMOVE DISPLACED UNIT(S) AND REINSTALL SALVAGED UNIT(S). REPLACE WITH IN-KIND BRICK IF DAMAGED.
- SCHEDULE QUANTITY BY UNIT COUNT

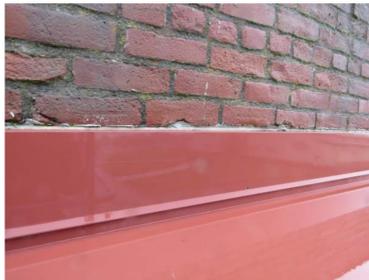
BR-5 - BRICK REPAIR 5

- CONDITION: CHIPPED BRICK UNITS AT EDGE OF REGLET FLASHING.

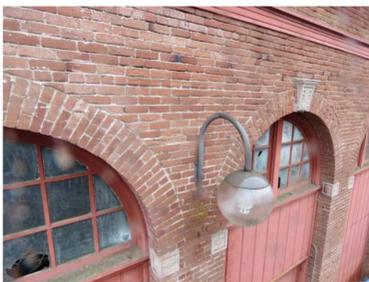
BR-6 - BRICK REPAIR 6

- CONDITION: LIGHT FIXTURE MOUNTED TO BRICK.
- REPAIR: REMOVE LIGHT FIXTURE, ANCHORS, & CONDUIT. PROVIDE REPAIR MORTAR AT ANCHOR AND CONDUIT HOLES.
- SCHEDULE QUANTITY BY UNIT (1 UNIT)

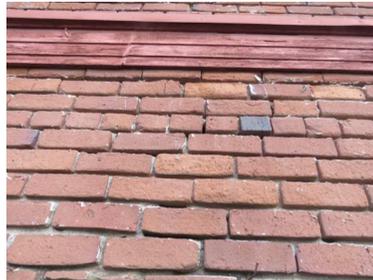
BR-7 - GENERAL CONDITION

- CONDITION: LOSS OF FIRED CLAY OUTER LAYER, LIKELY FROM PREVIOUS SANDBLASTING TO REMOVE PAINT.

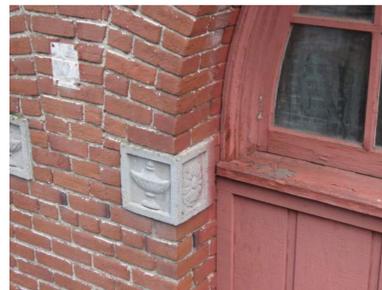
BR-8 - BRICK REPAIR 8

- CONDITION: ANCHOR AT BRICK OR PREV. REMOVED ANCHOR AT FORMER MOUNTING PLATE.
- REPAIR: REMOVE ANY REMAINING UNUSED ANCHORS & PROVIDE MORTAR TO MATCH ADJACENT SURFACE; SEE ALSO MC-3 FOR PAINT REMOVAL.
- SCHEDULE QUANTITY BY SQUARE FOOT (SF).

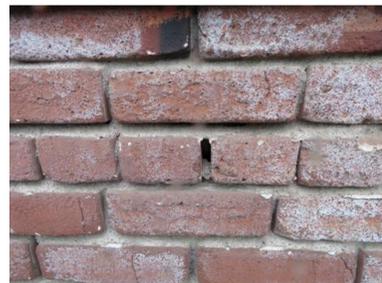
JR-1 - BRICK JOINT REPAIR 1

- CONDITION: CRACKED, ERODED, CRUMBLING OR SPALLING, DE-BONDED OR MISSING MORTAR JOINTS AT BRICK MASONRY UNITS. MAY ALSO INCLUDE JOINTS PREVIOUSLY REPOINTED WITH NON-COMPATIBLE MORTAR.
- REPAIR: SAW-CUT AND RAKE OUT EXISTING DETERIORATED MORTAR, AND REPOINT WITH NEW MORTAR AS SPECIFIED.
- SCHEDULE QUANTITY BY LINEAR FOOT (LF)

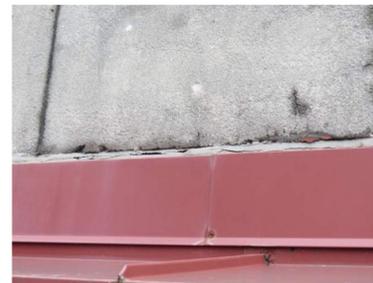
JR-2 - BRICK JOINT REPAIR 2

- CONDITION: FAILED SEALANT AND BACKER ROD.
- REPAIR: REMOVE SEALANT & BACKER ROD, PROVIDE NEW SEALANT AND BACKER ROD PER SPECIFICATIONS.
- SCHEDULE QUANTITY BY LINEAR FOOT (LF)

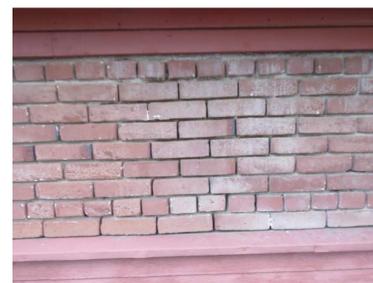
MC-1 - MASONRY CLEANING 1 (OVERALL)

- CONDITION: LIGHT TO MODERATE ATMOSPHERIC SOILING AND OTHER DEPOSITS ON BRICK SURFACES.
- REPAIR: CLEAN BRICK MASONRY SURFACES AS SPECIFIED.
- SCHEDULE QUANTITY BY SQUARE FOOT (SF)

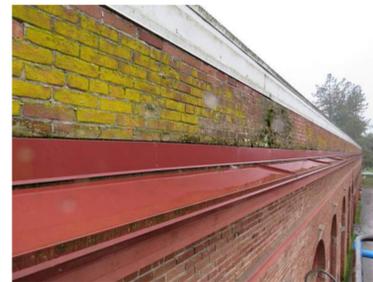
MC-2 - MASONRY CLEANING 2, LOCALIZED

- CONDITION: LOCALIZED MODERATE TO HEAVY SOILING THAT COMPRISES MATERIAL REQUIRING SPECIALIZED REMOVAL, SUCH AS BIOLOGICAL GROWTH, MASTIC, EFFLORESCENCE, OR GRAFFITI.
- REPAIR: CLEAN BRICK MASONRY SURFACES AS SPECIFIED.
- SCHEDULE QUANTITY BY SQUARE FOOT (SF)

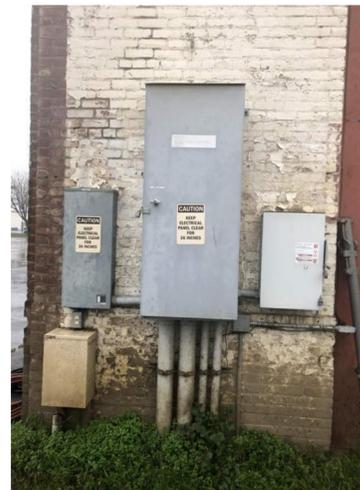
MC-3 - MASONRY CLEANING 3

- CONDITION: PAINTED SURFACES AT BRICK AND CAST STONE.
- REPAIR: REMOVE PAINT FROM BRICK AND CAST STONE, CLEAN SURFACES.
- SCHEDULE QUANTITY BY SQUARE FOOT (SF)

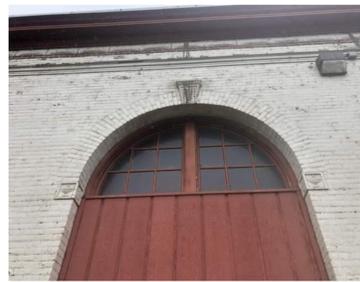
MC-4 - MASONRY CLEANING 4

- REPAIR: REMOVE MASTIC DRIPS FROM BRICK AND CAST STONE ELEMENTS.
- SCHEDULE QUANTITY BY SQUARE FOOT (SF)

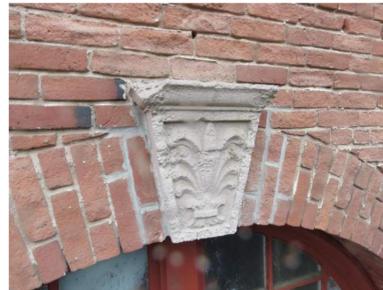
CS-2 - CAST STONE REPAIR 2

- CONDITION: KEYSTONE WITH SIGNIFICANT SURFACE EROSION, LOSS OF PROFILE.
- REPAIR: REPLACE WITH CAST STONE UNIT TO MATCH ORIGINAL IN PROFILE, COLOR, AND TEXTURE AND FINISH.
- SCHEDULE QUANTITY BY UNIT (1 UNIT).

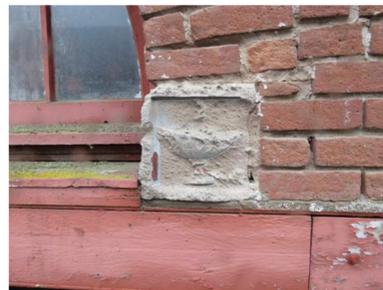
CS-3 - CAST STONE REPAIR 3

- CONDITION: IMPOST BLOCK WITH SURFACE EROSION CONDITION AND LOSS OF PROFILE.
- REPAIR: REPLACE WITH CAST STONE UNIT TO MATCH ORIGINAL IN PROFILE, COLOR, TEXTURE, AND FINISH.
- SCHEDULE QUANTITY BY UNIT (1 UNIT)

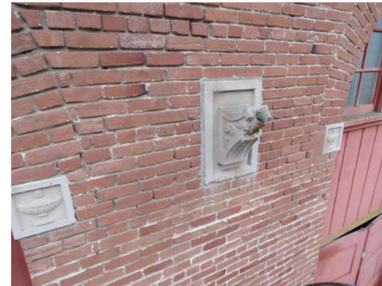
CS-4 - CAST STONE REPAIR 4

- CONDITION: CAST STONE FLAGPOLE BASE WITH SPALLING PROJECTING SURFACES.
- REPAIR: REPLACE WITH CAST STONE FINISH TO MATCH ORIGINAL IN PROFILE, COLOR, TEXTURE, AND FINISH.
- SCHEDULE QUANTITY BY UNIT (1 UNIT). SEE A503.

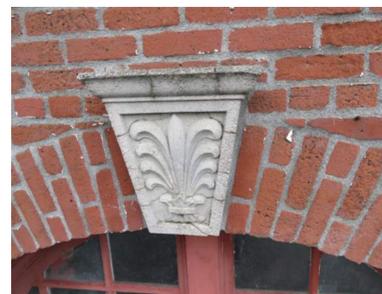
CS-6 - CAST STONE REPAIR 6

- CONDITION: HAIRLINE CRACK; KEYSTONE W/ HAIRLINE CRACKING SHOWN.
- REPAIR: NO ACTION AT SOUND HAIRLINE CRACKS.

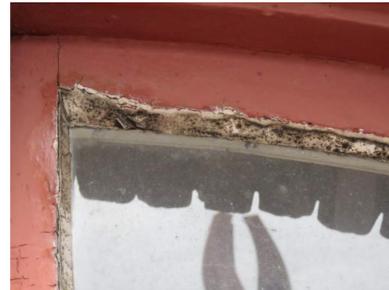
GENERAL NOTE: GLAZING PUTTY REPLACEMENT

- REPAIR: REPLACE 100% OF GLAZING PUTTY AND GLAZING POINTS.

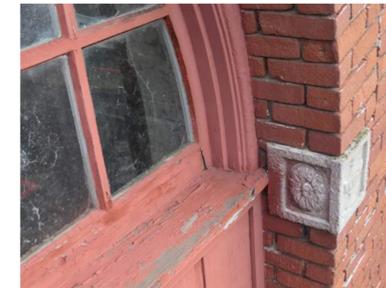
W-9 - PERIMETER OF WOOD FRAME AT M.O.

- CONDITION: NO SEALANT TYP. AT PERIMETER OF WOOD FRAMES BETWEEN WOOD & MASONRY.
- REPAIR: NO ACTION. REMOVE PREVIOUS SEALANT REPAIRS WHERE ADDED AT PERIMETER OF FRAME.

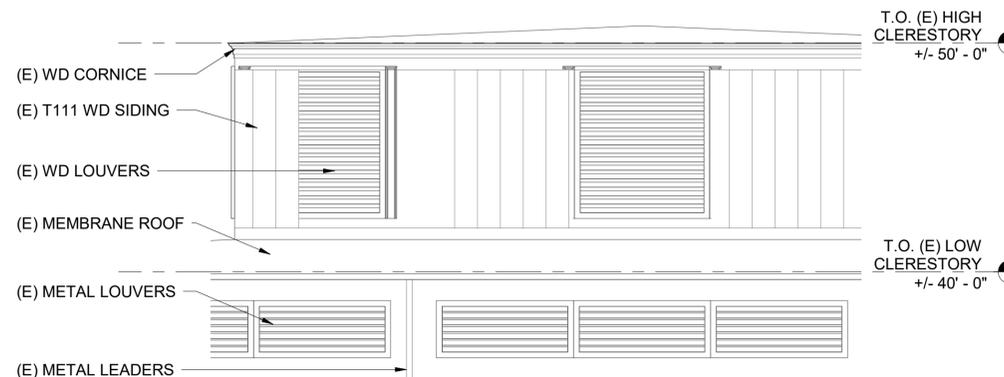
- CONDITION: NON-ORIGINAL METAL LOUVERS TO REMAIN. MTL LOUVERS ARE AT ORIGINAL LOCATIONS OF WINDOWS PREVIOUSLY REMOVED.
