DECISION OF THE HISTORIC LANDMARKS COMMISSION

HISTORIC DESIGN REVIEW CASE NO.: HIS18-04

SUMMARY: A proposal to replace the failing front porch and bay window foundation, porch and steps; replace the non-historic rear upper deck and lower sunporch steps, hand railing and balustrades; and replace 24 windows on the Daniel S. Yoder House (c.1891).

Daniel S Yoder House
1811 Chemeketa St NE
Salem, OR 97301

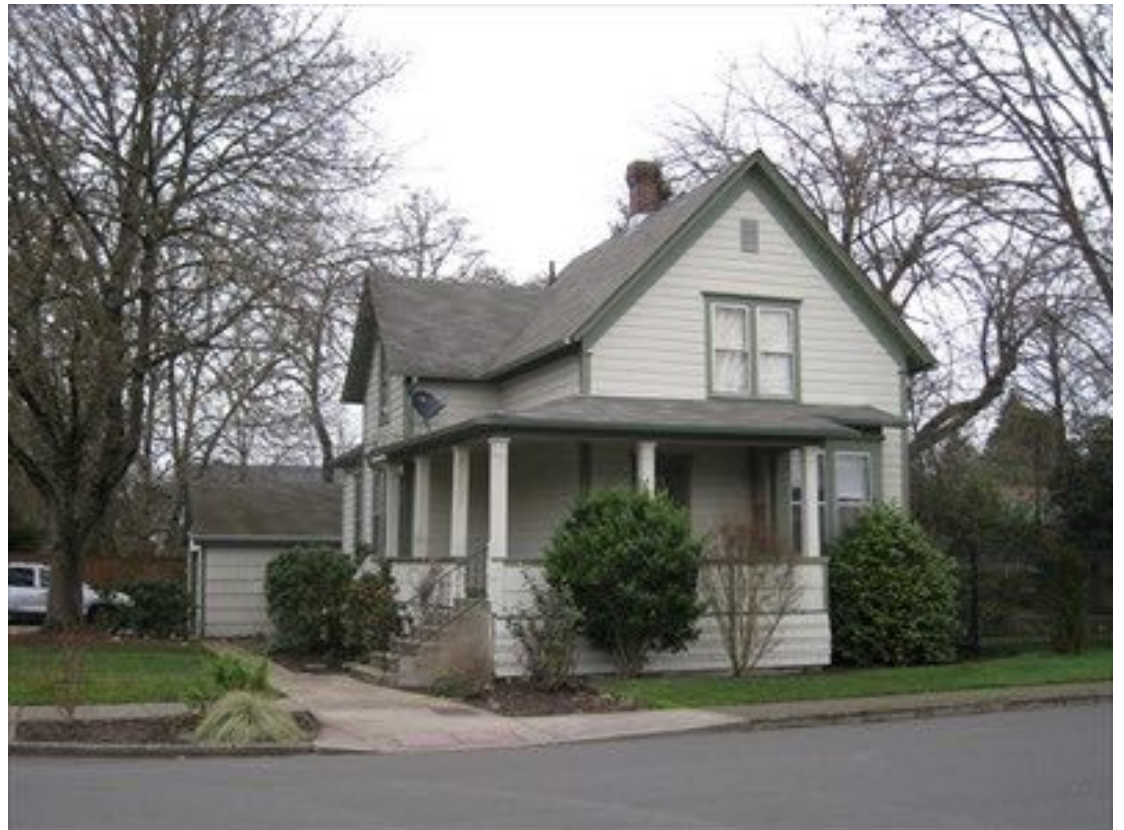
Street View

This street view from Chemeketa shows the front wrap-around porch.

This is the area in the worst condition. The front porch appears to have had a foundation replacement sometime that was done in a substandard manner.

The porch and bay window foundation is dry stack cinderblock with no concrete or other stabilizing materials except chicken wire. The footing that the block rest on is not sufficient to prevent settling.

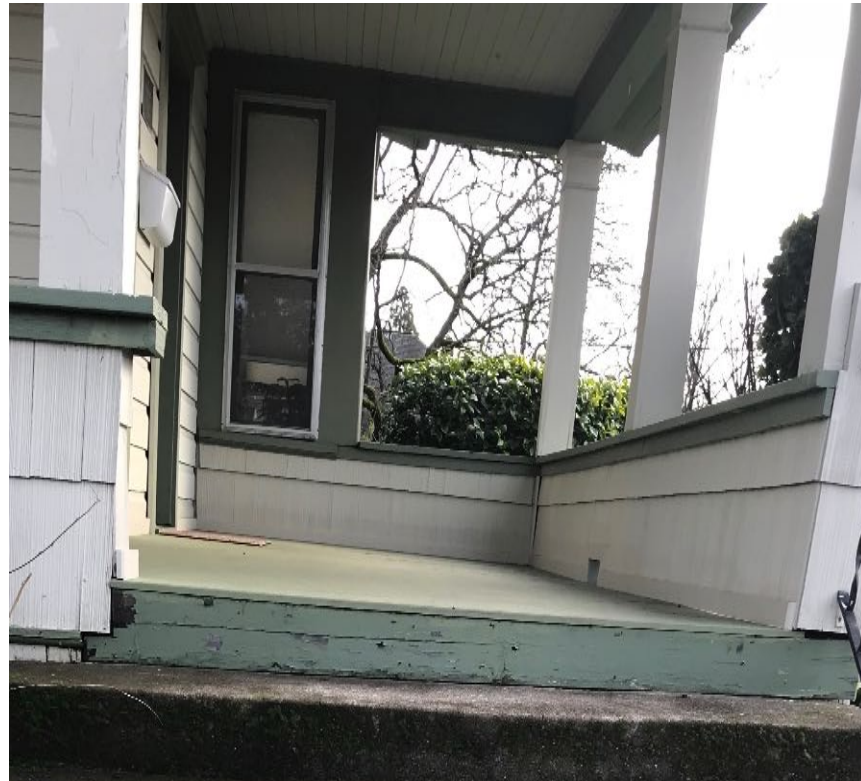
Porch View From Entry Steps

This a view from the stair side of the porch. The slope is a little exaggerated by the photograph, but it does show that the drop of the porch from square relative to the post in the foreground and the exterior wall of the bay window. To provide perspective, the far right corner of the porch is supported by the slipping foundation we just saw.

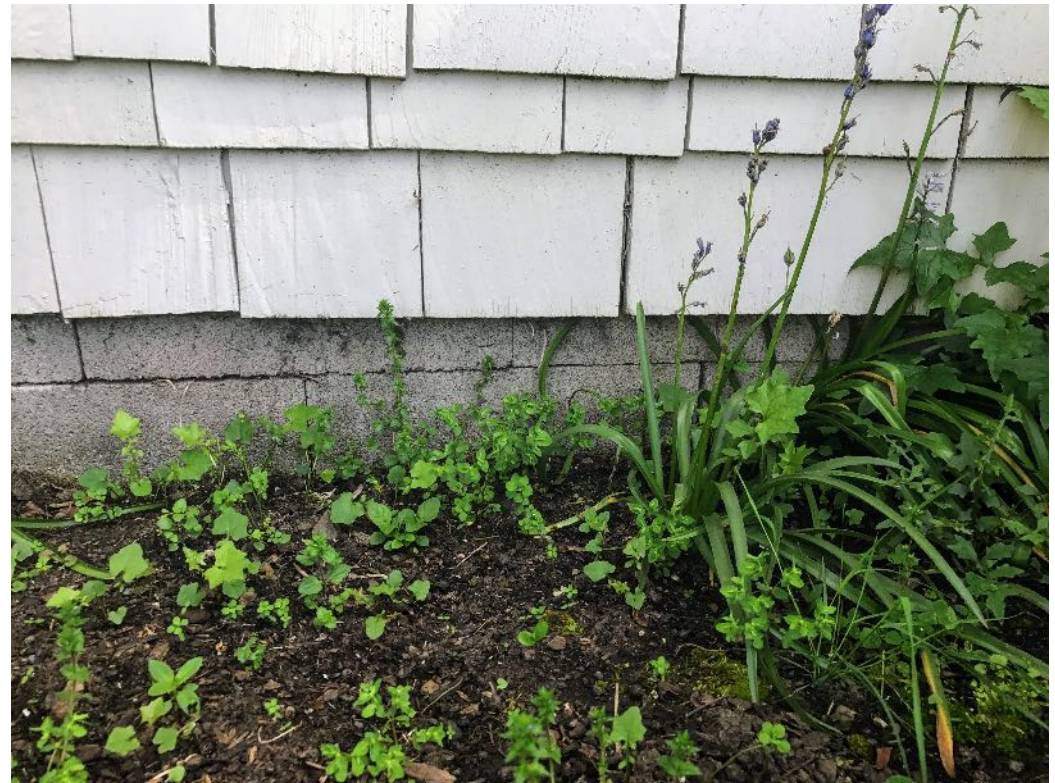
Exterior Photos

The photos from the exterior show that very little if any of the actual foundation shows from the exterior of the house. It also shows something more disturbing – upon close examination you will see there is no mortar, concrete or other binding material. These are hollow blocks filled with loose rock for stability.

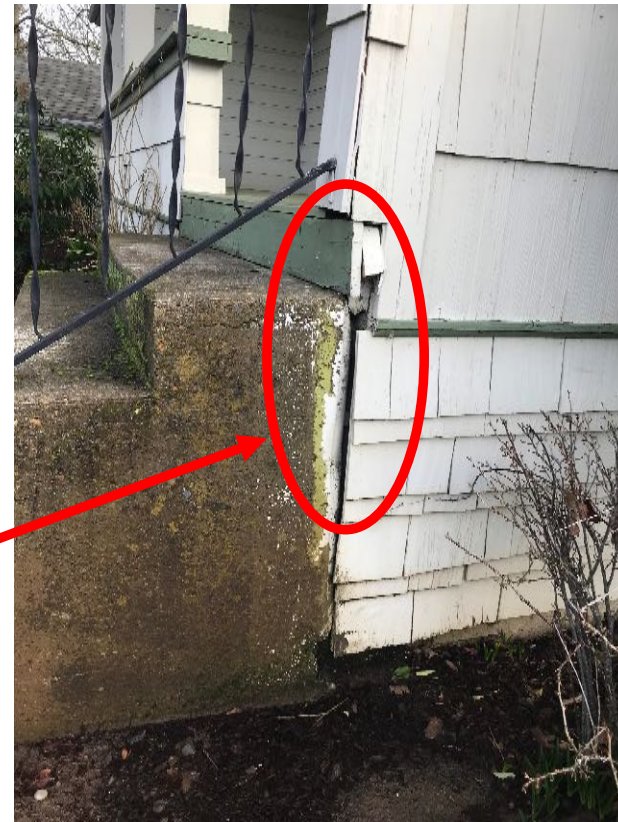
Looking at the stairs themselves, not only are they weathered they are very unattractive and not in keeping with the character of the house.

The design of the stairs is a contributing factor to the ongoing damage to the porch. There is no continuous foundation behind the stairs. The stairs themselves are used as unattached support for the front porch. This picture shows the porch sliding away from the concrete stairs.

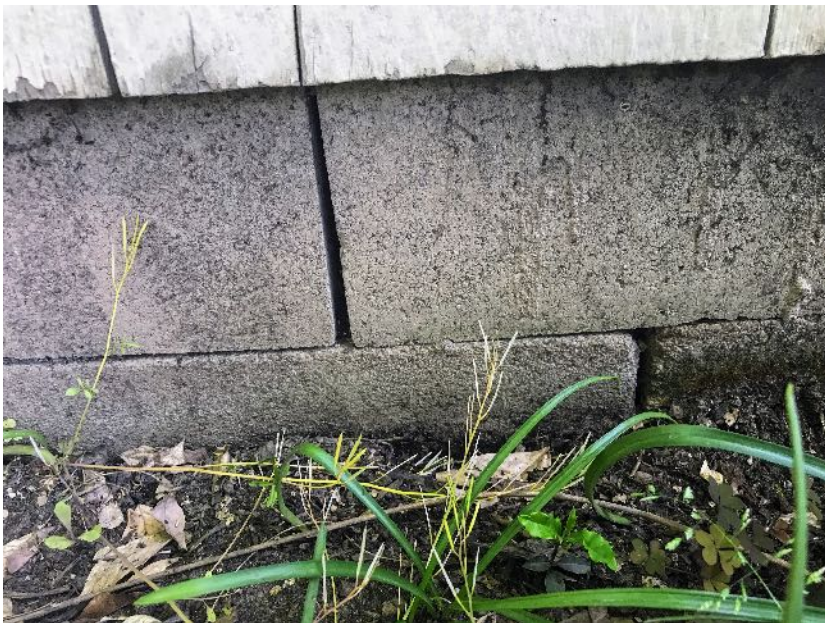
Close-up Exterior Photos

Close up showing no mortar or cement of any kind. This photo shows that the foundation is slipping apart

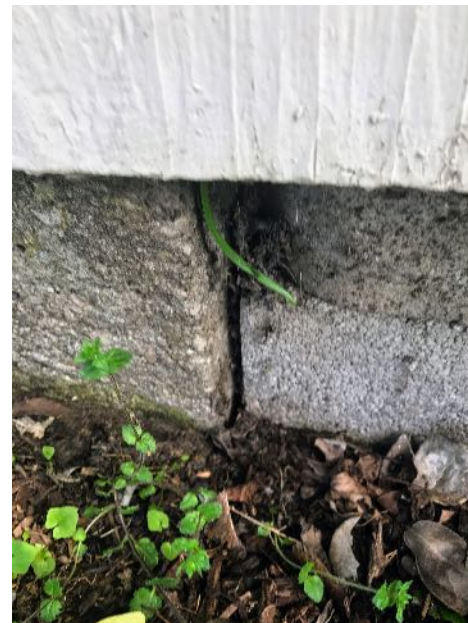
This photo shows that there are plants beginning to grow in the cracks.

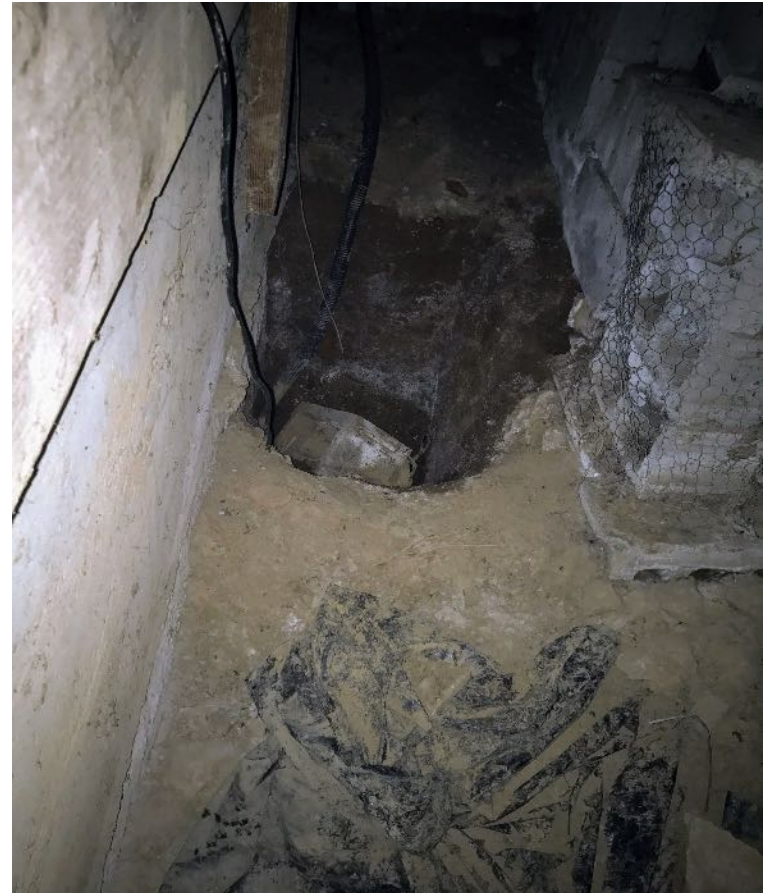
View Underneath Bay Window

The bay window seen on the right in the street view photo on the second slide and is supported by the cinderblock stack to the right in this photo. The edge of the plastic tarp is evident in the foreground. On the left of the photo is the concrete foundation of the main house. Straight ahead is a hole dug between the house foundation and the foundation of the bay window where a sump pump was placed. The dry stack cinderblocks secured with chicken wire on the right face Chemeketa St NE.

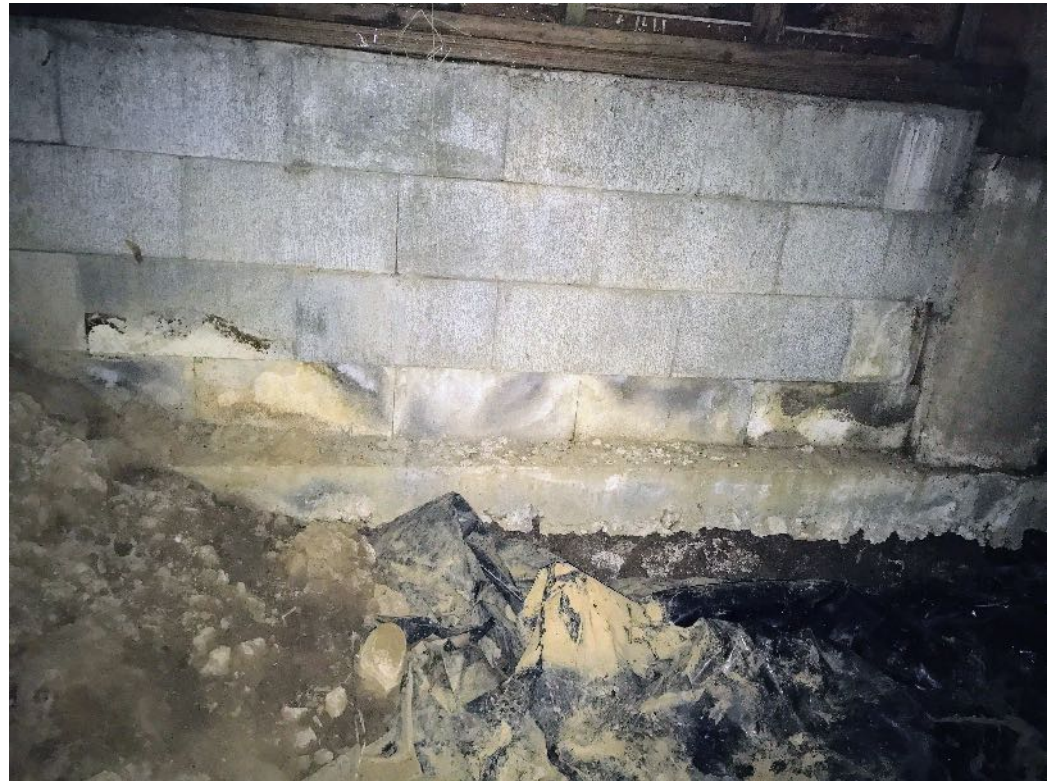
Interior View Underneath Porch

The severity of the problem is seen from a crawl space accessed through the basement. The top course of block is the course above ground in the previous photo. The wood header in the photo is where the deck and the foundation attach. The footing below is the only concrete in this foundation section. This concrete runs about 8" deep. The cinderblocks are dry stacked upon one another.

The watermark on the blocks below show that the water has been seeping in for years. A previous owner covered the dirt with a plastic tarp to control the moisture level under the deck.

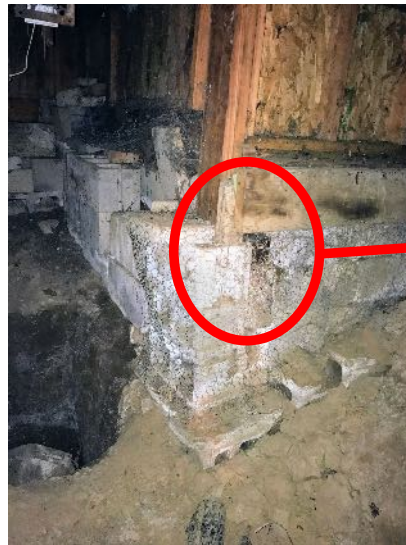
These photos are from underneath the porch, facing east.

The dark spot identified with the red circle shows a large gap due to shifting of the foundation. Above the dark gap to the left shows that the load of this corner is supported by about 2.5 inches of cinderblock.

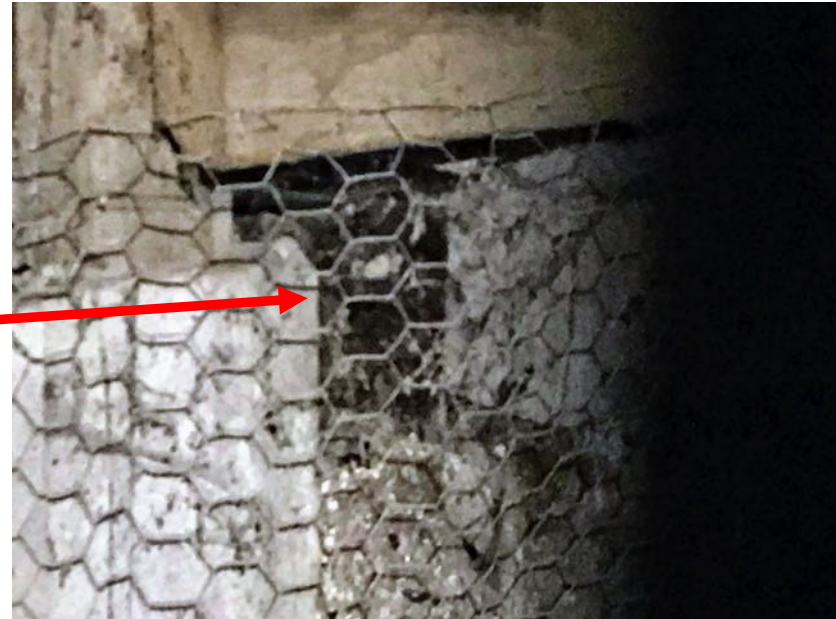
The chicken wire is stapled to the underside of the bay window structure in the hopes of keeping the foundation blocks in place.

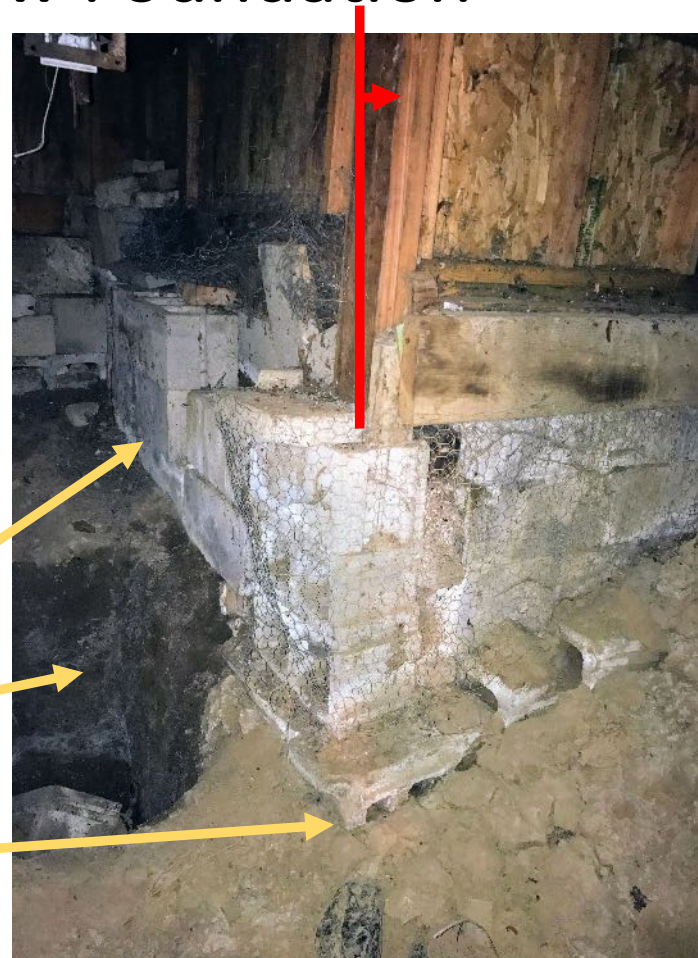
Additional Detail on Foundation Closeup

This is the same photo as in the last slide. It is the area directly under the bay window..

The standing red line represents an approximate 90 degree angle. The support is only a 4x4 and is off plumb by about 4 inches.

In this enlarged picture, several reasons for the shifting of the foundation are apparent.

- 1) There is no fill at all in many of the cinderblocks.
- 2) The foundation is slipping into the large hole created by the improperly installed sump pump.
- 3) The unfilled cinderblocks used as footers can not bear the weight of the structure.

- Level front porch and construct new foundation
- Hang 4X6 beams no more than a span of 6' through the crawl space under the front porch
- Level the soil and install precast 18" pads with adjustable brackets under the beams
- Set 4X6 posts in the adjustable brackets
- Mechanically connect the posts to the beam and the post to the adjustable brackets
- Attempt to lift and level
- Once we have lifted to the maximum we will hand excavate the exterior soil around the foundation
- Cut and remove Concrete steps to the front porch
- Remove the dry stacked block, we will leave the solid concrete pillars
- Drill and set steel into the existing footing and the concrete pillars to help bind new concrete
- Build and set forms flush with existing pillars
- Set a steel grid inside new concrete foundation
- Pour Concrete and let set, remove the forms
- Back fill excavated soil

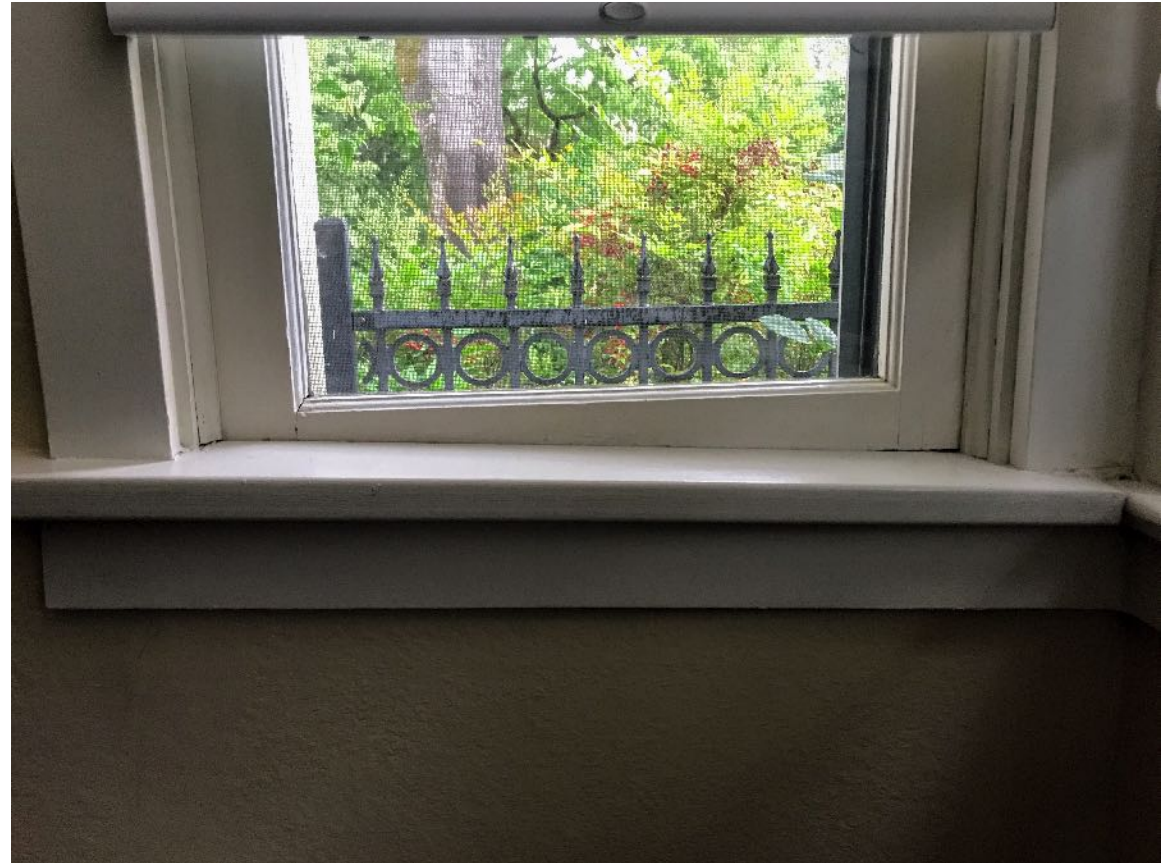
Porch Settling Impacts Visible Inside the House

The view out this window looking toward 19th Street shows how far the floor has sunk in that area. The line of the window is about even with the line of the fence, but the floor has dropped nearly three inches as shown by the slope of the windowsill.

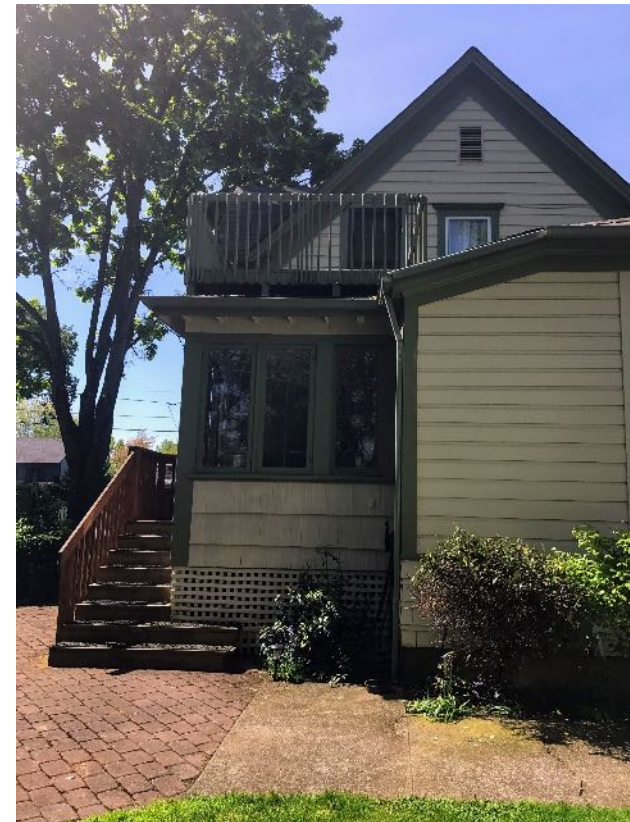
Sunporch View From Back Yard

By the leaded glass windows, the sunporch looks to have been added somewhere around the 1930's. A deck and balcony above were added at the same time. Sometime in the early 1980's prior to listing on the Historic Register, both were updated.

The estimated time frame for the improvements comes from both the style of railings used on the deck and the pier and post system used as a foundation.

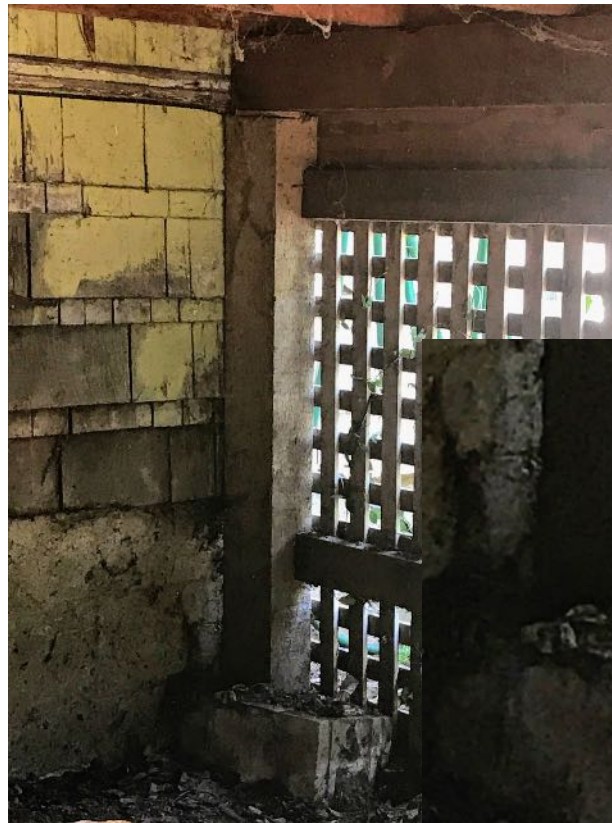
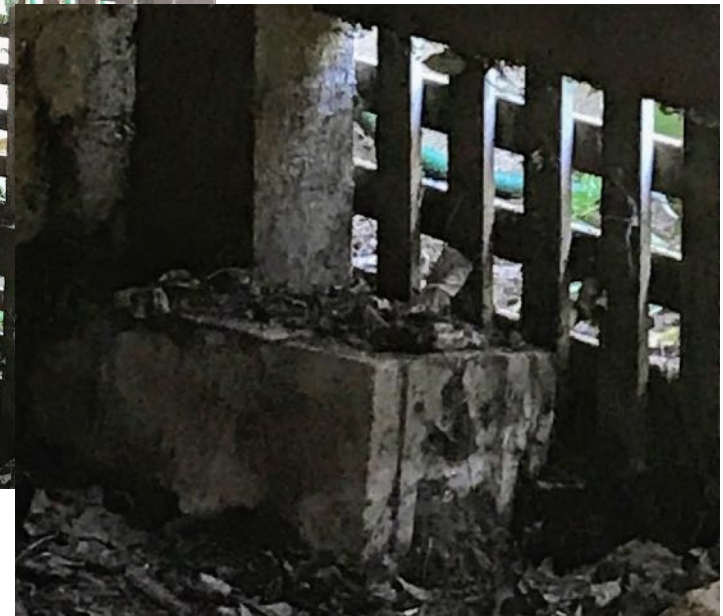
Sunporch Footings and Posts

The close up of the footing shows that it is a single concrete block with no foundation or structure underneath it. It is sitting on bare earth. Close examination shows that this footing is not sitting square to the ground but is angled toward the lath covering.

- Set temporary posts
- Attempt to lift and level area
- Excavate soil, form and pour new footings
- Set and plumb new pressure treated 4X6 posts
- Mechanically connect the posts to the beams and to the footings
- Rebuild stairs and upper deck using the same style and materials proposed for the front stairs, specifically clear cedar supports and railings with Doug-fir treads

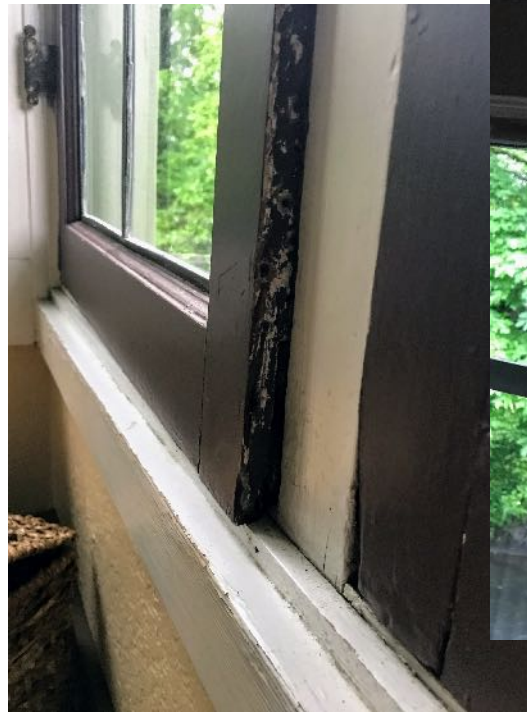
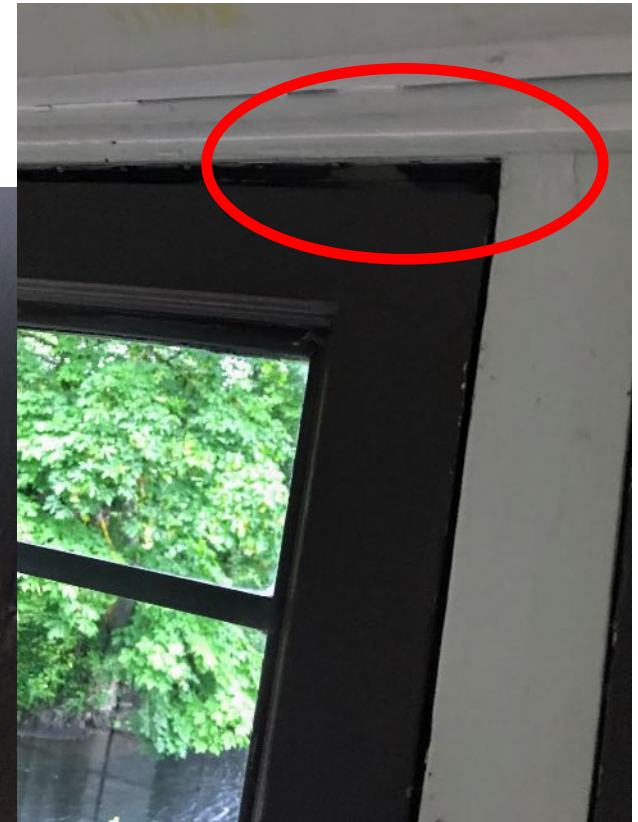
Impacts of Settling of Sunporch

The windows of the sunporch are lovely, but they are being bent and pushed out of the frame as the sunporch sinks and shifts due to the lack of proper foundational structure.

That outside corner of the sun porch (which is the left side in the photos) is sinking. Though difficult to see against the dark trim in the photo, the upper corner of that same window shows a gap of greater than ½ inch.

This shifting sunporch is literally pulling the house in its direction. Many kitchen cupboard doors no longer close properly, and there is a noticeable shift which can be felt when walking on the upstairs area near this side of the house.

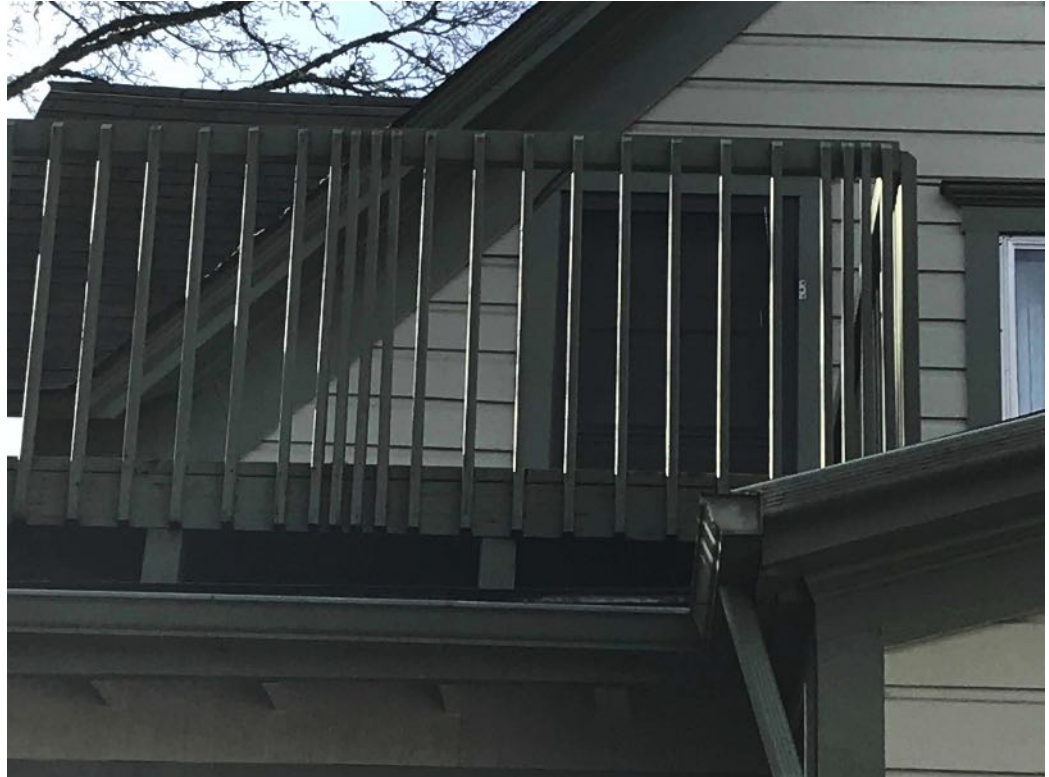
Needed Deck Replacement

During the 1980s (estimated) remodel, the railing of the deck was replaced with a style common at that time, diminishing the historic look and feel of the deck.

Additionally, the wood decking is not historic, but instead is common painted lumber. That deck now has rotted and soft areas making it a serious safety issue.

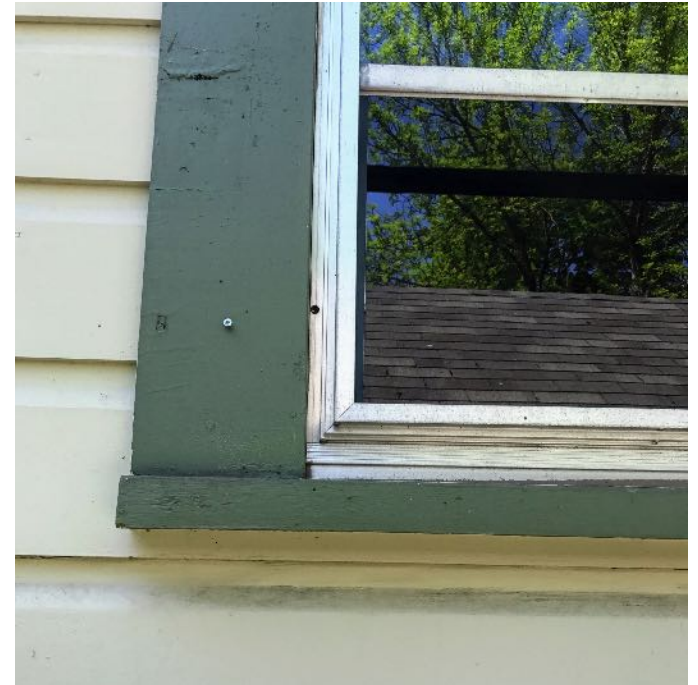
Needed Window Reconstruction

The issues with the sunporch foundation combined with the foundation issues under the front porch have literally been slowly twisting the house. Many of the windows have been shaved or altered a little at a time over the years to accommodate the shifting of the house. Virtually every window in the house must be rebuilt or replaced. The only thing that keeps rain and wind from entering the house are 80's vintage exterior aluminum storm windows.

Additionally, a contractor who looked at the house and examined the basement of the main structure indicated that while the foundation of the main structure of the house is level and sound, lifting the sun porch and bay/front deck area is likely to cause cracks in the lath and plaster, window breakage and the inability to open or close doors. It is likely nearly every door and doorframe, every window and window frame will have to be removed, rebuilt or re-squared or worst case replaced. He went so far as to say that he would not allow his team to do this work with the windows in place due to the risk of breakage and flying glass.

foundation. Prior to reinstallation, windows will be rebuilt with double paned thermal glazing and weather sealing construction in a manner to preserve the historic look from the exterior, allowing permanent removal of the non-historic storm windows.
