## ADMINISTRATIVE DECISION - MINOR HISTORIC REVIEW

**CASE NO.** Historic Review Case HIS14-43 / Amanda No. 14-119779-DR

**REQUEST:** Minor historic design review of a proposal to install a sign, rebuild the front porch and repair and replace as needed the trim and siding around the south side windows of the Burggraf-Burt-Webster House, a historic contributing building in Salem's Downtown Historic District, zoned CB (Central Business District), and located at 901 13<sup>th</sup> St SE; 97302; Marion County Assessor's Map and Tax Lot number: 073W26CC-13400.

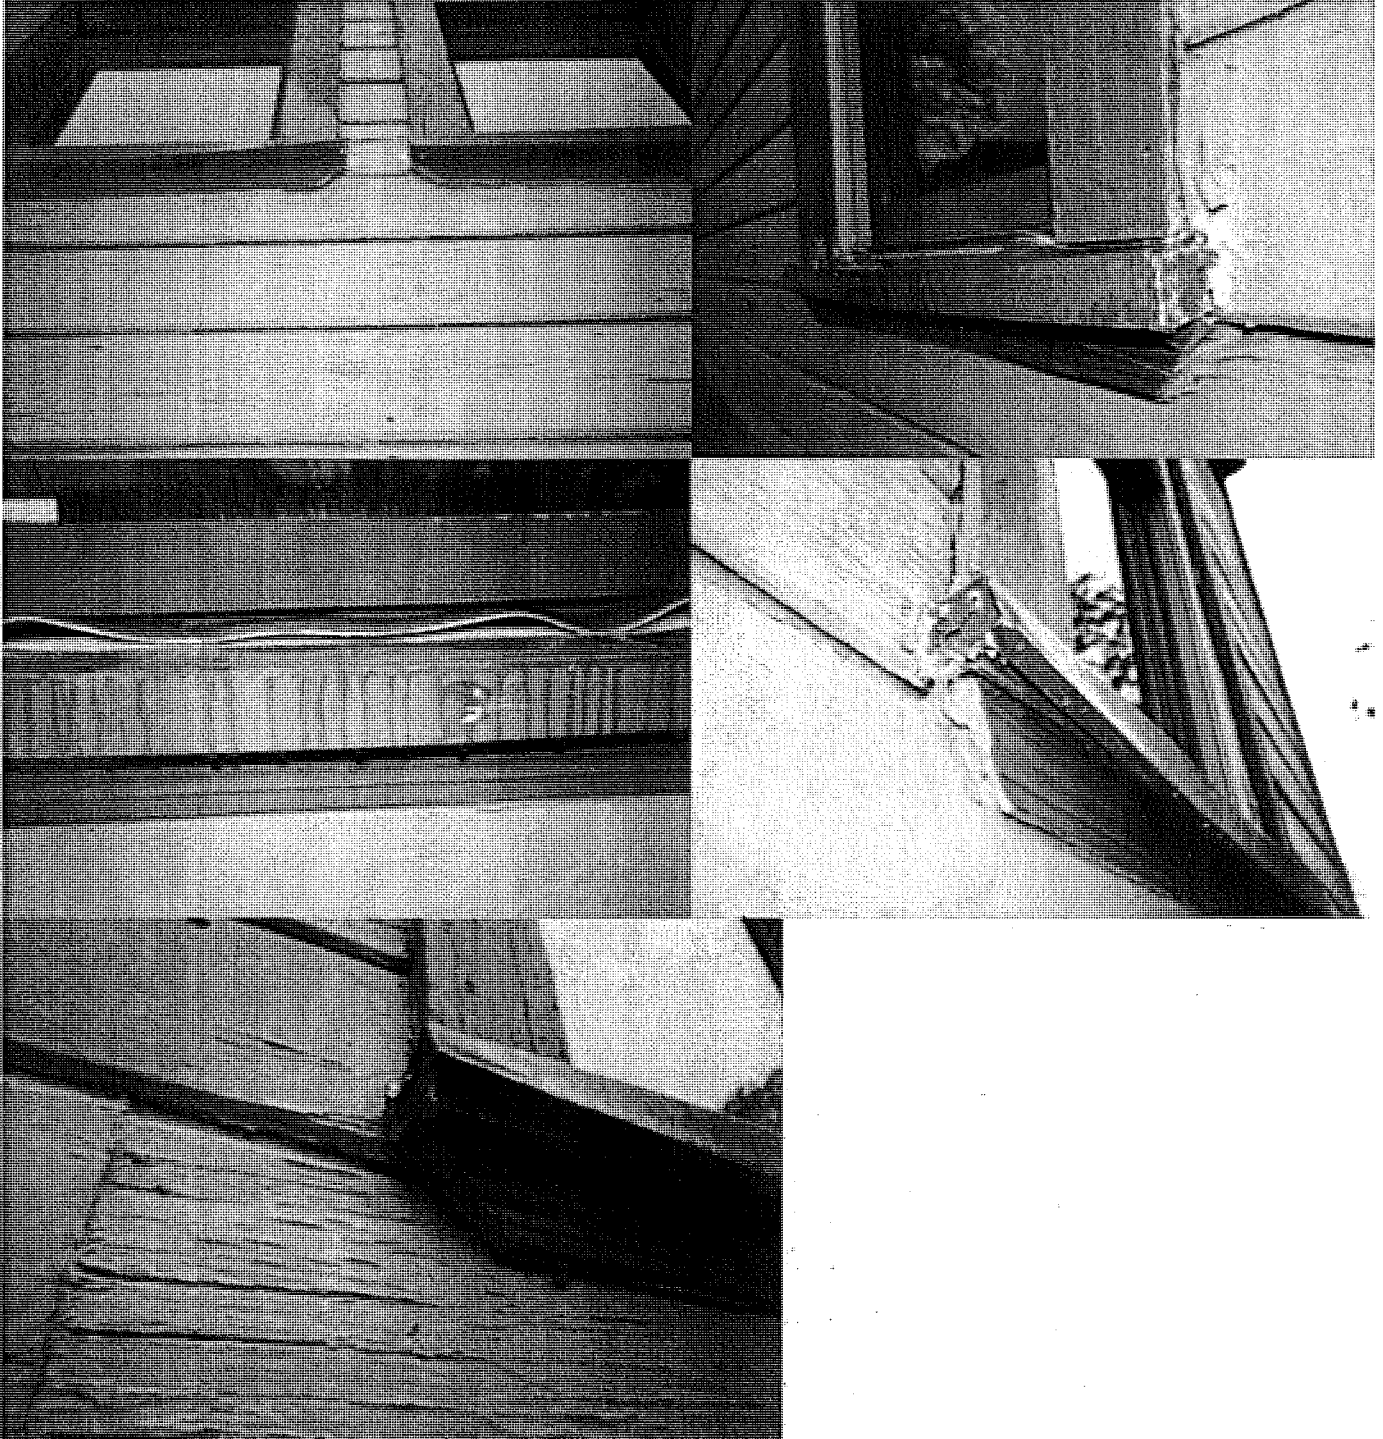
### South side window repair

The south side windows have an odd vinyl slide in them that has melted from the heat of the sun. The bathroom windows have flashing that was installed incorrectly and has been funneling water into the interior wall. The entire bathroom south wall needs to be opened to see the extent of the damage, repaired, and then new beadboard installed to match the original. There is currently plywood installed under one window so the leaking windows have been an issue for a while. Siding has some rot around the windows as a result and will need to be replaced with cedar siding to match.

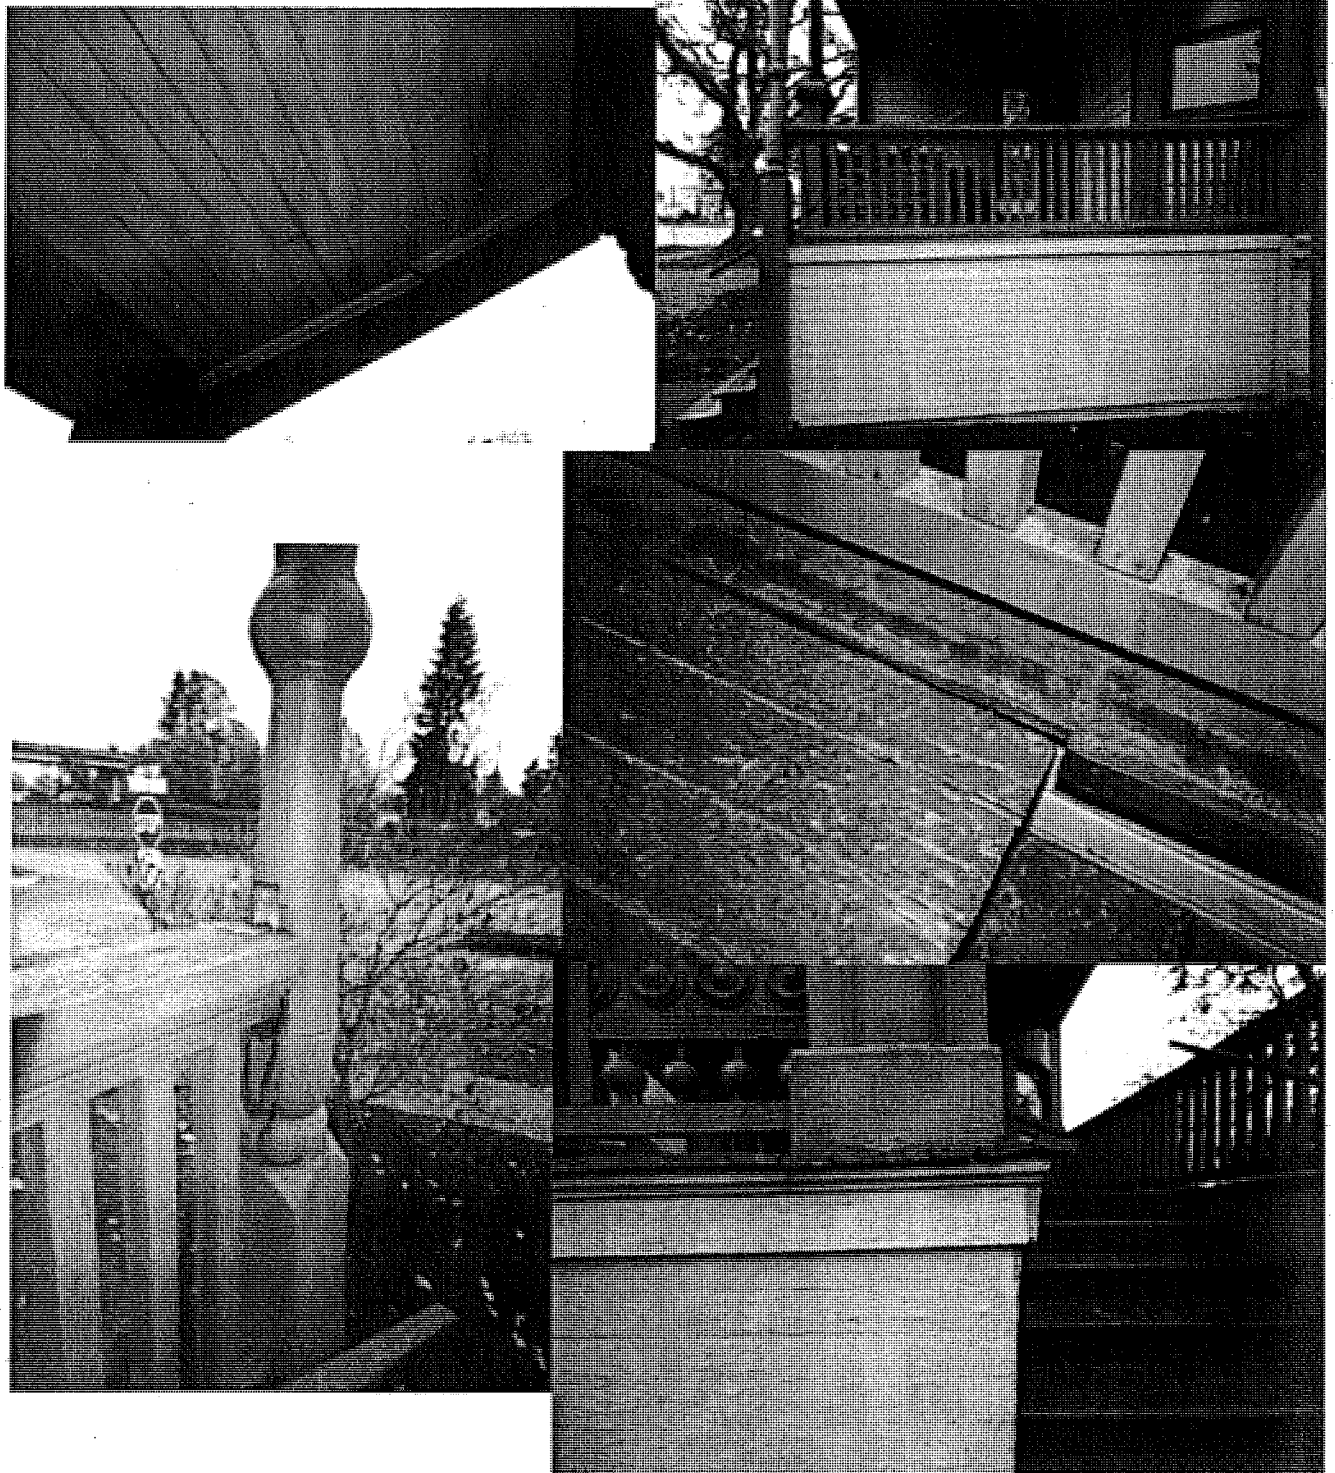
The front porch has termite damage in the support beams touching the ground. This has caused the front NE corner to sink, tilting the entire porch and putting strain on the roof line. The support posts have cracked and been held together with metal supports. The entire front porch needs to be removed, resupported, and anything original that can't be reused will be remilled to look like the original.
