# NOTICE OF DECISION

**MINOR HISTORIC DESIGN REVIEW CASE NO.: HIS22-17**

**SUMMARY:** A proposal to repair the original hopper windows on the south facade of the Pooler House (1920).

**IN THE MATTER OF APPROVAL OF ) MINOR HISTORIC DESIGN REVIEW  
HISTORIC DESIGN REVIEW )  
CASE NO. HIS22-17 )  
1527 CHEMEKETA ST NE ) June 2, 2022**

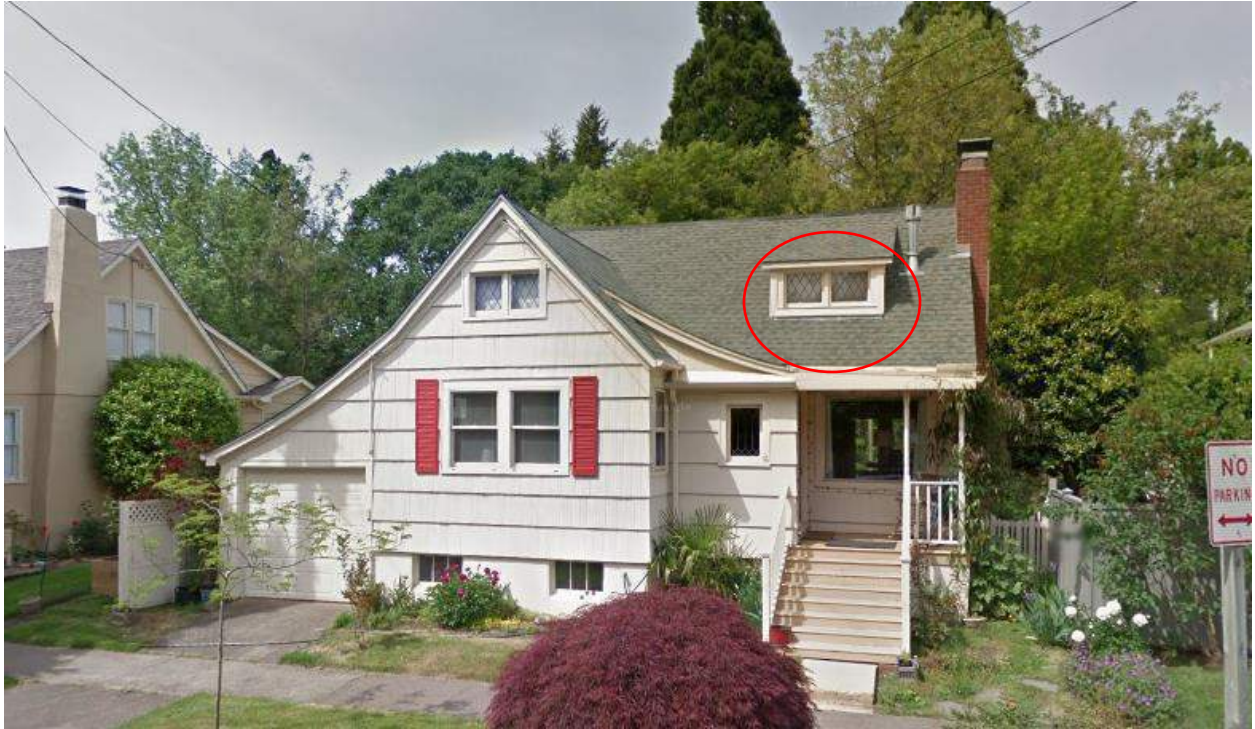
Primary Façade of Jeanette Pooler House (1920) NC to Court Chemeketa District

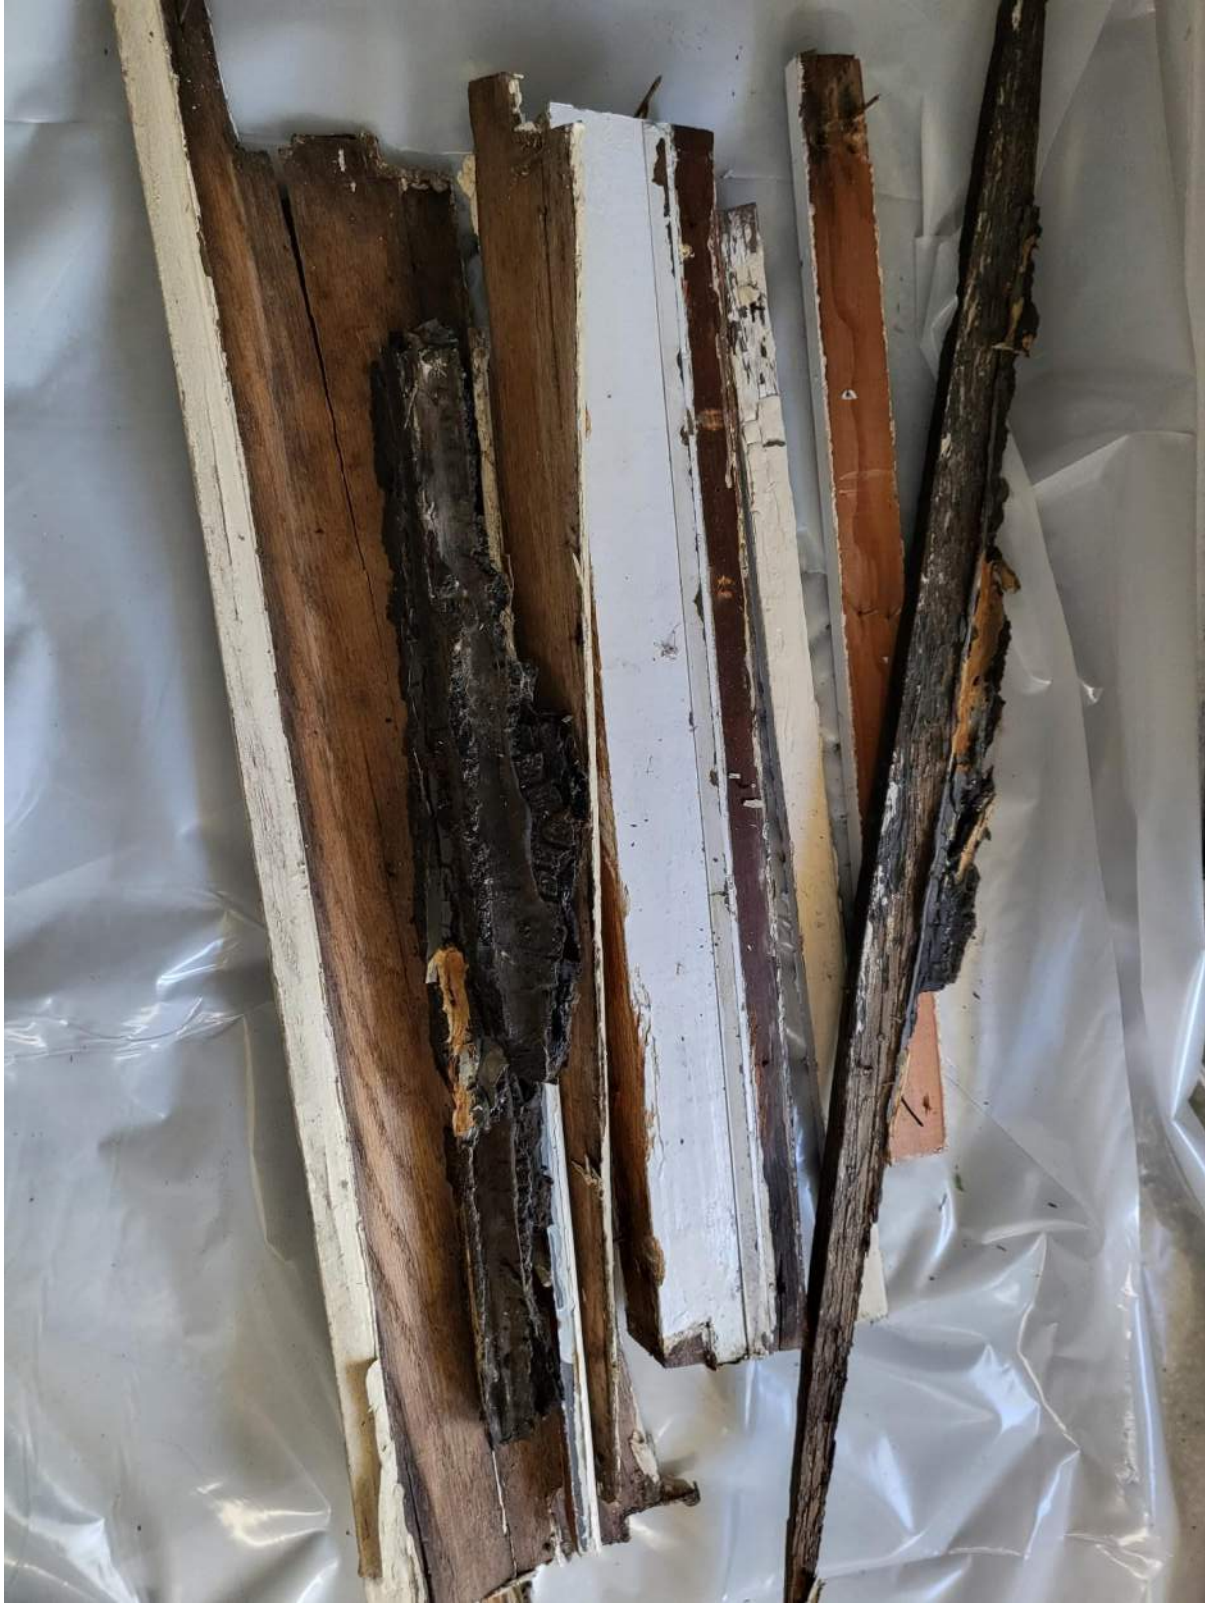
Existing sash and trim in poor condition

The applicant is proposing to repair the south facing hopper windows which are paired within the dormer on the east side of the south facade of the Pooler House. The repair will include taking the existing sashes, stops, post and casings to a commercial paint stripping service and then treated with linseed oil, primer and paint to match the existing trim on the exterior of the resource. The applicant is proposing to manufacture a new windowsill matching the original in material and design to replace the existing which is too deteriorated to repair. A new divider post may require replacement as well if this is in poor condition. The old glazing will be removed and refilled and the existing broken glass pane will be repaired. The applicant has

**Findings:** The applicant is proposing to repair a majority of the components of the existing paired hopper windows within the dormer on the east side of the primary façade. Where it is necessary to replace components of these windows due to their poor condition, such as the windowsill and the divider post, these will be replaced with wood, matching the original. Overall the repair of these windows will ensure that any replacement materials will duplicate to the greatest degree feasible the appearance and structural qualities of the material being replaced, therefore staff finds that SRC 230.030(b)(1) has been met for the proposal.

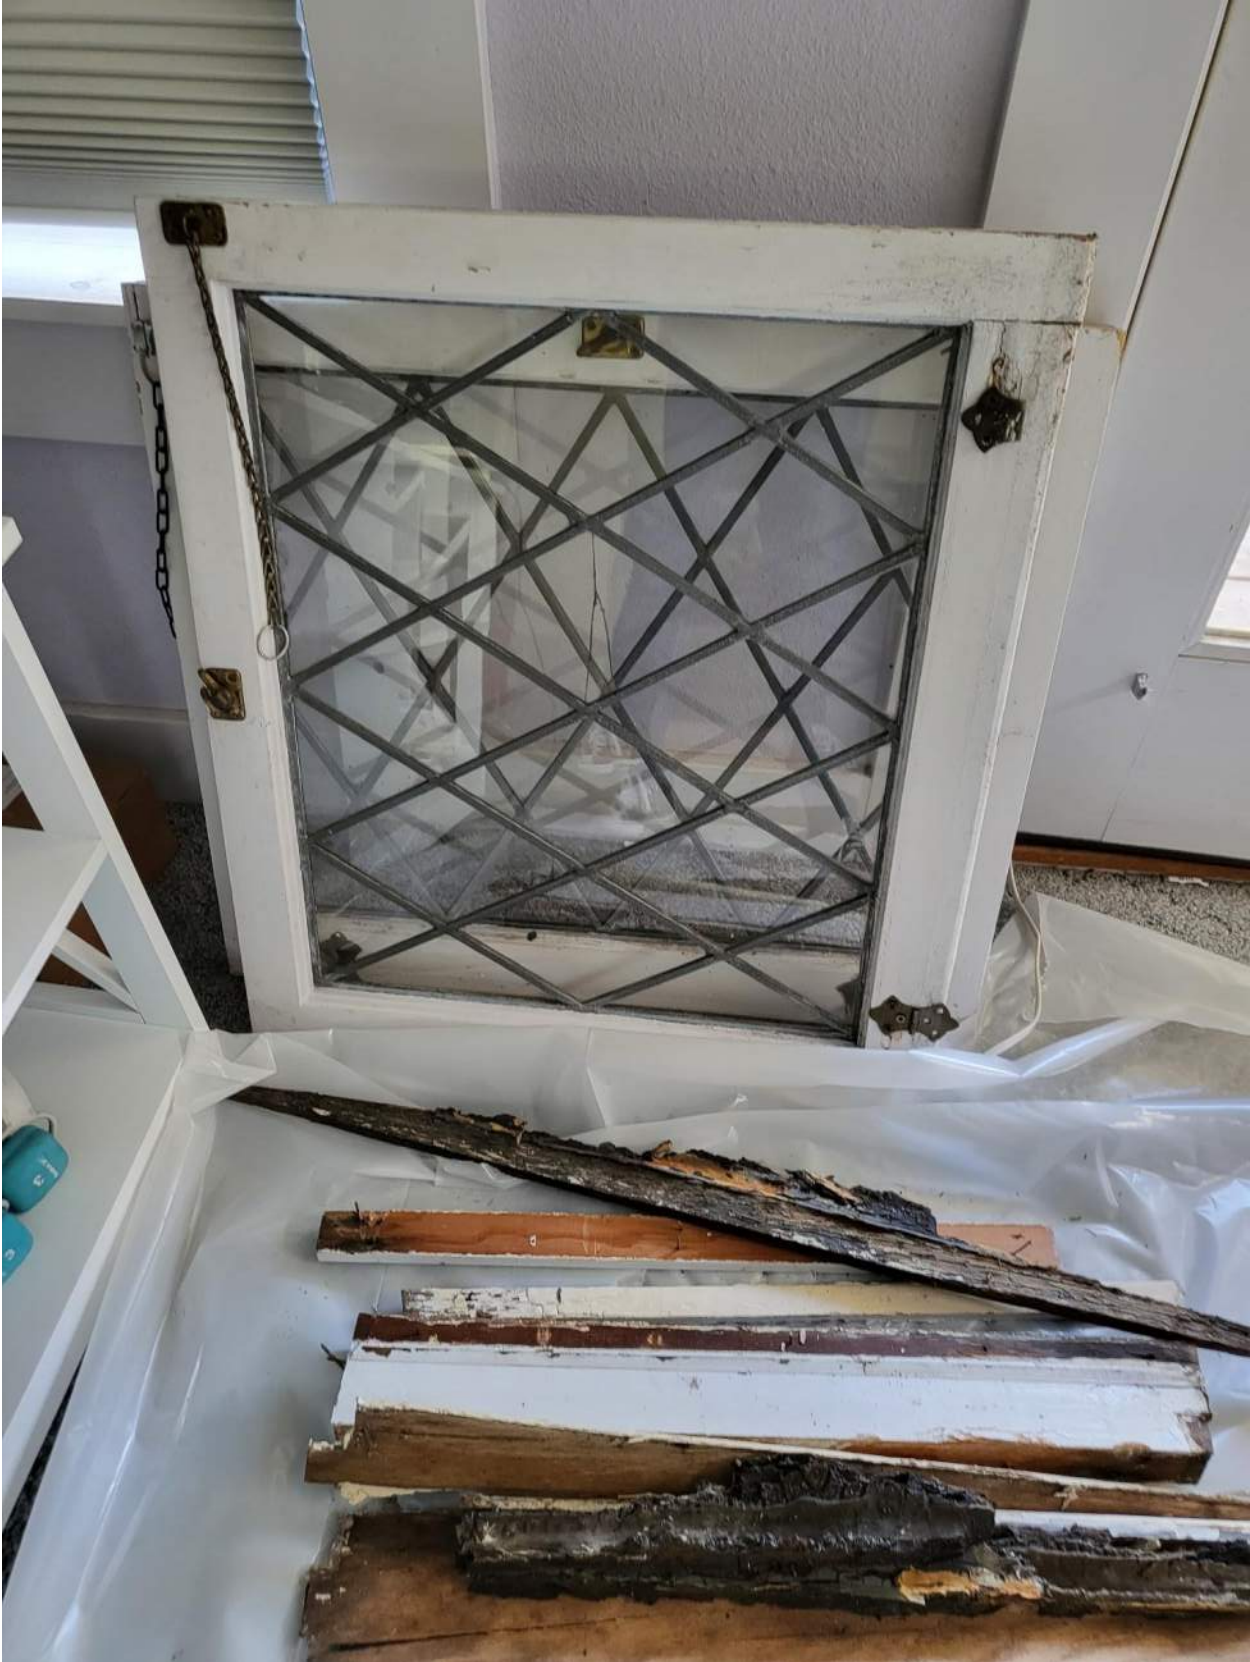
Existing window removed from frame

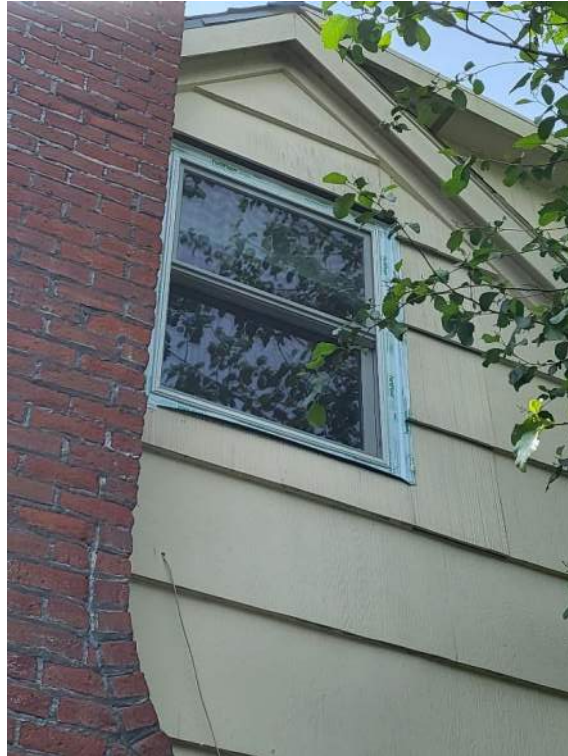
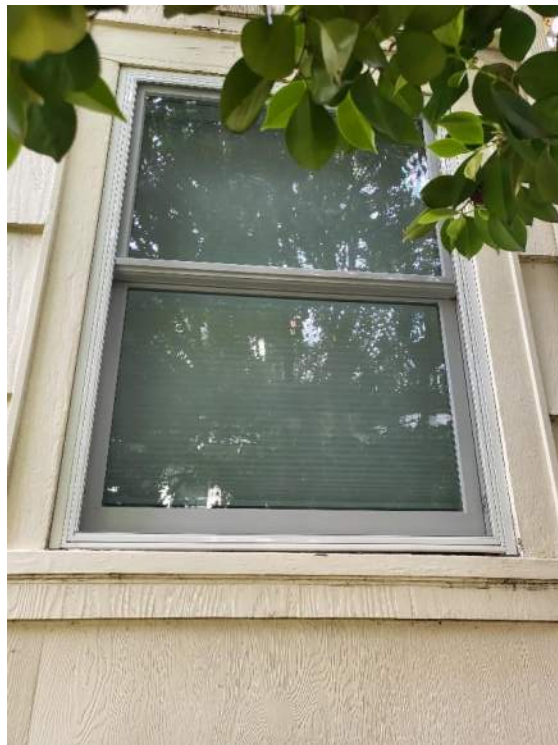
New windows on secondary façade(east)—replaced- not subject to review

also replaced two windows on the east façade of the resource with new windows. This portion of the proposal is not subject to design review per SRC 230.020 as they are located on a secondary façade of the resource. *230.030 (b) Standards for Non-Contributing Resources in Residential Historic Districts*, windows are applicable to the portion of the project on the primary façade of the resource.
