BUSH'S PASTURE PARK *and* DEEPWOOD ESTATE GARDENS

CULTURAL LANDSCAPE MANAGEMENT PLAN

APPENDIX B

List of Contributing and Non-contributing Landscape Features
for Bush's Pasture Park & Deepwood Estate Gardens

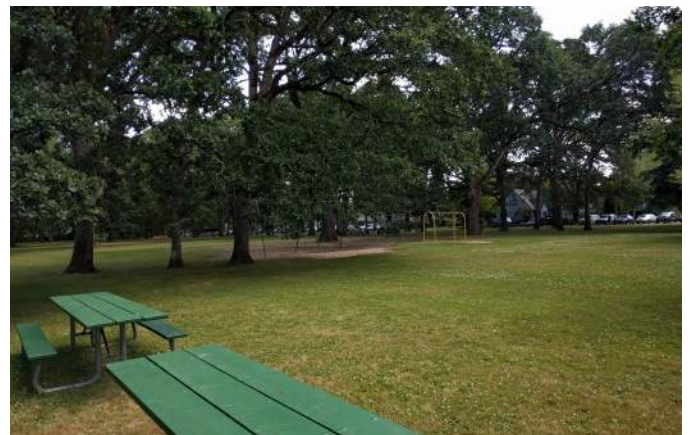
Spatial Organization: Other Playgrounds: Lower Leffelle in 2020

Spatial Organization: Other Playgrounds: Upper Leffelle Playground and Picnic Area in 2020

Two additional play areas are located at the park's southwest and southeast corners. The southwest or Upper Leffelle playground is located under the canopy of the Upper Oak Grove and is comprised of two swing sets, today all of which are missing swings. A 1967 park base map denotes that swings and a merry-go-round were installed at this location. There are no accessible routes to play features. This playground is associated with a popular picnic spot at Bush's Pasture Park. The Upper Leffelle playground was a gift to the City of Salem in 1950 by the Soroptimist Club of Salem and was dedicated by Mayor Loucks in 1951. The playground is in poor condition.

The southeast play area is located northwest of Phillips' Field and was renovated most recently in 2016 when perimeter curbing and swings were added. Prior to that, the other equipment was replaced in 1996. The original date of construction is unknown, but a 1957 park drawing shows a play apparatus at this location (although a later 1967 park base map does not show a play area here). It has functional play equipment in fair condition, but the features lack accessible routes or safety surfacing, as well as a recognizable relationship to their surrounding context. Several large specimen oak trees surround the playground, which should be protected and considered as part of any future renovation at this site. A concrete pad exists nearby that may have been associated with an old picnic shelter. The southeast playground is in fair to poor condition. During the historic period, the southwest playground was an oak-conifer woodland, and the southeast playground was part of the oak savannah ecosystem.

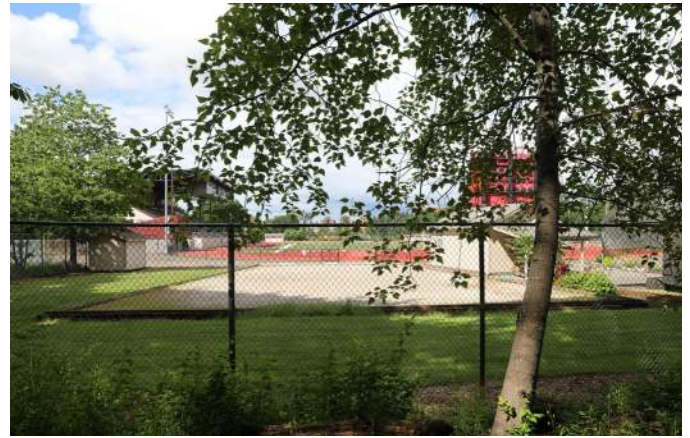
Cluster Arrangement: 1949 Willamette University Athletic Complex under construction. Prior to this time, the area was an oak savanna.

Cluster Arrangement: Willamette University Athletic Complex in 2020

reconsider the relocation of its present facilities in its long-term plans. The National Register nomination identified the athletic complex as a major intrusion to the park.¹² The complex continues to serve the Willamette University community, utilizing the Mission Street parking area. At some point in the recent past, bleacher construction around Lewis Field was deemed another intrusion into the park. A 9-foot chain link fence surrounds the complex. The athletic complex is in good condition.

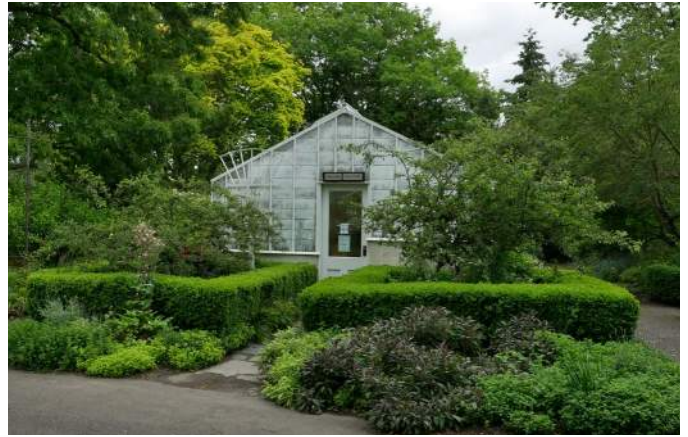
Buildings and Structures: Greenhouse (Conservatory) in 2020

A public restroom, greenhouse and kiosk were constructed by 1976 as part of the Deepwood and Yew Park parking lot development. The greenhouse – today used for storage and some plant display – is a Lord and Burnham brand greenhouse, a line that has been manufactured since 1849. These structures, in a small area and visible from the parking lot, support the needs of visitors to Deepwood Museum & Gardens. There is a direct pedestrian route to the main Deepwood garden entrance from the information kiosk and restrooms, but it currently lacks signage. Prior to construction, this area was a series of residential and commercial properties that fronted 12th Street with a north-south alley at their rear. The restroom, and kiosk are in good condition, but could be considered for upgrades that conserve water. The greenhouse's fiberglass roof and much of the siding is deteriorated.

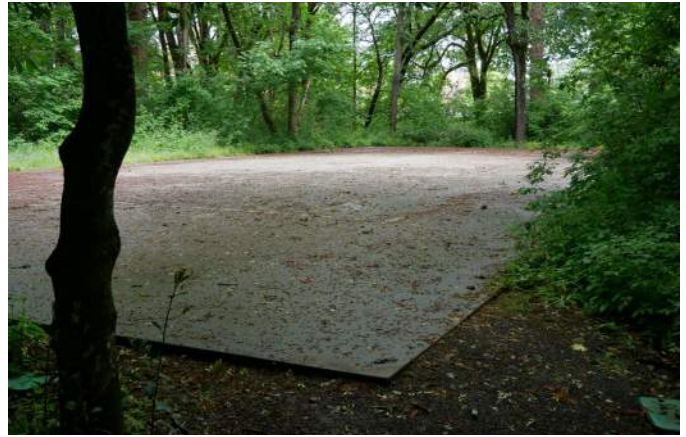
Buildings and Structures: Deepwood Carriage House in 2020

Buildings and Structures: Deepwood Tennis Court in 2020

An ornate carriage house with Queen Anne features is a companion to the Deepwood Museum Home and dates from the original construction.²² The carriage house is in good condition.

Brown and his son prior to the involvement of Lord and Schryver at Deepwood. It was the first tennis court in Salem and was originally enclosed on all four sides with high fencing. Prior to construction, the area was likely part of the woods that surrounds it. By the 1990s, it was in disrepair and was removed. In 2008, Friends of Deepwood raised funds to replace it with a concrete style court. In 2009, the court reconstruction was complete, and a path was added to connect it to the Lower Terrace. The concrete surfacing is in poor condition with cracks and heaves. There is a lack of planting material around the Tennis Court. Planting that does exist appears unkempt. There is an opportunity to incorporate the Lord and Schryver historic camellia collection between the formal gardens and the native landscape areas near the court.²³ Typically, between May and the end of October, a large tent is installed on the tennis court for rental events.

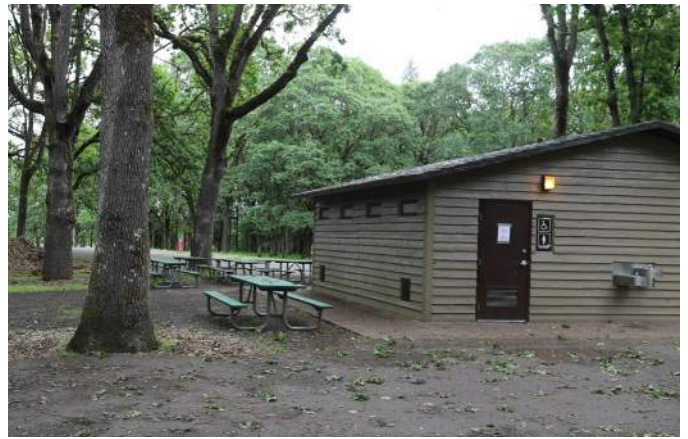
Buildings and Structures: Philips Field (City of Salem)

Buildings and Structures: Restroom at Soapbox Derby Track in 2020

Phillips' Field is a full-size softball field located north of the Lower Leffelle parking area in the Lower Pasture. Softball play has existed in the lower section of Bush's Pasture Park since the early 1950s. As interest and enthusiasm increased, more diamonds were developed, reaching a maximum of a four-field complex in 1971. Due to community concern and inadequate parking, the complex was phased out in the mid-1970s. Phillips' Field remained.²⁶ The field, bleachers and dugouts are in fair to good condition.

The restroom under oaks trees at the south end of the soap box derby track is set on a concrete pad with connections to the park's paved trail network. It may have been built in conjunction with the construction of the soap box derby track. The original construction of the restroom was concrete block. In 2008, it was demolished and replaced with a CXT-brand prefabricated restroom. The restroom is in fair to good condition.

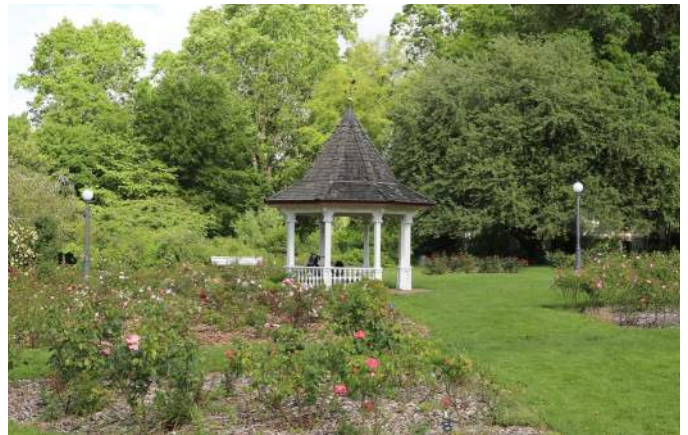
Buildings and Structures: Pringle Creek Bridge at Waller Street in 2020

Buildings and Structures: Victorian-style Gazebo at Rose Garden in 2020

In 1968, the Spring House was donated to the city by the Powells and moved to the rose garden at Bush's Pasture Park. In 1977, the Friends of Deepwood requested return of the Spring House. It was relocated to its original position in the Shade Garden in the mid-1990s.²⁷ Prior to construction of the gazebo, a pergola was the focal point for the rose garden. The pergola was originally built in 1978 for the City of Salem by a local scout troop. It was removed and replaced by the current gazebo in 1996 using a design by architect Keith Chrisman, who was inspired by the exterior details of the Bush House Museum. In 2014-2015, the gazebo was refurbished by the City of Salem – cladding on the columns was replaced, front railing west of entrance was replaced due to carpenter ant damage, wood bench tops replaced, brick flooring renovated, exterior was repainted, and preventative trenching at the gazebo perimeter to deter burrowing wildlife was installed. The gazebo is in good condition.

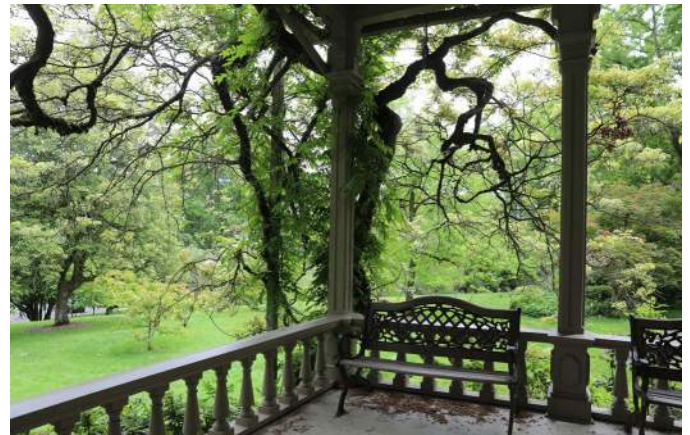
Vegetation: Oak Specimens on Bush House Museum Grounds in 2020

Vegetation: Chinese Wisteria at Bush House Museum in 2020

The oak specimens around the Bush House were originally quite numerous. They are dominant, iconic features in photographs that date to the historic period. Most of them have died and have been removed, many after the 1962 Columbus Day storm and later from root rot brought on by irrigation for turf grasses.³⁸ Today, there are few, if any, Oregon white oaks around the Bush House Museum. Fronting the house are a mix of small, medium, and large deciduous and evergreen trees. The nearest concentration of oaks is located south of the Bush Barn Art Center and around the Upper Pasture perimeter.

There are two wisteria plants on the Bush House grounds. The first was originally attached to the northeast corner of the porch. In the early 1990s, due to the stress placed on the structure by the vine, a metal frame was constructed to take the weight of the wisteria. The second Wisteria is freestanding in an oval planting bed north of the house. The wisterias are a prominent historic feature of the house and garden and are featured in many photos taken over many decades. Today the wisterias are in good condition.

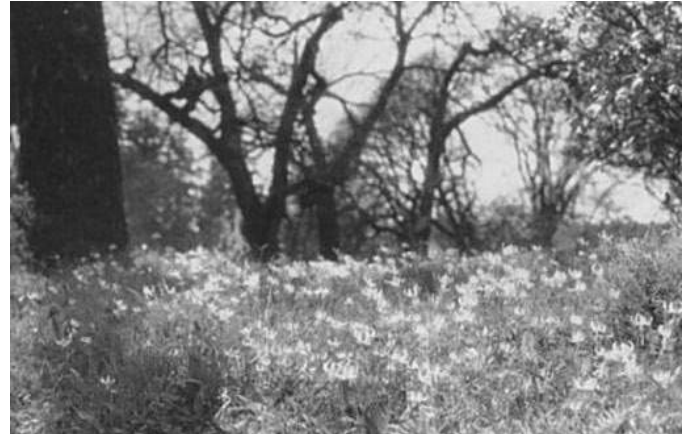
Vegetation: Remnant Oak Savanna and Camas Field

Vegetation: (undated photograph) Wildflower Slopes on the grounds of the Bush House (Bush House Museum, Salem Art Association, bh0110)

camas fields bloom in the spring. The condition of the interface is degrading due to non-native grass species detected during the spring 2020 site evaluation. This area is not protected from informal foot traffic diverging from established trails.

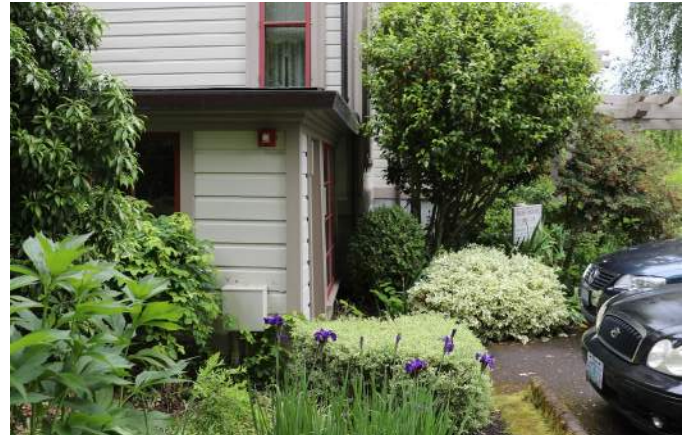
Vegetation: Foundation Plantings along Bush House Museum, Bush Barn Art Center, Conservatory, and Root House

Foundation plantings comprised of perennial shrubs, deciduous and flowering trees, ferns, and bulbs were added following conversion of the house to a museum in 1953. The house museum is most heavily planted on the east side, which is the side visitors most often see. Victorian-era farmhouses typically did not feature foundation plantings. Images from the Bush era show virtually no foundation plantings. Common Boxwood is used within the

foundation plantings. Common Boxwood is known to be vulnerable to ‘boxwood blight’, a fungal disease caused by *Calonectria pseudonaviculata*.

By 1947, photographs show some shrubs and groundcovers around the Bush House. Based on that information, it is likely that many of the foundation plantings were installed in the early days of the current Municipal Park Era. Records from 1959 – Oregon’s centennial year – reveal that Lord and Schryver worked to improve the appearance and plantings around the Bush House with the anticipation of more visitors that year.⁷² The plant material is consistent Lord and Schryver’s plant range and include boxwood, fuchsia, and flowering annuals in blue and gold tones, Oregon’s state colors. Many of the extant plants were likely selected and placed by them. Successive park gardeners and “friends of the park” groups have added plants to the foundation beds, either to enhance the beds or to replace failing plants, based on the Lord and Schryver plant palette.⁷³ The Mission Street Parks Conservancy tracks all the current plants installed in these areas.⁷⁴

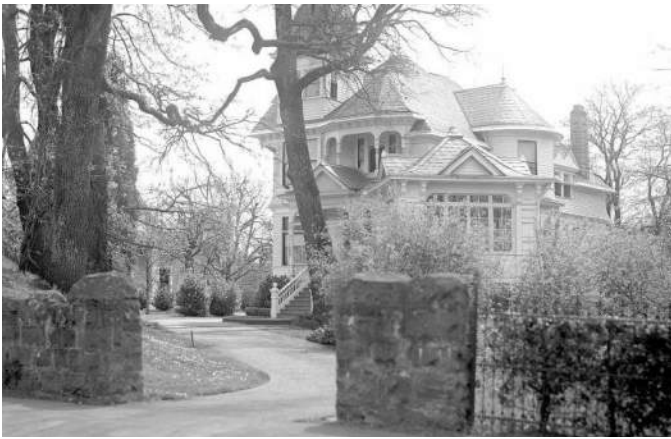
Small-scale Features: Wrought-iron Ornamental Gates and Fencing along Mission Street at Deepwood (Salem Public Library Historic Photograph Collections, Salem Public Library, Salem, Oregon, HSTC222)

Ornate wrought-iron gates and fencing at the Deepwood Mission Street driveway along Mission Street were added by Judge Bingham.⁷⁶ Today the driveway gate and fencing are in fair to poor condition, but they are important details to the Deepwood entry along Mission Street. The gates and fencing are connected to the mortar-set stone walls associated with Deepwood. Friends of Deepwood records show the entry wrought-iron gate was purchased by George Bingham in 1902 from Portland Iron Works.

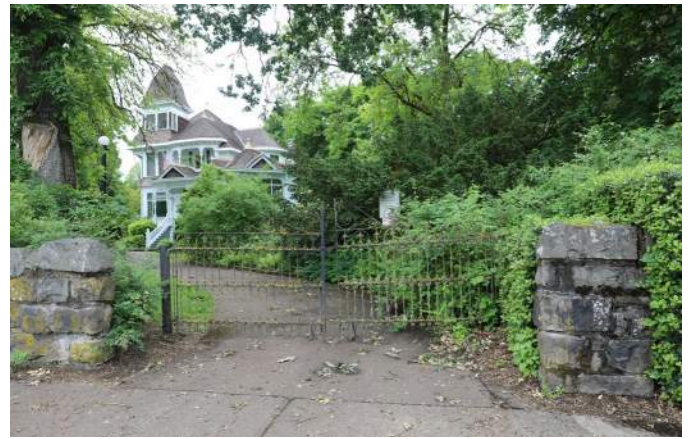
Small-scale Features: Wrought-iron Ornamental Gates and Fencing along Mission Street at Deepwood

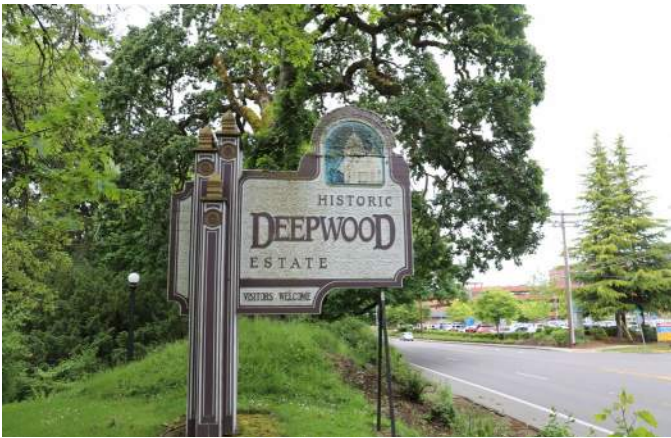
Small-scale Features: Park Signage in 2020

A variety of park signage exists for directional, regulatory, and identification purposes. All signage is considered contemporary and replaceable. Most is located along parking areas or pedestrian trails. Some larger park signs exist along 12th Street, Mission Street and High Street to identify the Bush House Museum and Deepwood Museum & Gardens. Signage fronting 12th Street for the Deepwood Museum is spread out could be better consolidated. The signage is in poor condition, with missing pieces and substantial fading.

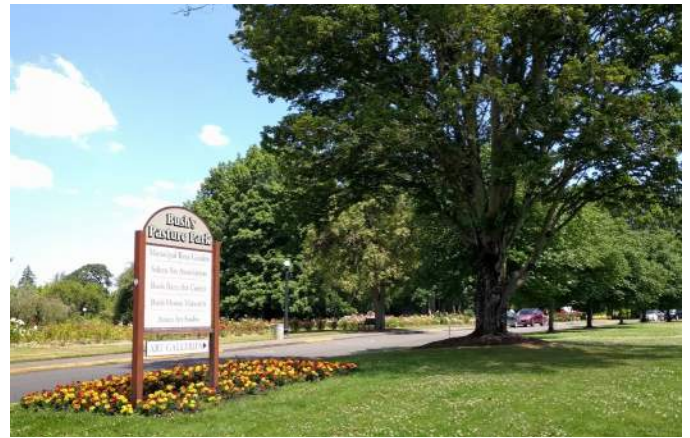
Small-scale Features: Park Signage in 2020

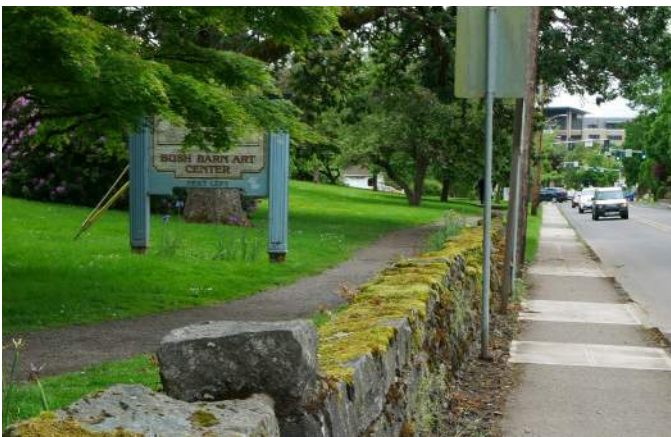
Small-scale Features: Park Signage along Mission Street in 2020

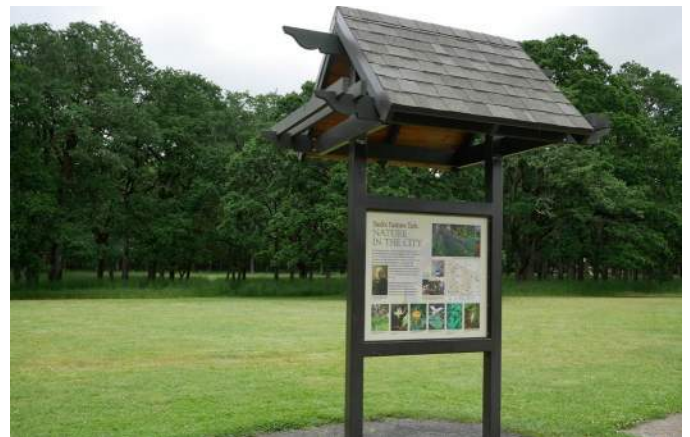
Small-scale Features: Interpretive Kiosk Signage in the Lower Pasture in 2020

fields.⁷⁷ The project was supported with private and public funds, donations, and grants. The kiosks have a gable style roof and metal frames for the interpretive panels. They are in good condition.

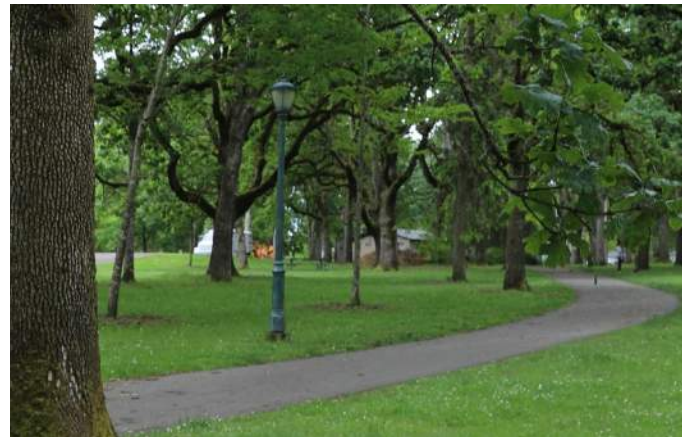
Small-scale Features: Path Lighting between Bush Barn Art Center and Lower Leffelle Parking Area in 2020

Path lighting was installed along the asphalt trail between the Bush Barn and the Lower Leffelle parking area in 2006, a four-year effort assisted by SCAN. The fixtures are installed on 12-foot metal light poles with a patina finish. The path lighting varies to some extent as to where and how the light fixture is attached to the pole. The poles are in fair to good condition.

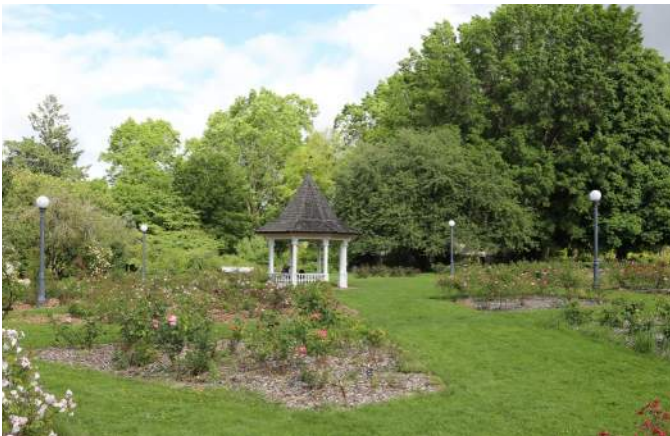
Small-scale Features: Bush House Museum Grounds Lighting in 2020

Lighting in two styles of decorative light poles exist in various locations on the Bush House Museum Grounds. The first style, on the south side of the house and at the High Street driveway entrance, features a taller pillar with 4 lights. The second style runs along the driveway to High Street and features a shorter pillar and one light. There are four additional poles of this type located around the Victorian-style gazebo in the rose garden. These non-historic lamps were selected to complement the Victorian buildings.⁷⁸ The lighting is in good condition.

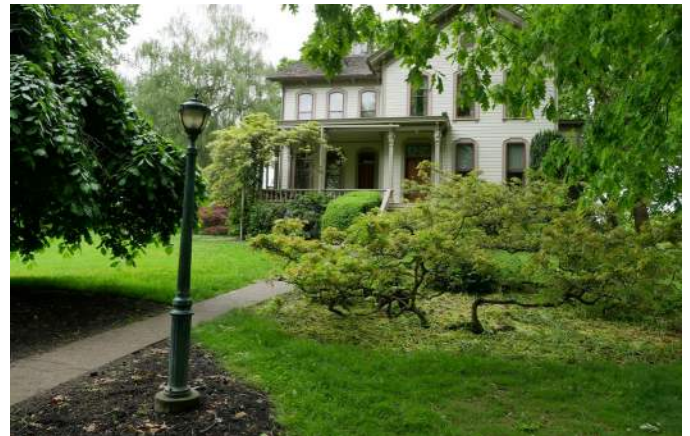
Small-scale Features: Bush House Museum Grounds Lighting in 2020

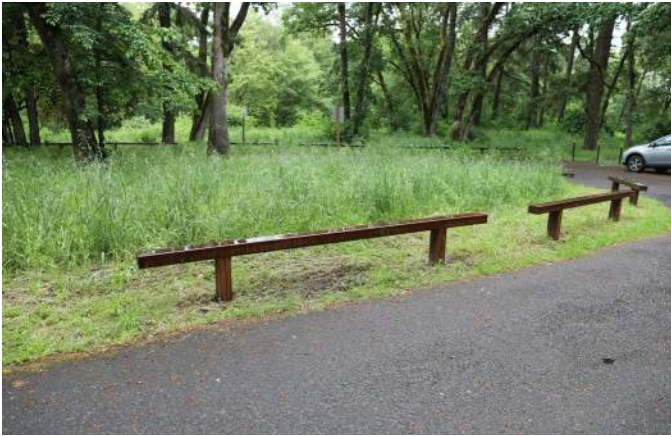
Small-scale Features: Metal Barricades along Parking Lots in 2020

Cor-ten steel horizontal barricades, approximately 30-inches in height and six-feet long and mounted on two posts, are used to demarcate the edges of parking at the inset Mission Street lot and the Leffelle parking areas. It is unknown when they were installed but appear to be contemporary. The barricades appear to be reminiscent of hitching posts used for livestock. They are spaced a couple feet apart to allow for pedestrian passage between them. Some of the barricades are new and replaced other previous obstructions to detour people from driving into the park. A 1967 park base map depicts the existence of barrier posts in similar locations in the Leffelle parking areas.

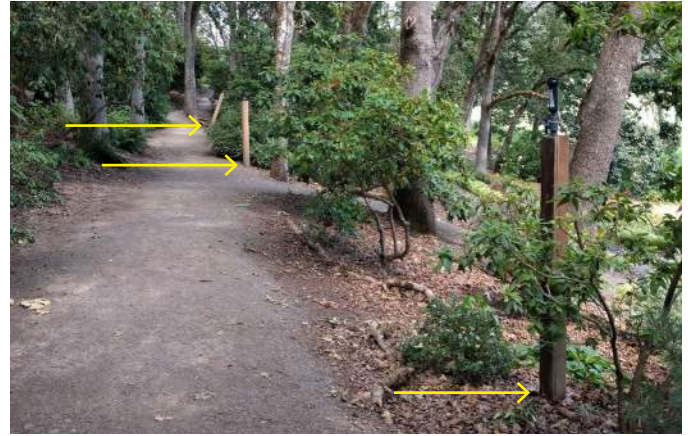
Small-scale Features: Irrigation at Rhododendron Hillside in 2020

Irrigation at the Rhododendron Hillside is comprised of wood post mounted spray heads installed within the rhododendron beds. Irrigation was installed as part of the hillside garden design implemented by Friends of Bush Gardens (predecessor to Mission Street Parks Conservancy). The spray heads provide summer irrigation in an area where existing oaks have been adapted to summer drought and consultants have noted this may potentially lead to lack of oxygen in the root zone, increased soil compaction, and growth conditions for root decay organisms.⁸¹
