BUSH'S PASTURE PARK
and
DEEPWOOD ESTATE GARDENS

Preservation Project, Lord and Schryver Gardens, Historic Deepwood Estate:
Addendum to the Historic Deepwood Estate, Historic Landscape Report
(Lord & Schryver Conservancy)

*Preservation Project
Lord and Schryver Gardens*

ADDENDUM
to the
Historic Deepwood Estate, Historic Landscape Report,
Land and Community Associates, 1990

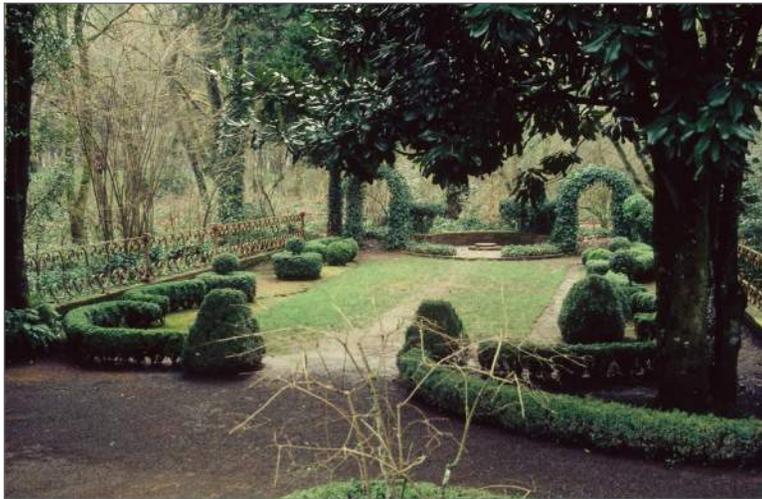
Figure 2: Scroll Garden, 1997

By 1997 the scroll garden was a remnant of its former glory. The garden was entirely overgrown with encroaching trees creating deep shade, poor drainage, and, therefore, a failing lawn. (Fig. 2)

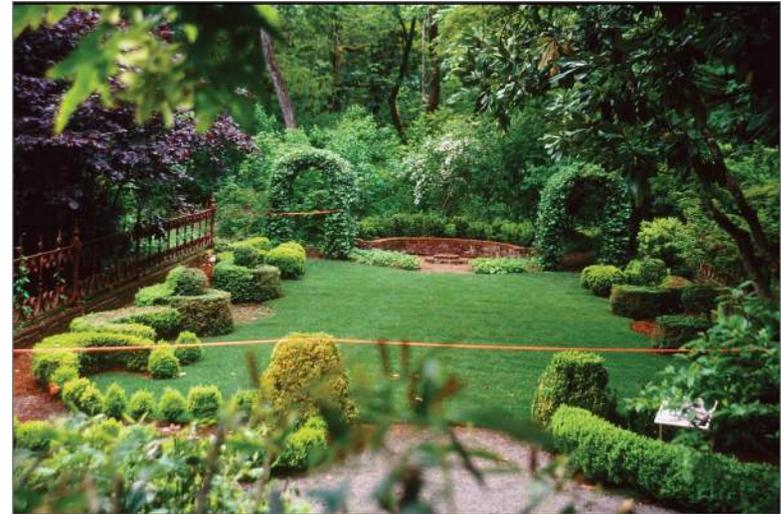
Figure 3: Scroll Garden with newly installed lawn, 2003

1. The lawn was graded and replanted, extending the turf to the boxwood scroll hedge. (Fig. 3)
2. A row of brick on edge was added as transition between the gravel area and the turf. This type of historic transition as it exists in the Great Room was copied.

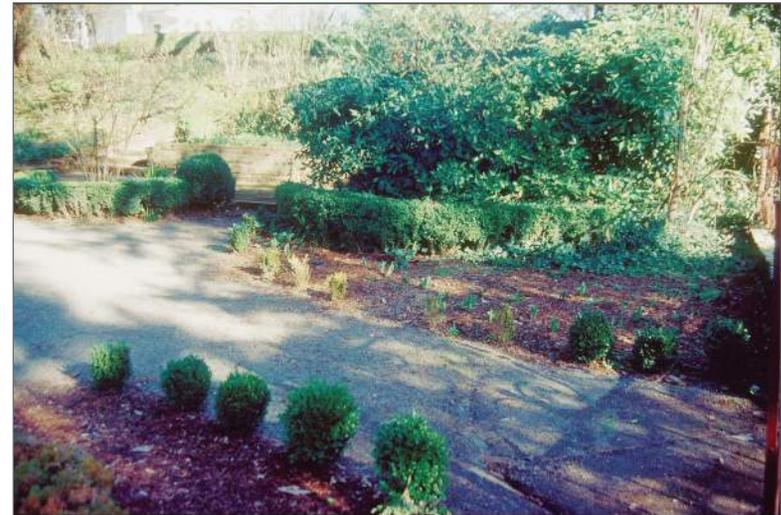
Figure 4: Lower Terrace before rehabilitation began, 2003

Hedges: The two hedges flanking the south gate had been more recently planted and were failing in part. (Fig. 4)

The missing boxwood were replaced and properly aligned with the other boxwood elements in the garden. The two extra boxwood hedges (see above) were used as a source for

the taller, easternmost hedge in the Lower Terrace. All of the boxwood hedges outside and east of the Scroll Garden should be kept at 22". (See page IV-11 for recommendations on how to bring a boxwood hedge into scale.)

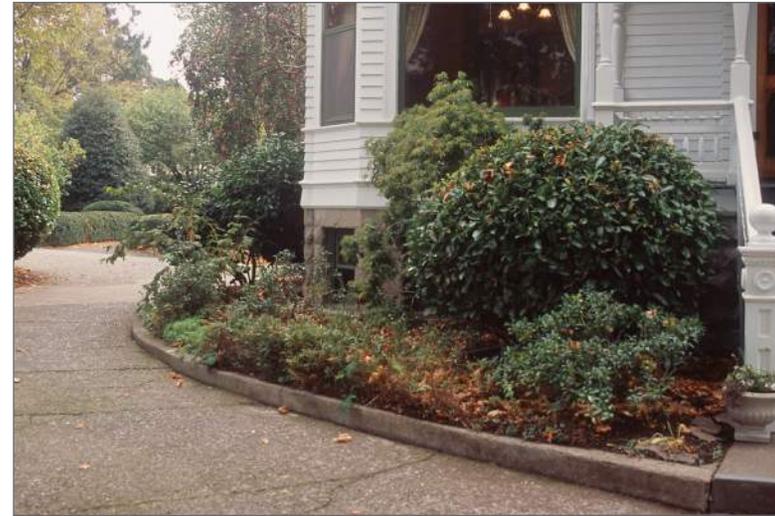
Figure 5: Foundation Plantings before rehabilitation began, 2003

The plantings existing in 2003 (Fig. 5) reflected improper care and lack of replacement of dead plant material during the interim 35 years since Alice Brown Powell's departure from the property in 1968.

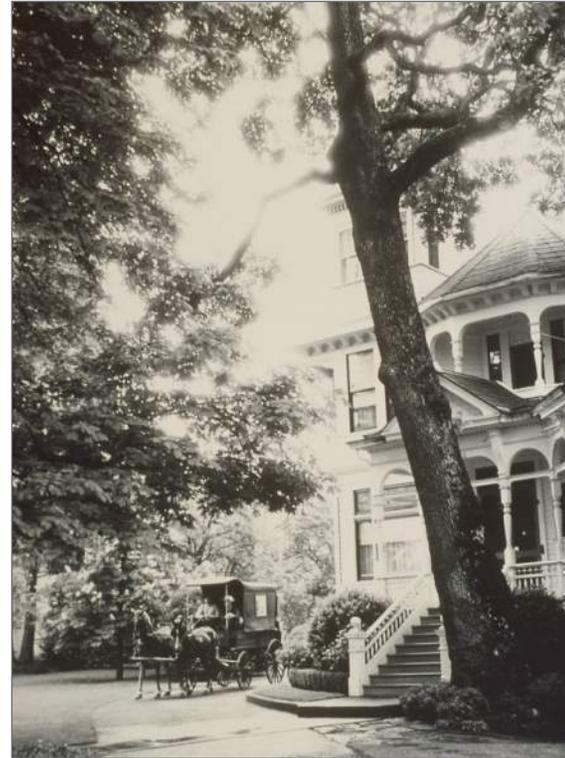
Figure 6: Meier & Frank delivery van on driveway, circa 1950s

Hedges: According to the photographs from the 1950's (Fig. 6), a low boxwood hedge bordered the foundation shrubs and

extended from the south, wrapping around the house to the newel post at the front steps. Grass extended from the boxwood hedge to the curb. The background shrubs are much larger now and no evidence of the lawn and boxwood hedge existed when we began our rehabilitation [Appendix A2 and Appendix D3(b-#624).

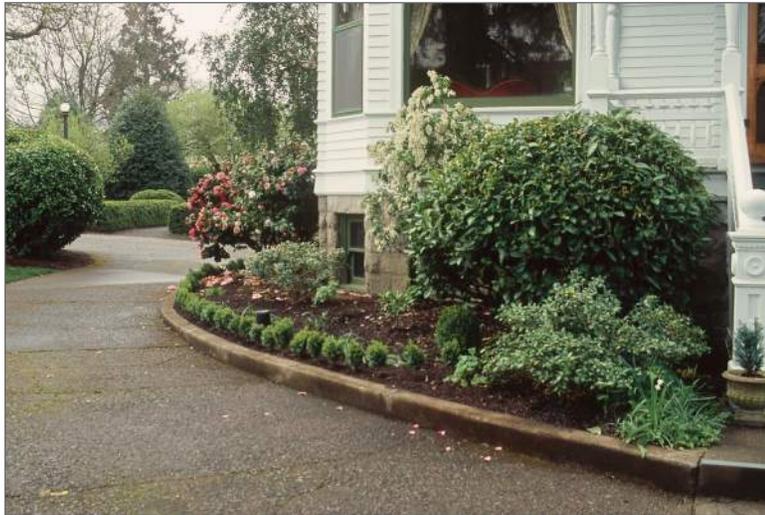
Figure 7: Foundation Plantings after boxwood installation, 2004

A boxwood hedge was planted immediately against the curbing where indicated in the treatment plan (Appendix A2) (Fig. 7)

The front edge of the mature boxwood hedge should be in the same plane as the front edge of the curb. This will help take the invasive effect of the curb out of the landscape. In addition, the boxwood hedge element ties in with the hedge elements found in the south end of the Entry Garden near the Carriage House and the north entrance to the Great Room.

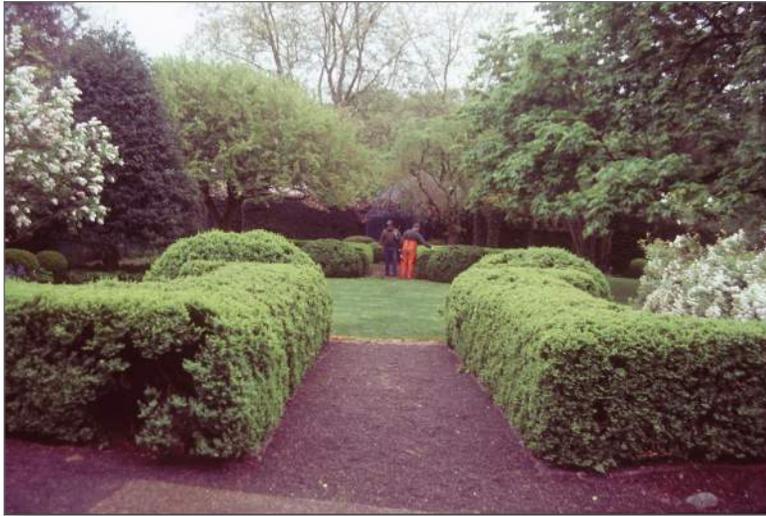
Figure 8: Great Room showing boxwood hedges prior to pruning, 2004

The "cartoon" character of the boxwoods as described in The Historic Landscape Report (pages IV-10, 11) was addressed by the city in the late winter of 2005. (Fig. 8)

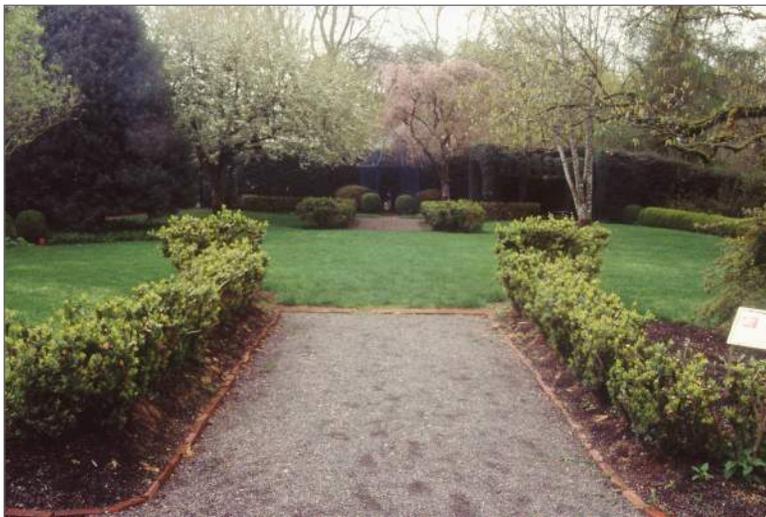
Figure 9: Great Room showing boxwood after pruning, 2006

The hedges were drastically opened up and reduced to several inches below their present height. (Fig. 9)

With continued oversight, the boxwood hedges are filling in nicely and have been returned to a scale more in keeping with the garden. At the same time, the gravel paths between the boxwood hedges were lowered to their original grade, revealing the detailed historic brickwork surrounding them. Notice that the boxwood hedge at the north end of the garden on the east side was extended at some point, possibly when the city acquired the property. The extension of the hedge is a different type of boxwood.

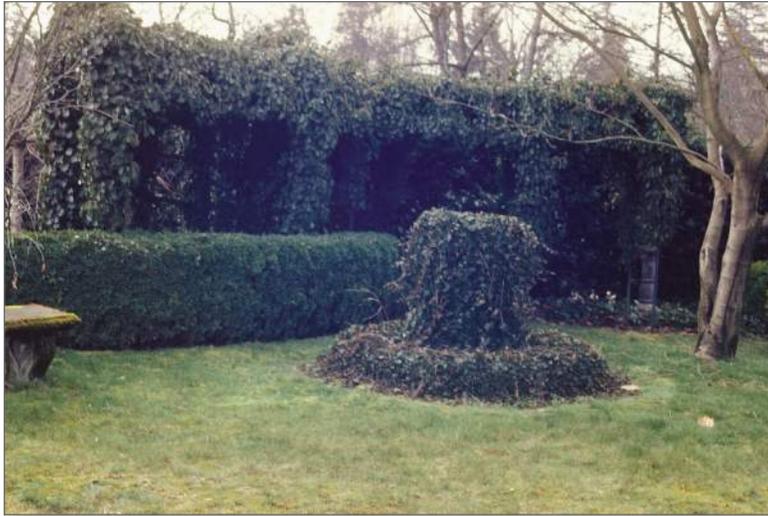
Figure 10: Great Room showing stump of willow in center of 'well', 1971
Note laburnum on right

The so-called 'well' of the present day garden was actually the circular rock structure Alice Brown built surrounding the weeping willow [Page II-6 or Appendix D1 (a-#293)] which dates from Judge Bingham's ownership. (Fig. 10)

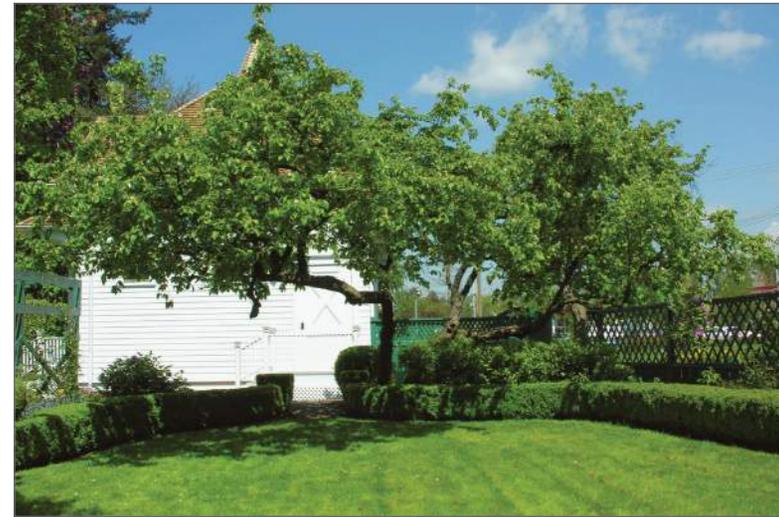
Figure 11: Spring Garden looking north, 2005

To our knowledge this garden was not initially designed by L&S but perhaps had elements of their designs shared informally with Alice through the years. It was planted in grass, boxwood, roses and peonies [Appendix D5 (b)]. The old fruiting quince enclosing the north end of the garden dates from Judge Bingham’s residency when this part of the property included vegetable gardens and fruit trees. This quince is thought to be the oldest cultivated plant in the historic gardens dating from the early 1900s and adds significantly to the charm of the Spring Garden as well as the Carriage House Entry. This entrance area was not well defined on its south side, especially west of the quince. (*Fig. 11*)

The present Spring Garden lacks enclosure overhead, especially on the east side in the area of the bench. The original apple tree which stood in the lawn near the southern boxwood hedge was removed some time after 1987 [Appendix D1(a-Ron Cooper 1987 photo)] and Appendix D5(b)]. The hawthorn growing in the northeast corner of the Tea House Garden is large enough to create some ambiance overhead in the southeast corner of the Spring Garden but very little.

The bench was donated to the garden in 1988 from a garden at 860 Union St and is similar to two other benches located in the historic gardens known to have been purchased by Alice Brown. At the time of its placement in the Spring Garden,

Fran Duniway stated that “A bench had been in the place it (the new bench) is now situated.” A few boxwood had to be removed, probably installed by the city in the early 1980s to ‘fill in’ the hedge where the bench was missing. This particular bench has been used to make the form for the new bench in the Scroll Garden, as well as the two concrete benches in the Tartar Old Rose Garden in Bush’s Pasture Park.

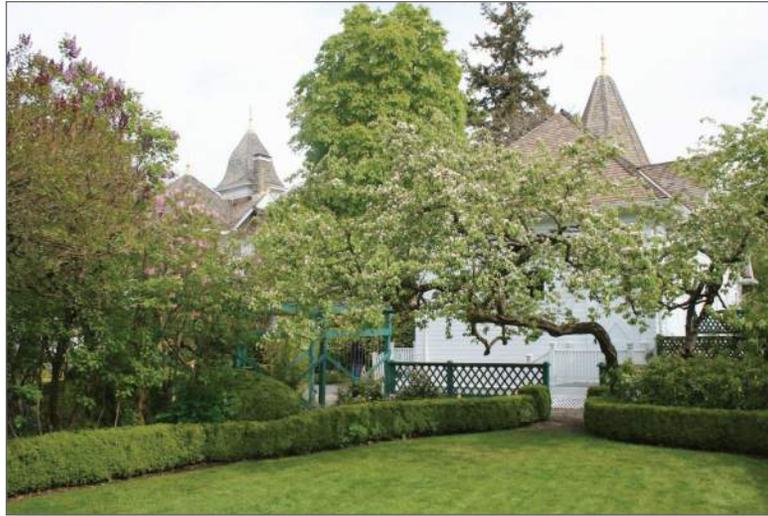
Figure 12: Spring Garden looking north after fence installation, 2009

1. A fence from the south side of the east gate at the Carriage House Entry to the grape arbor at the north end of the Running Brick Walk has been built as indicated in an oral history [Appendix D5(c-Darrell Belcher)] and on the 'Master Plan for Deepwood' dated 1978 [Appendix D5 (e-drawing attached to note to Fran Duniway)], leaving an entrance into the north end of the Spring Garden. The design for this fence was spun off the fence at the entrance to the Tea House Garden and is approximately two-thirds the height of the existing fence on the east side. The western part of this addition was mounted on the existing brick wall. (The remnants of a mounting bolt were present on the top of the brick wall.) Due to the presence of one of the major quince trunks, the new fence stops short of meeting the east fence. This reconstructed fence creates a much stronger feeling of enclosure, both for the Spring Garden and the Carriage House Entry. (Fig. 12)

2. The fence was painted the blue-green color of the other wood structures in this part of the garden. Consult Appendix C for the appropriate stain formula.

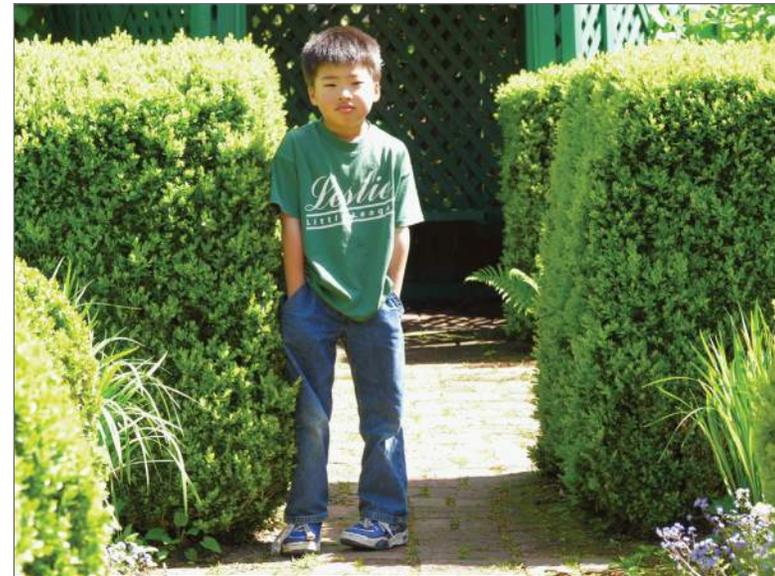
Figure 13: Tea House Garden looking east, unidentified visitor, 2005

Hedges: As late as 2005 the boxwood plantings in the Tea House Garden were overgrown and cartoon-like in appearance totally blocking the interior views across the garden. (Fig 13 & Fig. 14)

In the late winter of 2006 the city staff head-gardener, having witnessed the earlier success in reclaiming the boxwood hedges in the Great Room, severely cut the boxwood back to good wood at a height of 8 – 10 inches. See the Historic Landscape Report (Page IV-14) for the correct method of restoring boxwood. Almost two years later the original boxwood hedge had fully recovered forming a lush, much shorter hedge.

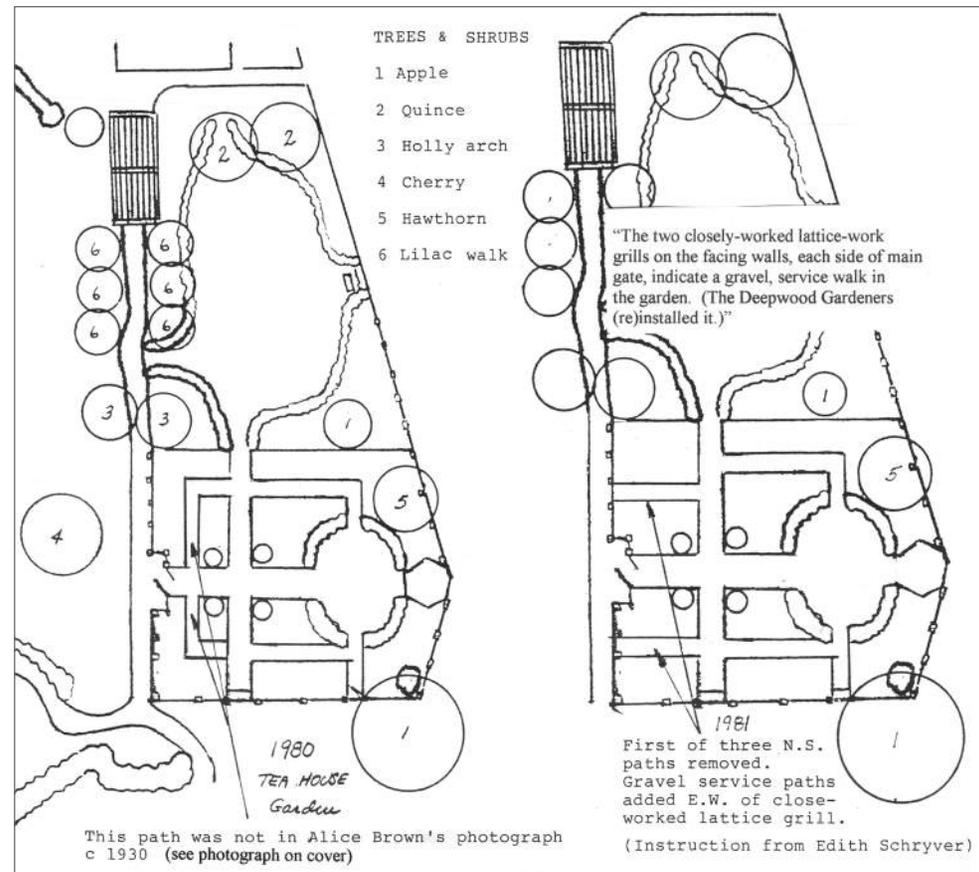
Figure 15: Drawing of Tea House Garden path restructuring

Paths: The paths in the Original Construction Plan (II-11) and the Original Planting Plan (II-12) of the Tea House Garden differ from the present design, and early photographs do not clearly give a definitive answer as to what was actually installed, but we can state that the path seen immediately east and paralleling the front fence in the Columbus Day Storm photo [Appendix D3(f - #2007.1.15)] was not in the original garden design [Appendix D1(a-#212b), also front cover]. It is therefore assumed that Edith's corrections shared with the Deepwood Gardeners in 1981 [Appendix D5(a)], as seen in (Fig. 15) represent the intent of the original design.

The brick paths have become slightly uneven through the years. In 2006 a volunteer raised the edges of the brick paths to more closely follow the original design [Appendix D1(a-#212b and a-68.1.8A)]. The three secondary paths are gravel as originally intended.

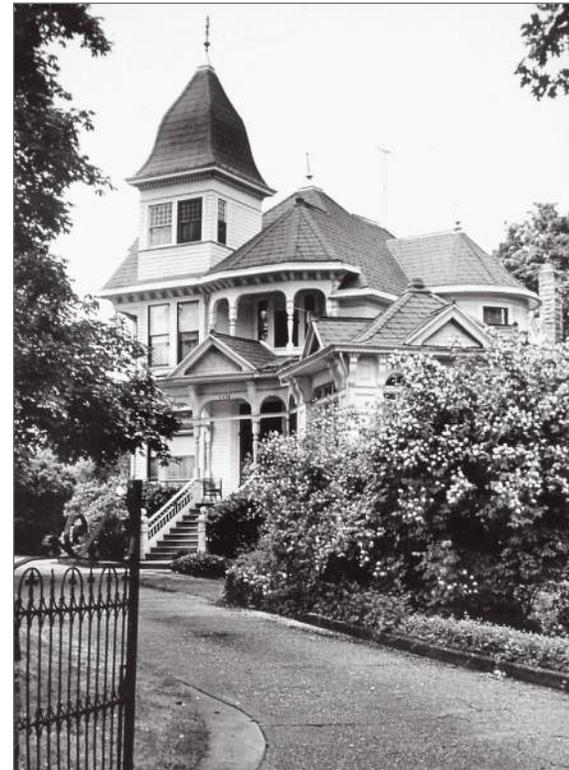
Figure 16: Entry Garden taken from driveway entrance, Shade Garden on right, 1967

See the Historic Landscape Report for history of this area (II-24) and treatment (IV-20). The lawn had deteriorated even further than described in 1990 and the broad-leaved evergreens were in drastic need of pruning. In addition, rugosa roses had been planted on the slope above the Spring House late in the 1990s. In the historic garden this area above the Spring House was completely planted with native mock orange (Philadelphus lewisii) as seen in the 1967 photograph (Fig. 16) of Deepwood taken from the driveway entrance [Appendix D1(a-'Campaign to Save Deepwood' - Nobel Bashor photo)].

Nobel Bashor, then Salem Parks Gardener, wrote, “The formal approach to Deepwood off Mission St. combines enchantment from a framed glimpse, an intriguing partial view, with the necessity for genteel ostentation so dear to the Victorian heart.” [Appendix D5 (a)] With the removal of the mock orange, this ‘partial view’ from the street has been lost.

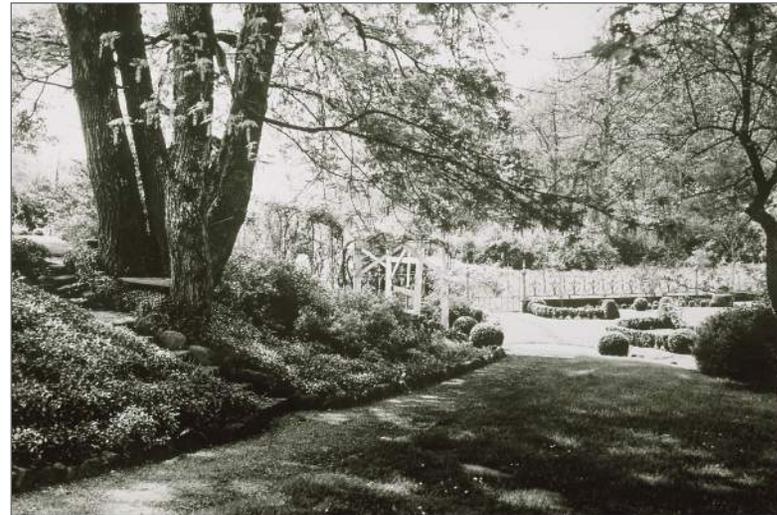
Figure 17: Fern Bank, circa 1938

This area has continued to be full of invasive plant material, mainly waterleaf (*Hydrophyllum* sp.) which dies down in summer and too many sword ferns. An historic photograph of this area (Fig. 17) shows a solid carpet of *Vinca minor*, its dark green leaves reflecting the light.

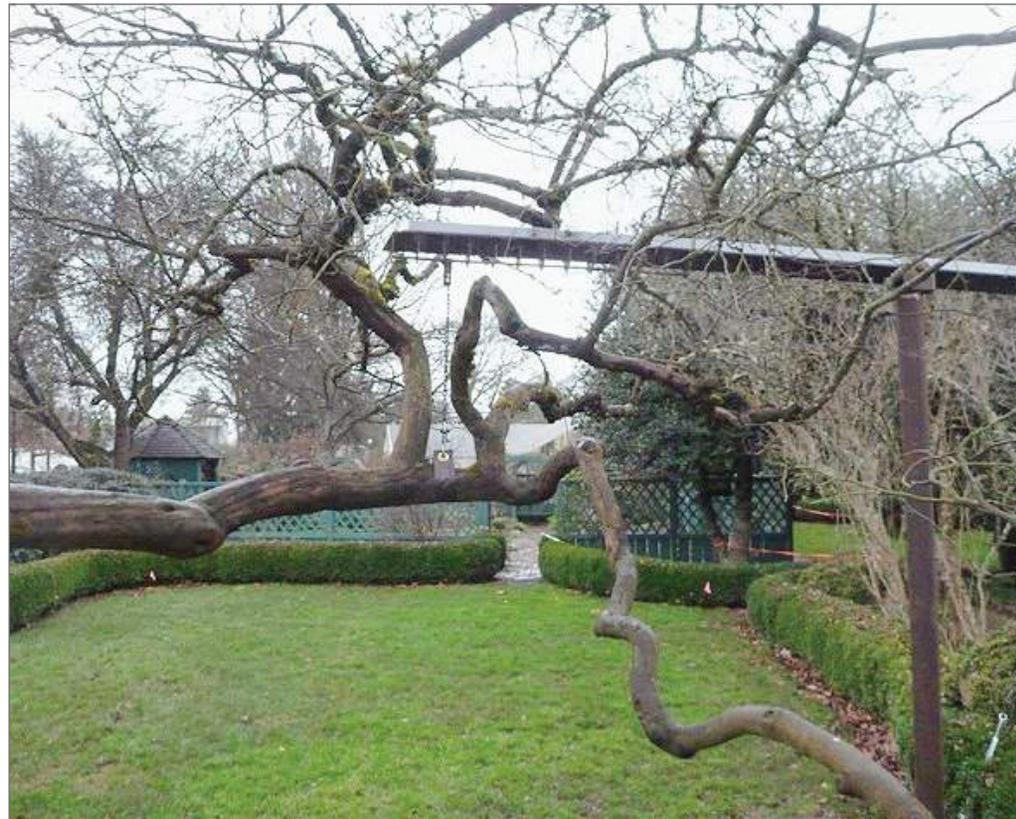
Figure 18: Quince tree showing initial support of main trunk, Spring Garden, 2011

Dimensions for the cantilevered support were determined for the third stem and submitted to Bob Oaks, the welder. In August, 2011, the two 4X4 supports were installed. After several months of

experimentation by Bob, the cantilevered support for the third stem was installed in December. Woody then applied a hardware sling connecting the third stem to the support arm. (Fig. 18) Two additional slings will stabilize two other branches. The cantilevered support is designed to be available for future permanent and potentially temporary attachments, depending on future growth and the need for protection from branch failures due to loads of fruit, ice, or snow.
