NOTICE OF DECISION

CLASS 1 MINOR HISTORIC DESIGN REVIEW CASE NO.: HIS23-29

SUMMARY: A proposal to replace glazing on three windows at the Methodist Church (1871).

Window Assessment – Exterior

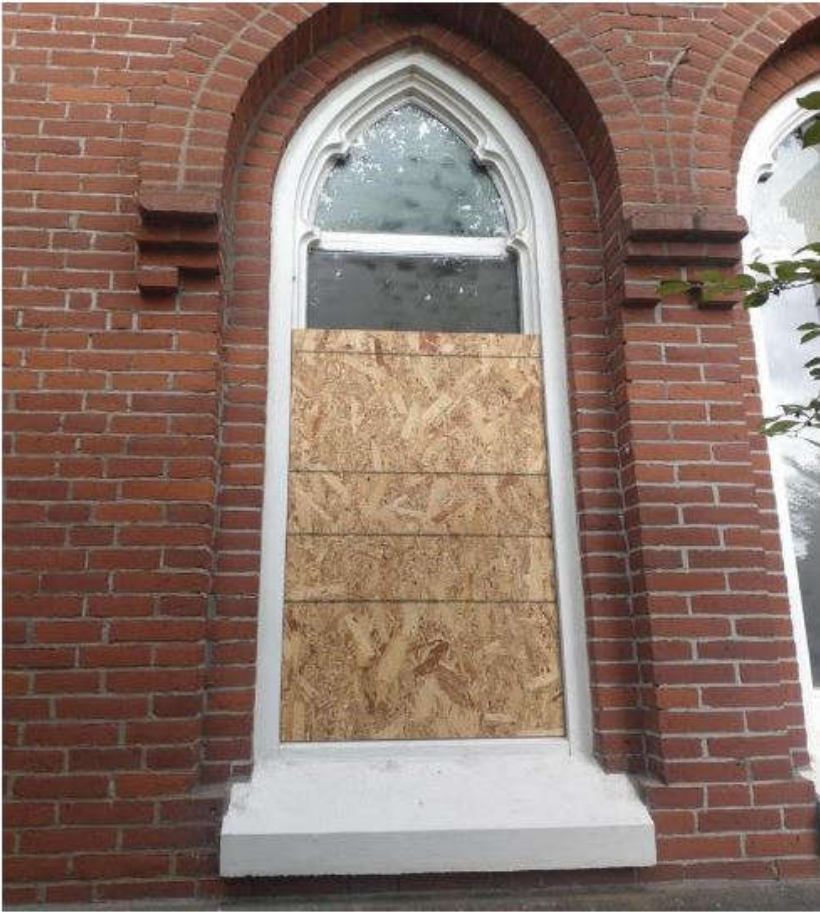
Location:
1st floor- east elevation

Window Description:
wooden pointed arch sash window.

Glazing Putty: must remove to replace glazing

% to replace 100

- Old
- New
- Broken broken through vandalism

Window otherwise sound, but glazing is broken.

Overall Condition: Good

Findings: The applicant is proposing to replace the existing broken glass within the arched window on the east elevation of the church. The original glass was most likely either the “Rimpled Cathedral” or the “Morroco” design made by the Pikington Brothers in Portland, from their patterned glass and cathedral glass collection. While this company no longer exists or creates this type of patterned glass, the applicant has selected a company that manufactures architectural glass with a pattern that replicates the original to the greatest degree feasible. This is the same replacement that was selected in previous case HIS22-18. The applicant also proposes to replace glass in two double-hung rectangular sash windows on the south elevation. Both the original and proposed replacement are un-tinted clear, flat glass. Overall, the repair of these windows will ensure that any replacement materials will duplicate to the greatest degree feasible the appearance and structural qualities of the material being replaced, therefore staff finds that SRC 230.060(b)(1) has been met for the proposal.

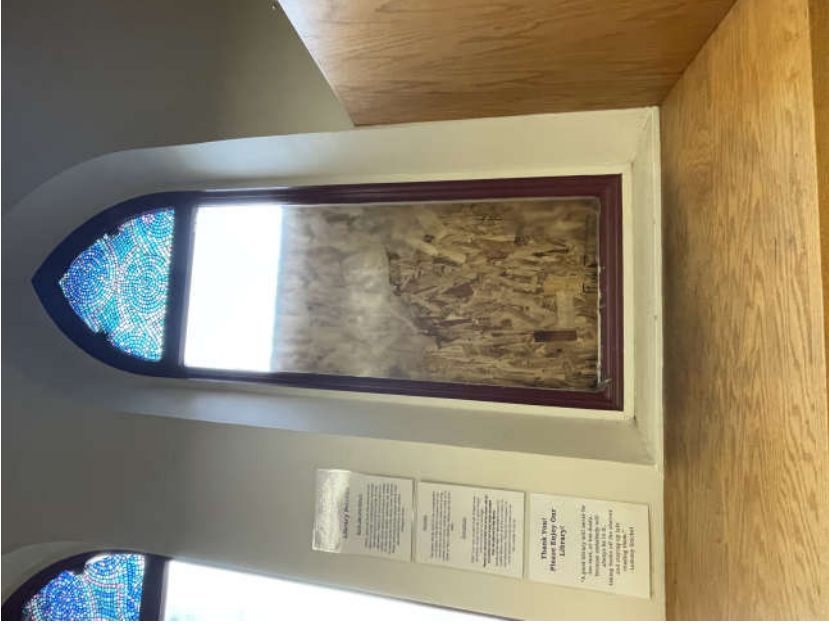
Location: 1st floor- east elevation
	Window Description: wooden pointed arch sash window.
	Stool: _____ <input type="checkbox"/> Remove paint <input type="checkbox"/> Repair <input type="checkbox"/> Replace
	Frame/Pulley/Stiles: _____ <input type="checkbox"/> Remove paint <input type="checkbox"/> Repair <input type="checkbox"/> Replace
	Sash/Muntins/Leading: _____ <input type="checkbox"/> Remove paint <input type="checkbox"/> Repair <input type="checkbox"/> Replace
	Trim: _____ <input type="checkbox"/> Remove paint <input type="checkbox"/> Repair <input type="checkbox"/> Replace
Dimensions of window:	Hardware Description: _____ <input type="checkbox"/> Remove paint <input type="checkbox"/> Missing
	Ropes/Chains: _____ <input type="checkbox"/> Replace
Remarks:	Weatherstripping: _____ <input type="checkbox"/> Replace

Overall Condition: Good

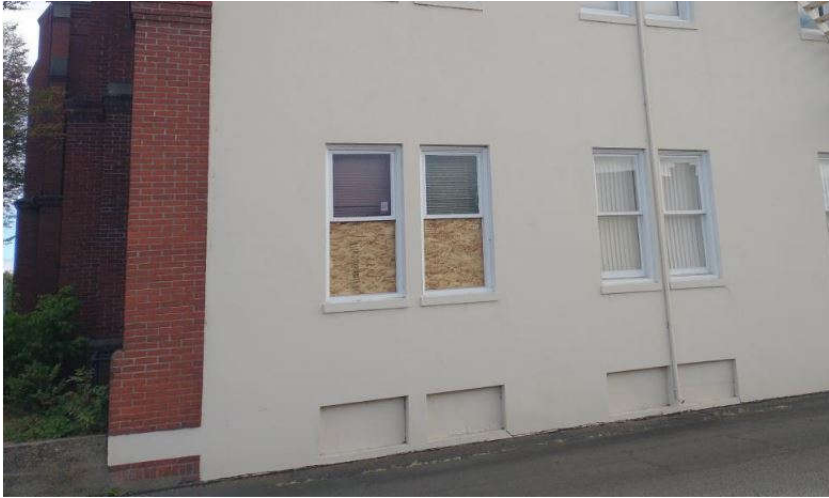
Location: 1st floor South elevation
	Window Description: rectangular wooden sash window
	Sill: _____ <input type="checkbox"/> Remove paint <input type="checkbox"/> Repair <input type="checkbox"/> Replace
	Frame/Trim: _____ <input type="checkbox"/> Remove paint <input type="checkbox"/> Repair <input type="checkbox"/> Replace
	Sash/Muntins/Leading: _____ <input type="checkbox"/> Remove paint <input type="checkbox"/> Repair <input type="checkbox"/> Replace
Glazing Putty: <u>must remove to replace glazing</u> % to repair _____ % to replace <u>100</u>	
Dimensions of window:	Glazing: _____ <input type="checkbox"/> Old <input type="checkbox"/> New <input checked="" type="checkbox"/> Broken broken through vandalism
Remarks: Window otherwise sound, but glazing is broken.	Hardware Description: _____ <input type="checkbox"/> Remove paint <input type="checkbox"/> Missing

Overall Condition: Good

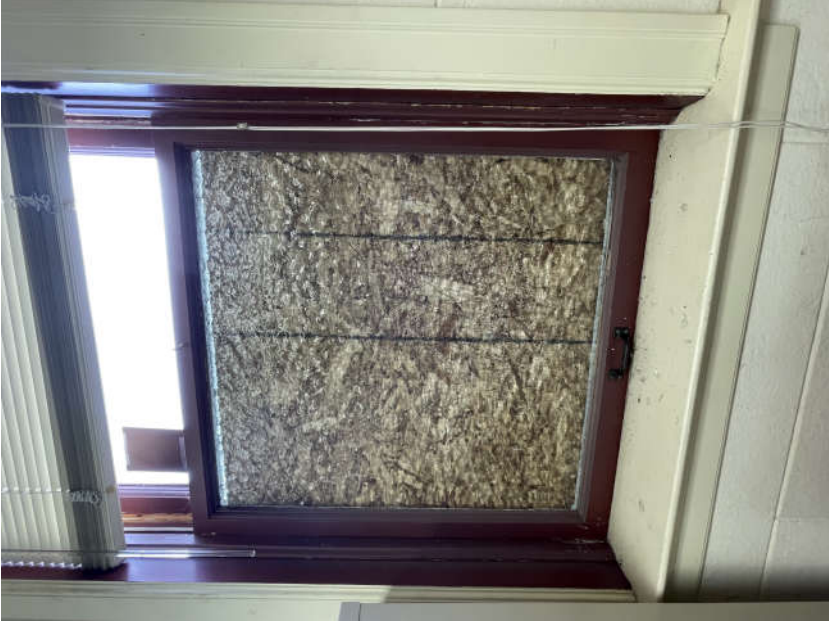
Location: 1st floor South elevation
	Window Description:
	Stool: _____ <input type="checkbox"/> Remove paint <input type="checkbox"/> Repair <input type="checkbox"/> Replace
	Frame/Pulley/Stiles: _____ <input type="checkbox"/> Remove paint <input type="checkbox"/> Repair <input type="checkbox"/> Replace
	Sash/Muntins/Leading: _____ <input type="checkbox"/> Remove paint <input type="checkbox"/> Repair <input type="checkbox"/> Replace
	Trim: _____ <input type="checkbox"/> Remove paint <input type="checkbox"/> Repair <input type="checkbox"/> Replace
Dimensions of window:	Hardware Description: _____ <input type="checkbox"/> Remove paint <input type="checkbox"/> Missing
	Ropes/Chains: _____ <input type="checkbox"/> Replace
	Weatherstripping: _____ <input type="checkbox"/> Replace
Remarks: Window otherwise sound, but glazing is broken.

Overall Condition: Good

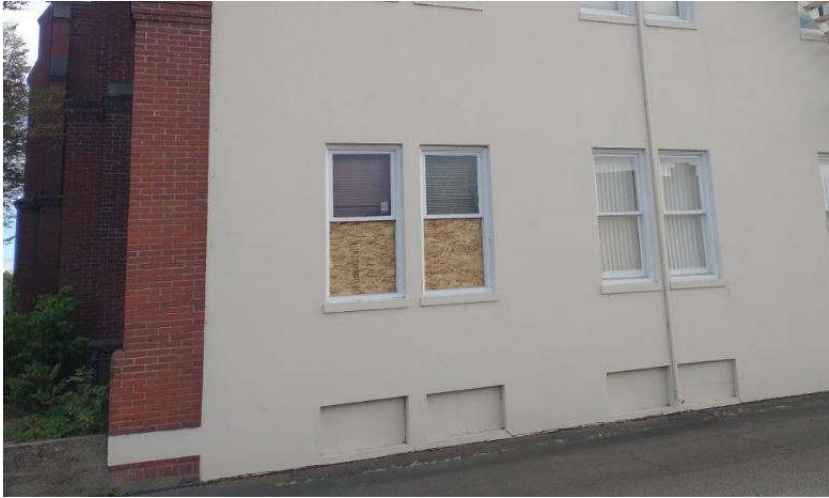
Location: 1st floor South elevation
	Window Description: rectangular wooden sash window
	Sill: _____ <input type="checkbox"/> Remove paint <input type="checkbox"/> Repair <input type="checkbox"/> Replace
	Frame/Trim: _____ <input type="checkbox"/> Remove paint <input type="checkbox"/> Repair <input type="checkbox"/> Replace
	Sash/Muntins/Leading: _____ <input type="checkbox"/> Remove paint <input type="checkbox"/> Repair <input type="checkbox"/> Replace
Glazing Putty: <u>must remove to replace glazing</u> % to repair _____ % to replace <u>100</u>	
Dimensions of window:	Glazing: _____ <input type="checkbox"/> Old <input type="checkbox"/> New <input checked="" type="checkbox"/> Broken broken through vandalism
Remarks: Window otherwise sound, but glazing is broken.	Hardware Description: _____ <input type="checkbox"/> Remove paint <input type="checkbox"/> Missing

Overall Condition: Good

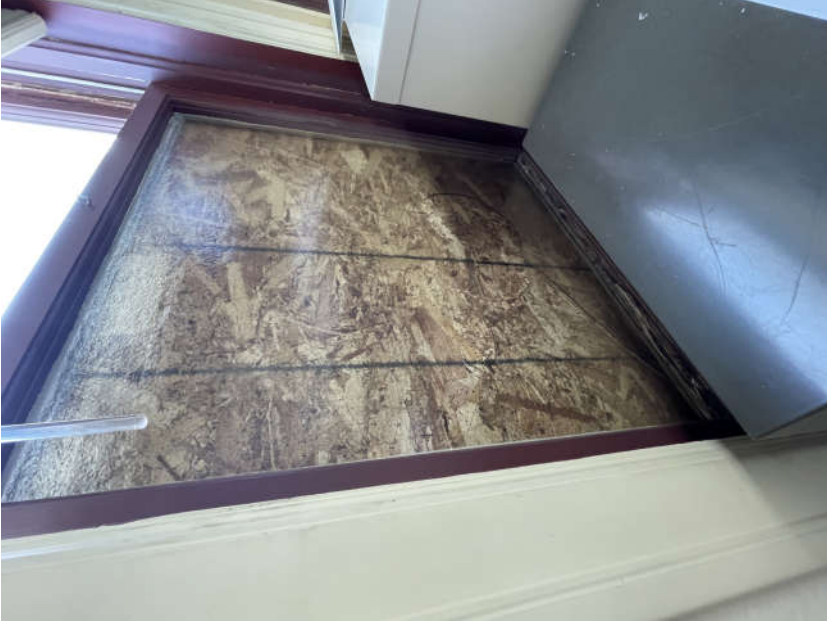
Location: 1st floor South elevation
	Window Description:
	Stool: _____ <input type="checkbox"/> Remove paint <input type="checkbox"/> Repair <input type="checkbox"/> Replace
	Frame/Pulley/Stiles: _____ <input type="checkbox"/> Remove paint <input type="checkbox"/> Repair <input type="checkbox"/> Replace
	Sash/Muntins/Leading: _____ <input type="checkbox"/> Remove paint <input type="checkbox"/> Repair <input type="checkbox"/> Replace
	Trim: _____ <input type="checkbox"/> Remove paint <input type="checkbox"/> Repair <input type="checkbox"/> Replace
Dimensions of window:	Hardware Description: _____ <input type="checkbox"/> Remove paint <input type="checkbox"/> Missing
	Ropes/Chains: _____ <input type="checkbox"/> Replace
	Weatherstripping: _____ <input type="checkbox"/> Replace
Remarks: Window otherwise sound, but glazing is broken.	_____

Overall Condition: Good
