DECISION OF THE HISTORIC LANDMARKS COMMISSION

HISTORIC DESIGN REVIEW CASE NO.: HIS19-05

SUMMARY: A proposal to reopen windows on the south façade of the Bligh Building (aka Pacific Building, 1926).

PACIFIC BUILDING
T.I. for: MWVCOG
100 HIGH STREET SE SALEM OR 97301

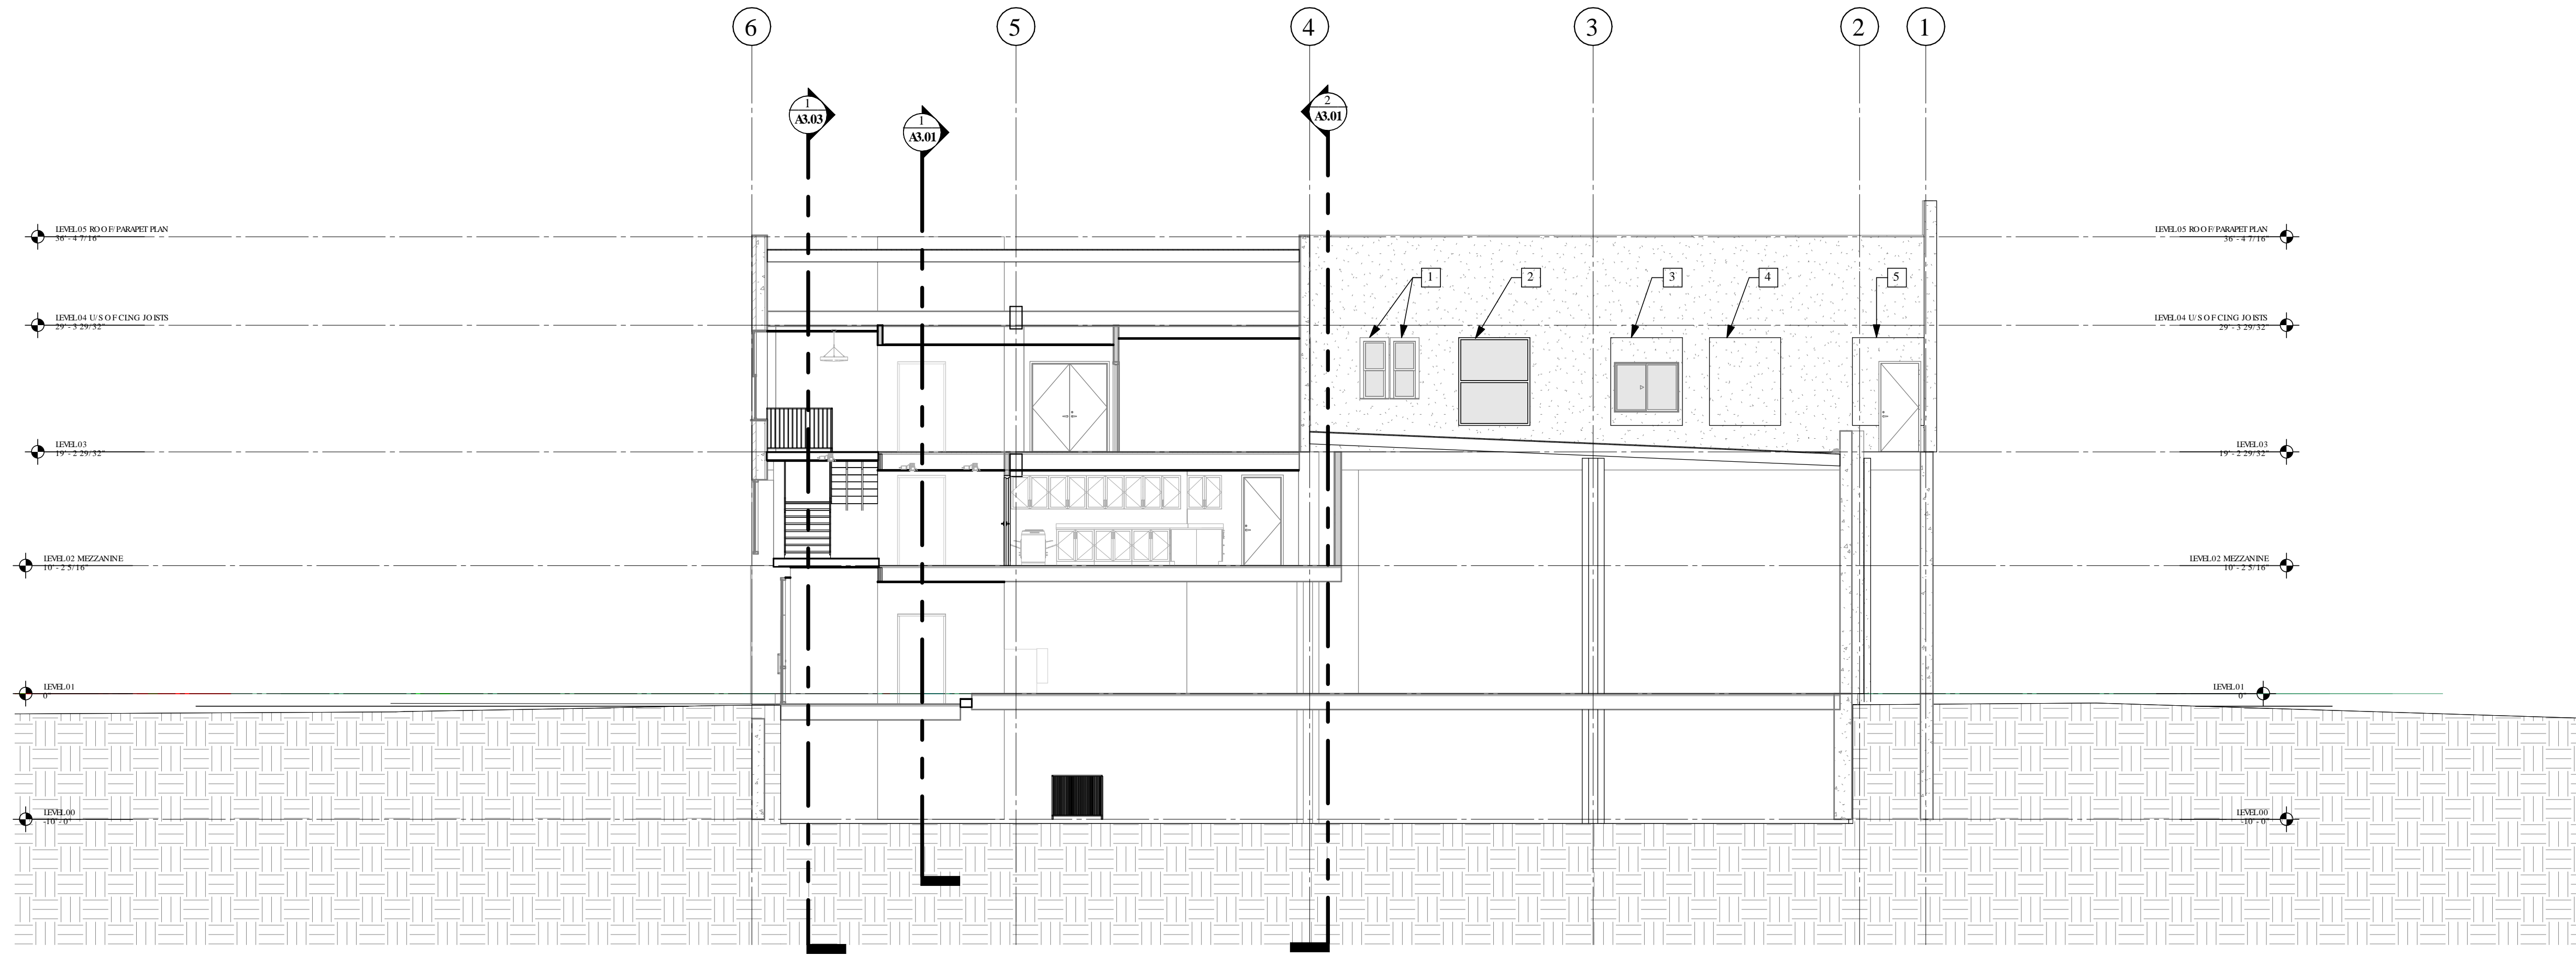
1 SECTION 3, HLC SUBMISSION
0" 2" 4" 8" 16" 24" 1/8" = 1'-0"

- 1 EXISTING WOOD DOUBLE OR SINGLE HUNG WINDOW. NOTE THESE WINDOWS ARE GENERALLY NO LONGER OPERABLE, BECAUSE THEY ARE BOTH PAINTED SHUT, AND/OR SWOLLEN BY MOISTURE PENETRATION INTO THE WOOD. GIVEN THEIR CURRENT STATE, THESE WINDOWS HAVE PRETTY MUCH REACHED 'END-OF-LIFE' STATUS. PREVIOUS REPAIRS ARE VERY NOTICEABLE AND FURTHER DETERIORATION HAS OCCURRED.

- 2 EXISTING WINDOW OPENING THAT HAS BEEN INFILLED WITH FRAMING AND STUCCO. WINDOW TO BE RE-OPENED AND RECEIVE NEW WINDOW WITH CONFIGURATION TO LOOK SIMILAR TO ORIGINAL AND EXISTING WINDOWS. MATERIAL TO BE EITHER PAINTABLE FIBERGLASS OR ALUMINUM.

- 3 EXISTING WINDOW OPENING THAT HAS BEEN INFILLED WITH FRAMING AND STUCCO, AND SUBSEQUENTLY PARTIALLY RE-OPENED. REMOVE EXISTING WINDOW AND WALL CLOSURE, AND PREPARE FOR NEW WINDOW WITH CONFIGURATION TO LOOK SIMILAR TO ORIGINAL WINDOWS, SAME AS NOTE 2 ABOVE. MATERIAL TO BE EITHER PAINTABLE FIBER GLASS OR ANODIZED ALUMINUM.

- 4 EXISTING WINDOW OPENING THAT HAS BEEN INFILLED WITH FRAMING AND STUCCO. NO ACTION AT THIS TIME.
- 5 EXISTING WINDOW OPENING THAT HAS PREVIOUSLY BEEN INFILLED WITH FRAMING AND STUCCO. SUBSEQUENTLY PARTIALLY RE-OPENED TO PROVIDE AN EXIT DOOR. (NO CHANGE).

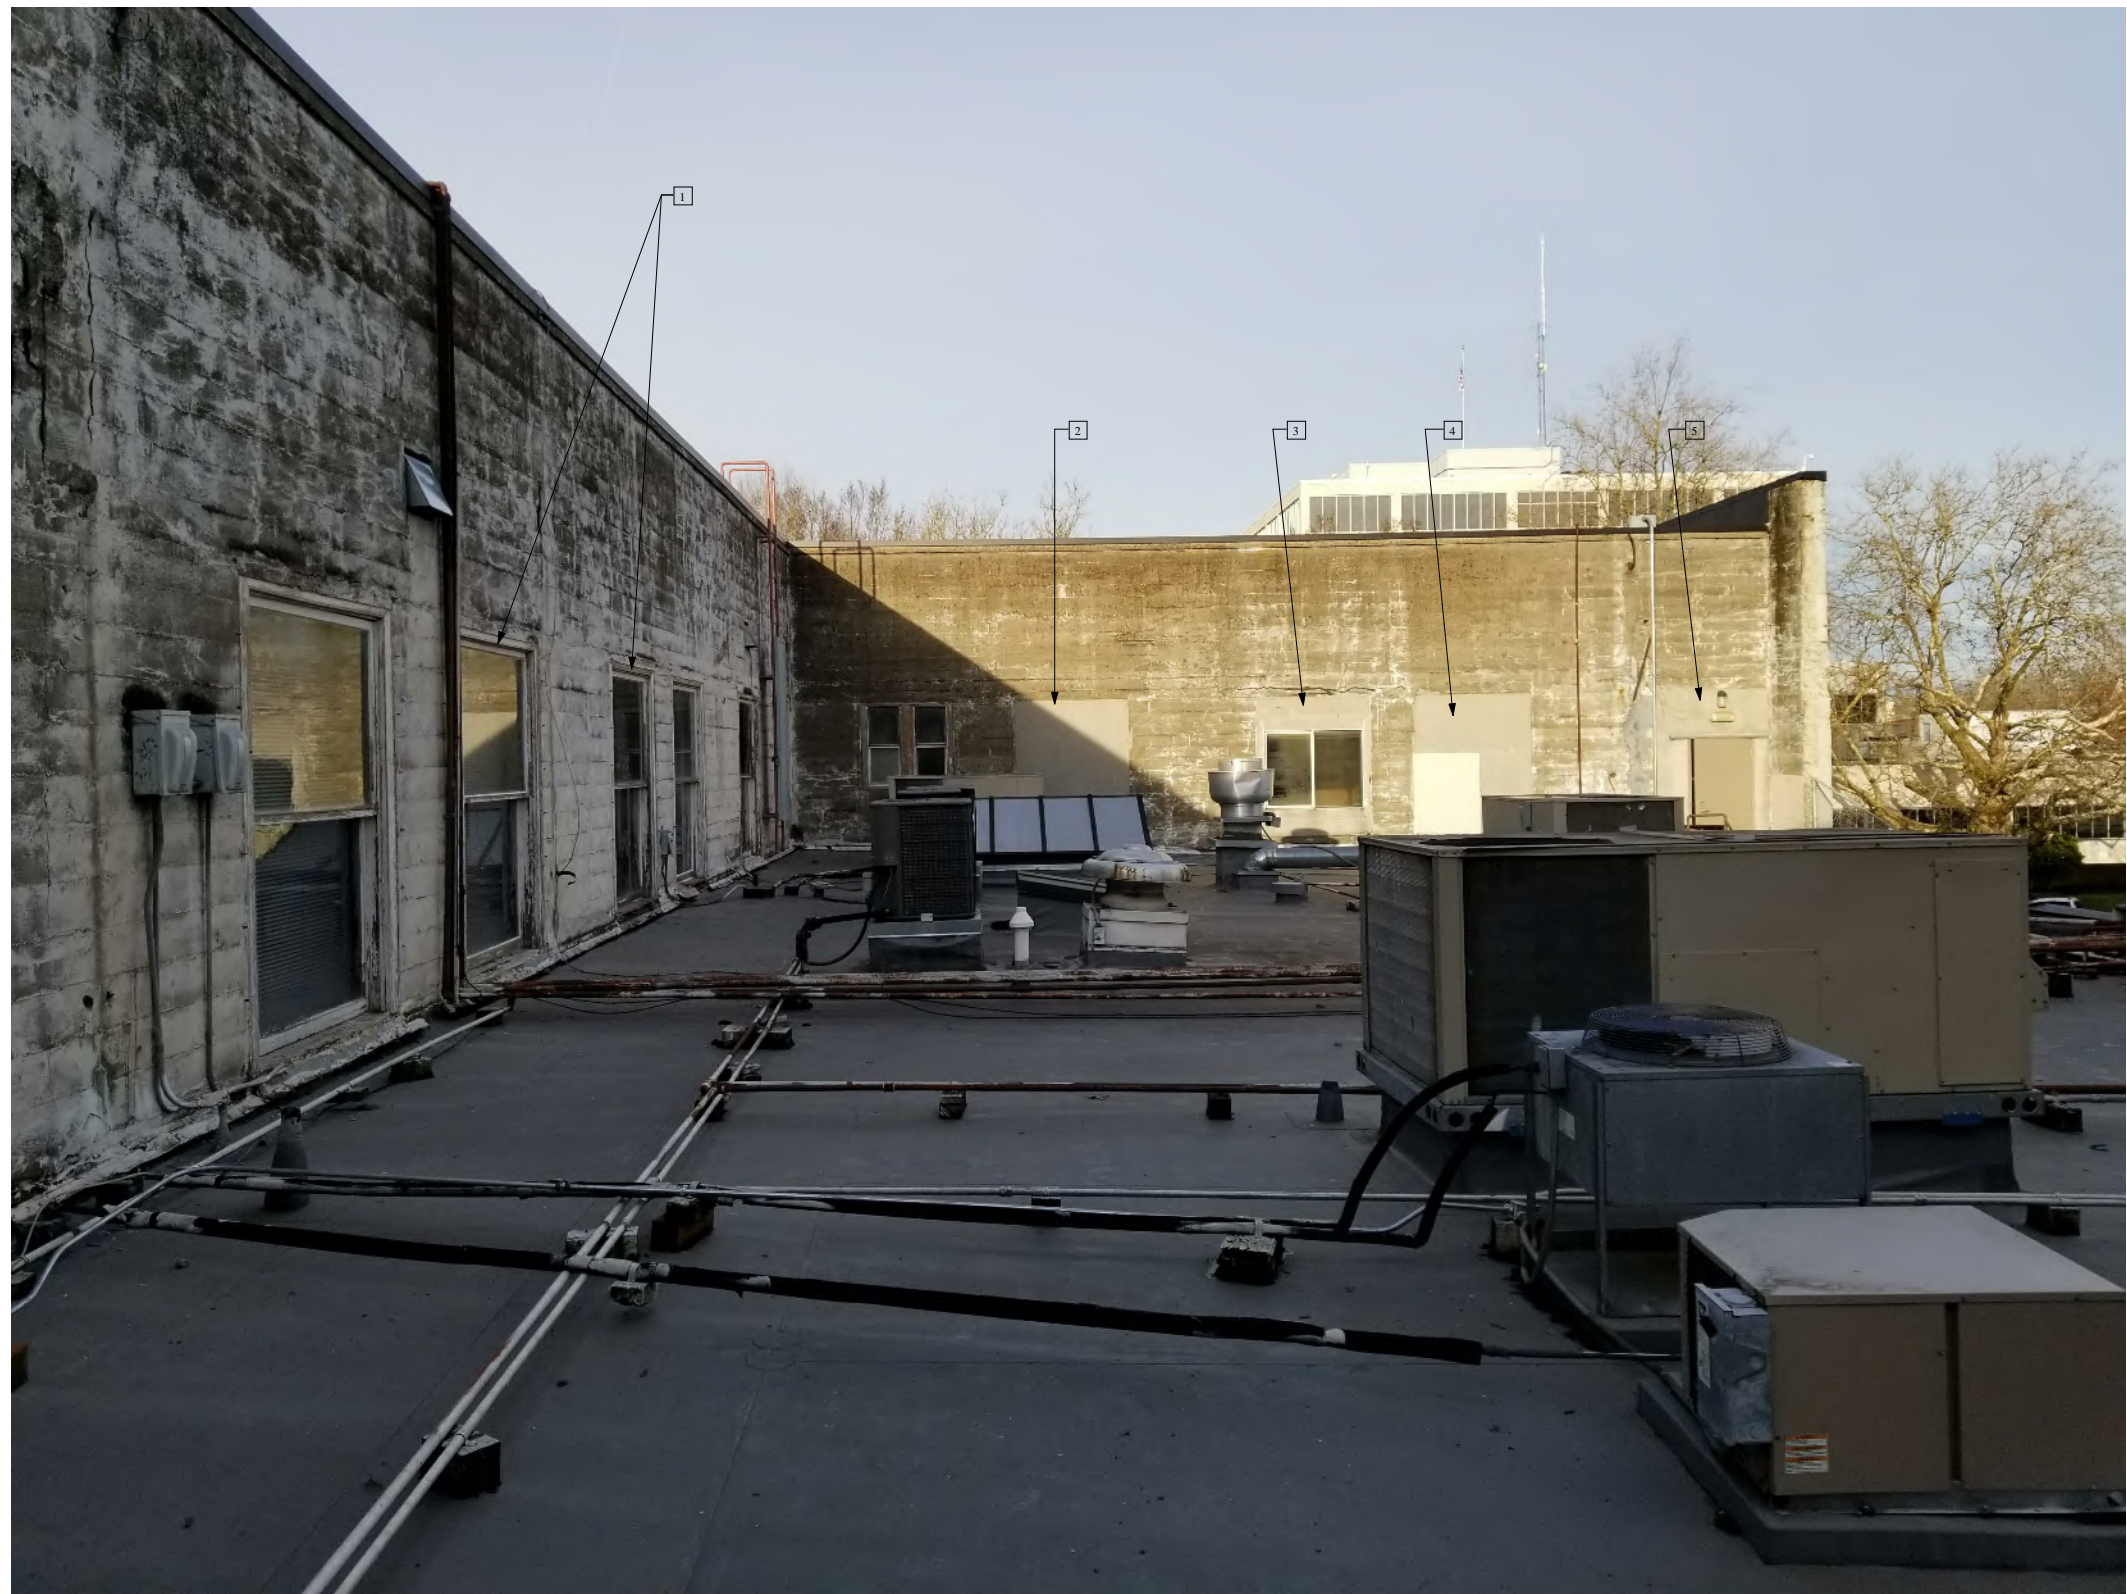
- 1 EXISTING WOOD DOUBLE OR SINGLE HUNG WINDOW. NOTE THESE WINDOWS ARE GENERALLY NO LONGER OPERABLE, BECAUSE THEY ARE BOTH PAINTED SHUT, AND/OR SWOLLEN BY MOISTURE PENETRATION INTO THE WOOD. GIVEN THEIR CURRENT STATE, THESE WINDOWS HAVE PRETTY MUCH REACHED "END-OF-LIFE" STATUS. PREVIOUS REPAIRS ARE VERY NOTICABLE AND FURTHER DETERIORATION HAS OCCURRED.

- 2 EXISTING WINDOW OPENING THAT HAS BEEN INFILLED WITH FRAMING AND STUCCO. WINDOW TO BE RE-OPENED AND RECEIVE NEW WINDOW WITH CONFIGURATION TO LOOK SIMILAR TO ORIGINAL AND EXISTING WINDOWS. MATERIAL TO BE EITHER PAINTABLE FIBERGLASS OR ALUMINUM.

- 3 EXISTING WINDOW OPENING THAT HAS BEEN INFILLED WITH FRAMING AND STUCCO, AND SUBSEQUENTLY PARTIALLY RE-OPENED. EXISTING WINDOW IS AN ALUMINUM OR VINYL HORIZONTAL SLIDER.

- 4 EXISTING WINDOW OPENING THAT HAS BEEN INFILLED WITH FRAMING AND STUCCO. TO BE RE-OPENED AT A LATER DATE.
- 5 EXISTING WINDOW OPENING THAT HAS PREVIOUSLY BEEN INFILLED WITH FRAMING AND STUCCO. SUBSEQUENTLY, PARTIALLY RE-OPENED TO PROVIDE AN EXIT DOOR. (NO CHANGE).
