NOTICE OF DECISION

HISTORIC DESIGN REVIEW CASE NO.: HIS19-10

SUMMARY: A proposal to repair the brick wall and replace the windows on the rear façade of the South Eldridge Block (1889).

LOCATION: 240-254 Commercial St NE

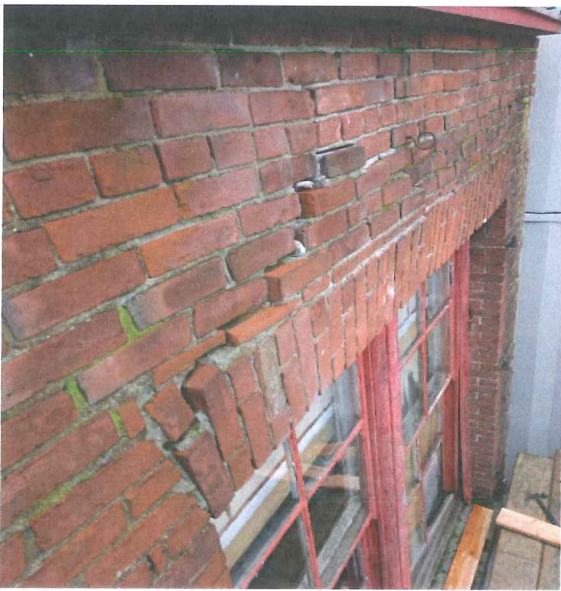
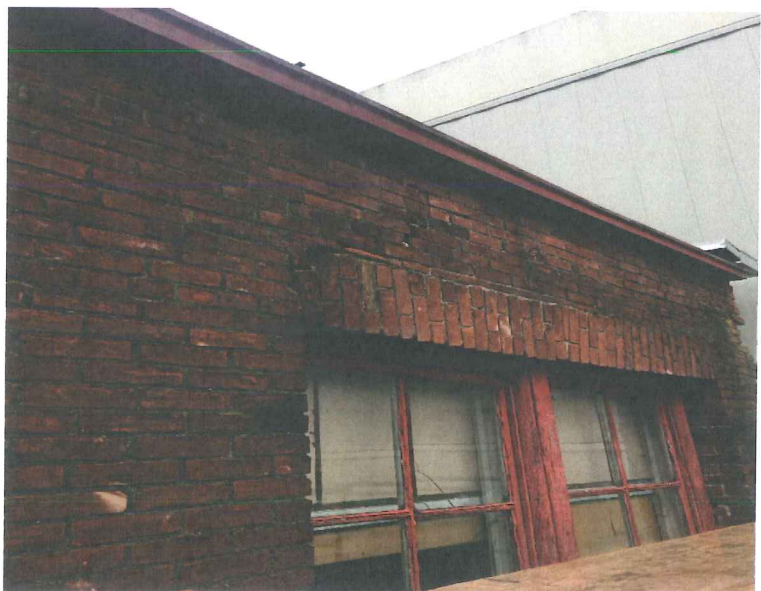
Upon closer examination of the wall mentioned above, we found severe cracking of the mortar joints and missing brick at the NE corner of the second story. Even more so, the “Flat – Bounded Arch” of the most Northern Window on the East Elevation, we found that the brick on the window crossover has dropped 2” inches and has rolled out proud of the building almost 2” inches as well.

Please see pictures below:

We took immediate action in shoring the Existing brick to avoid collapse.

The brick needs to be dismantled from the top of the wall, down to the bottom of the arch and then reconstructed in its original fashion.

After removal, I would suggest a Steel Lintel being place at the crossover for strength and longevity as the “Flat Arch” is the weakest arch constructed but it would still keep its historic integrity

Both windows on the second story east elevation are have severe dry rot and need to be replace.

The northern window will need to be removed to rebuild the Flat Arch correctly and I have little confidence it can be salvaged.

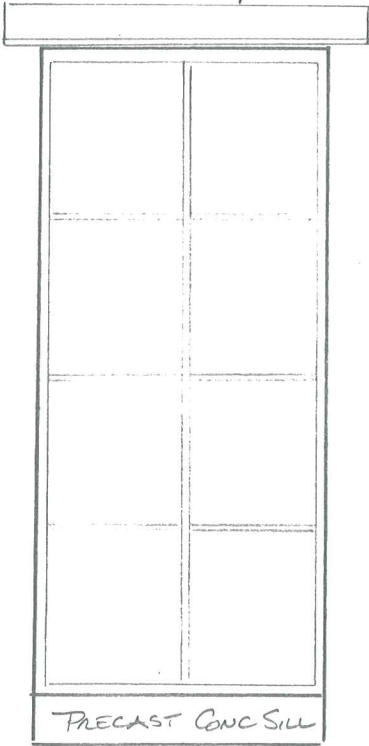
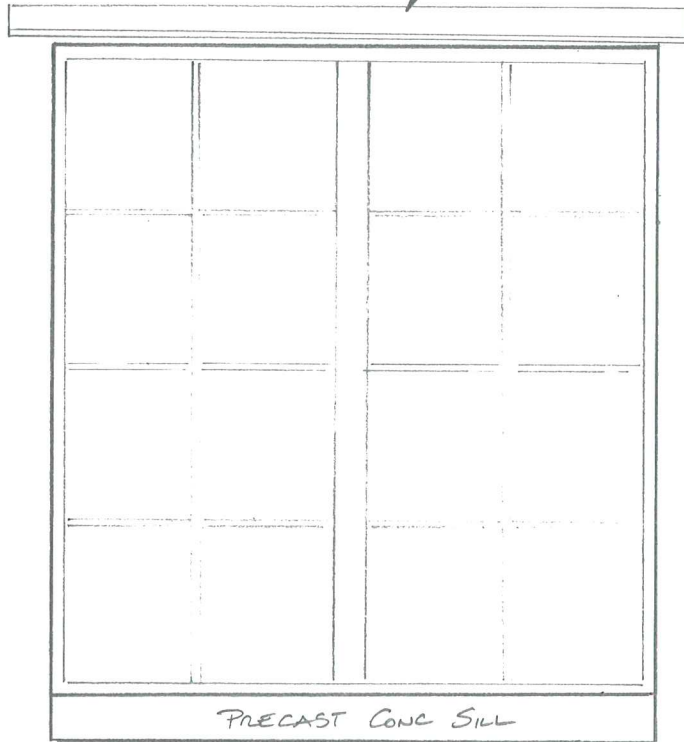
Scope: Existing turn-of-the century unreinforced brick masonry lintel facing east above windows is failing. We have been asked to size a steel lintel to add reinforcing underneath this masonry lintel to provide long term support.

EXISTING CONCRETE WALL

TOP of LOWER ROOF →

(N) L6x4x5/16
LINTEL ↘

(N) L8x4x1/2
LINTEL ↘

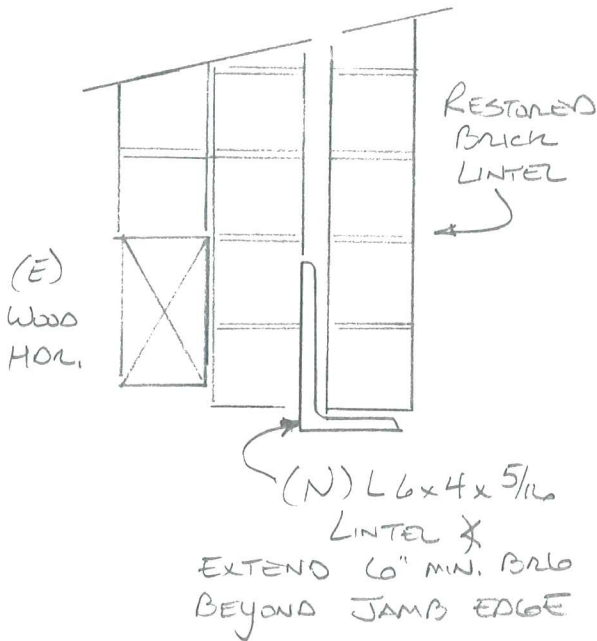
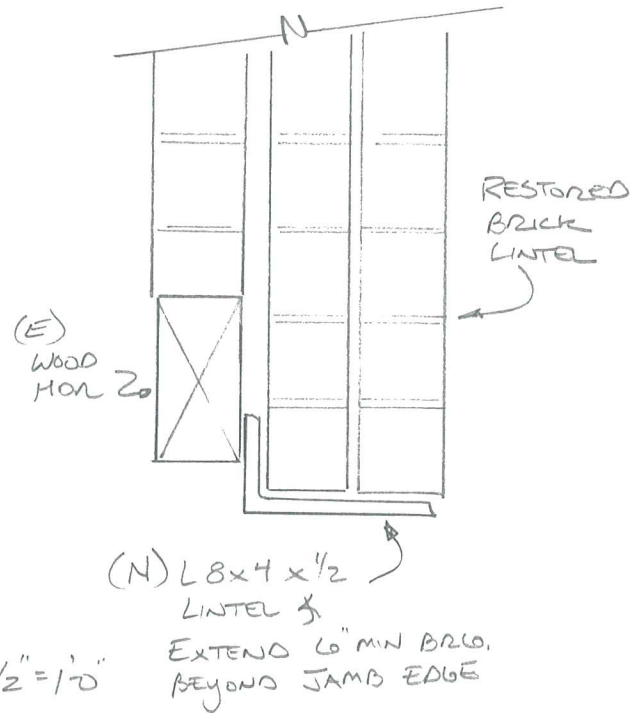
SCALE: 1/2" = 1'-0"

L6x4x5/16 S = 2.79 ✓

$\Delta = 0.0057" \Rightarrow 4/9133 \checkmark$
