# NOTICE OF DECISION

## DECISION OF THE HISTORIC LANDMARKS COMMISSION

**HISTORIC DESIGN REVIEW CASE NO.: HIS17-40MOD1**

**SUMMARY:** A proposal to modify a previous historic design review approval (HIS17-40) to renovate the facade of the Anderson Building (1900).

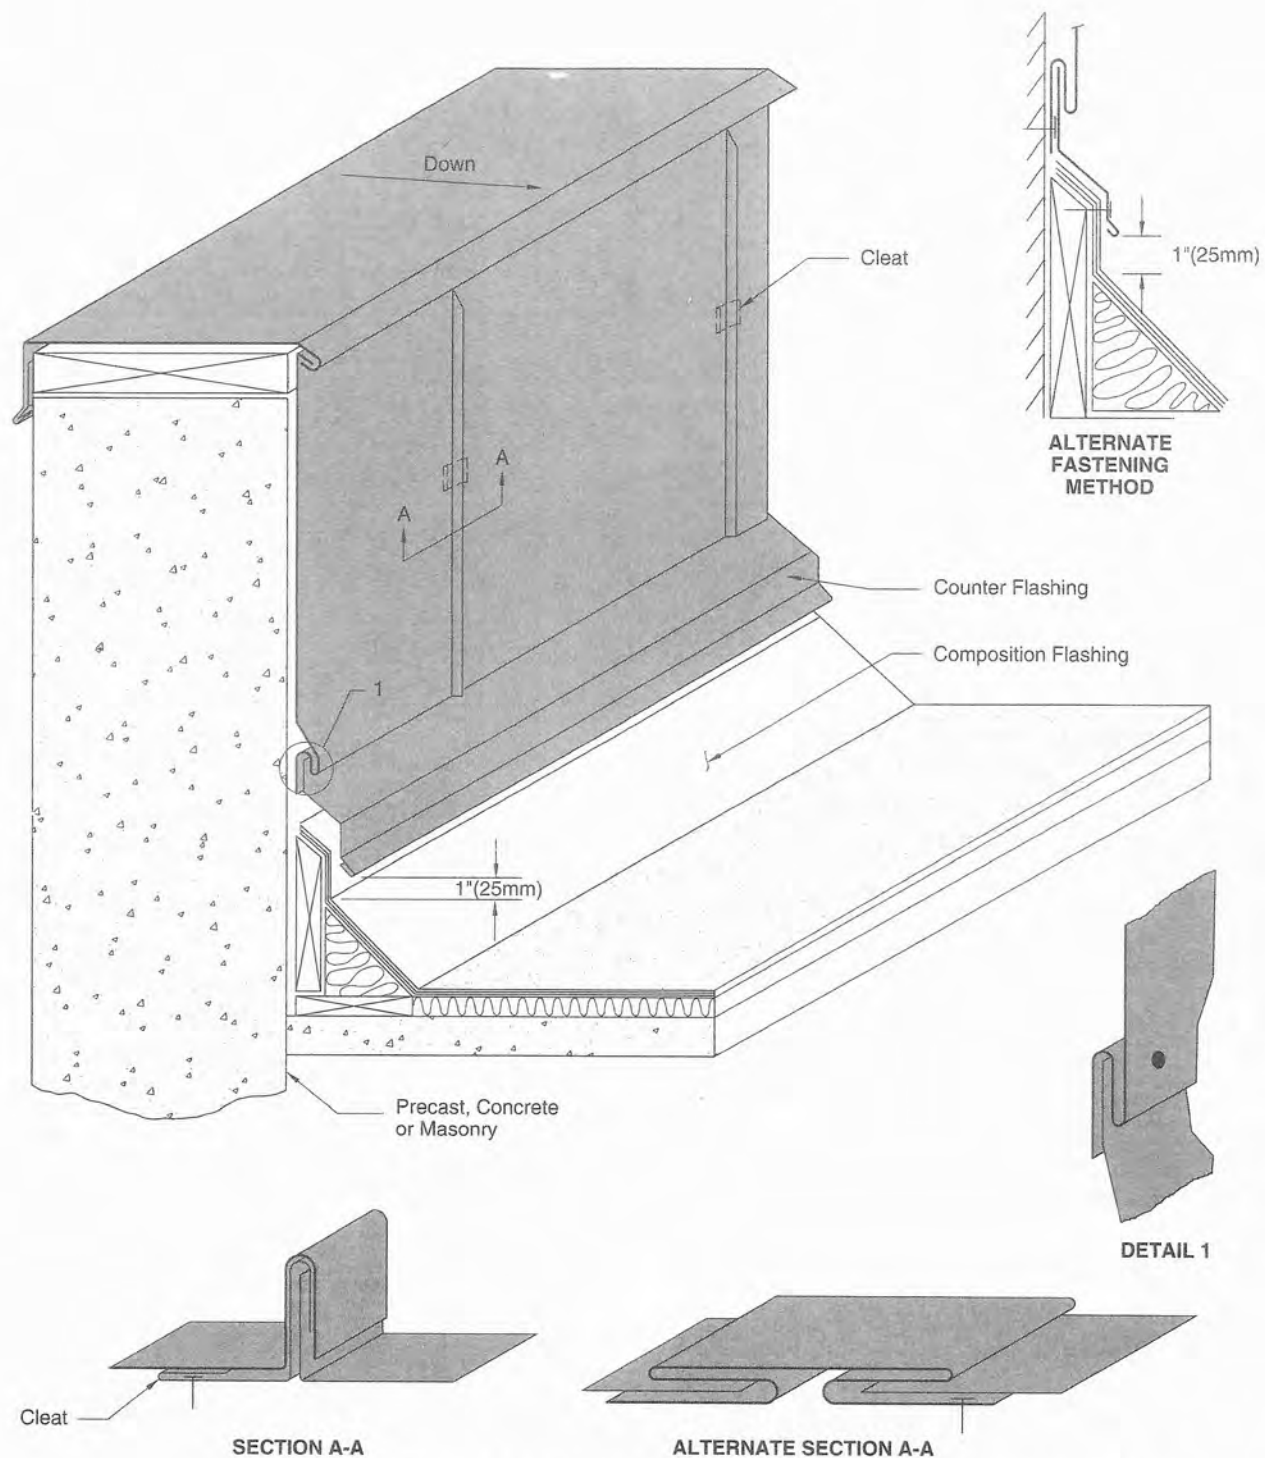
**FIGURE 3-9**

**PARAPET WALL COVERING**

I've attached an illustration from SMACNA that shows the type of protection we would like to put on the exposed parts of the west wall of the upper part of 211 Commercial, at the original wall line. The wall goes back to 1867 has had a lot of weathering. You probably noticed the loose brick in several locations.

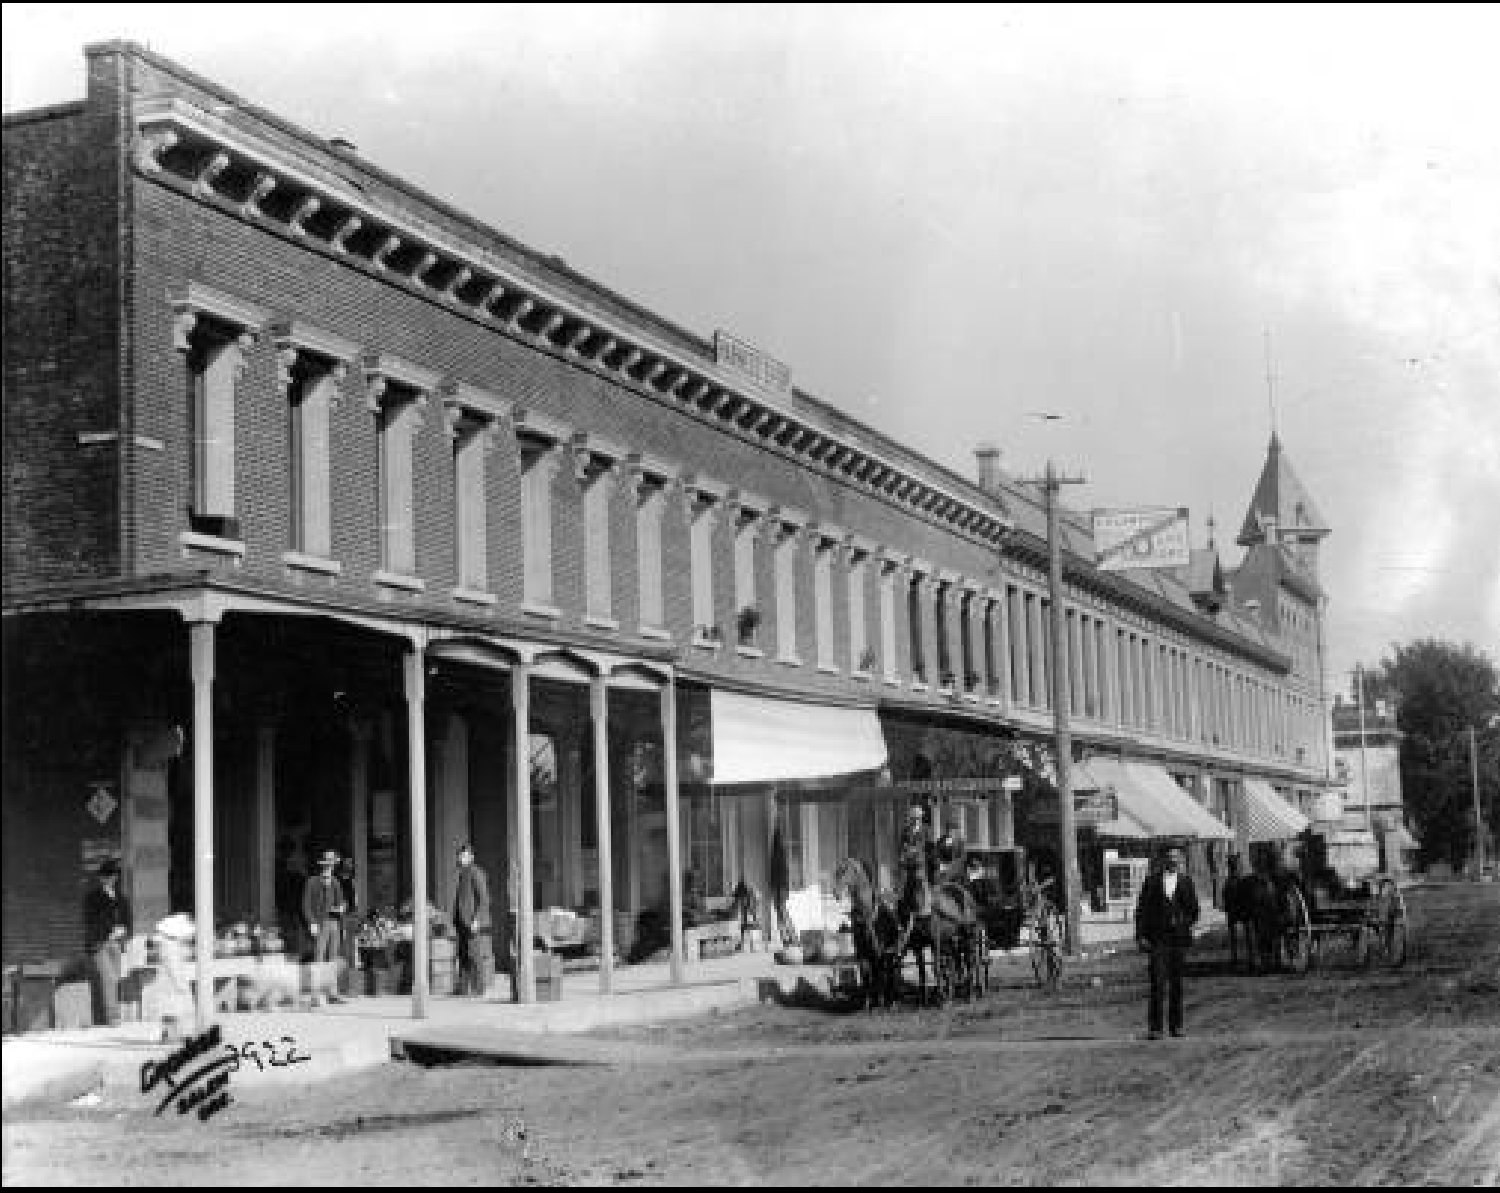
### Starkey/McCully Block in 1887

Originally built in 1867. The west side of Commercial Street between Court & Chemeketa in downtown Salem, Oregon. The buildings are all two-story and of brick, with bracketing under the roofline. Edward S. Lampert has the harness and saddlery; Edward C. Small's Oregon Clothing House is at the left of the utility pole and Charles W. Hellenbrand has a restaurant to the right of it. At the far end of the block is a three-story building with a square tower. At the next corner is a two-story building which became the site of the Star Exchange in later years. A horse-drawn carriage is pulled up in front of one of the shops and produce is displayed on the boardwalk in front of the ones on the left. Striped awnings extend over the walk, and wooden planks create a "sidewalk" to get across the street on. Several of the second floor windows appear to have plants in them.

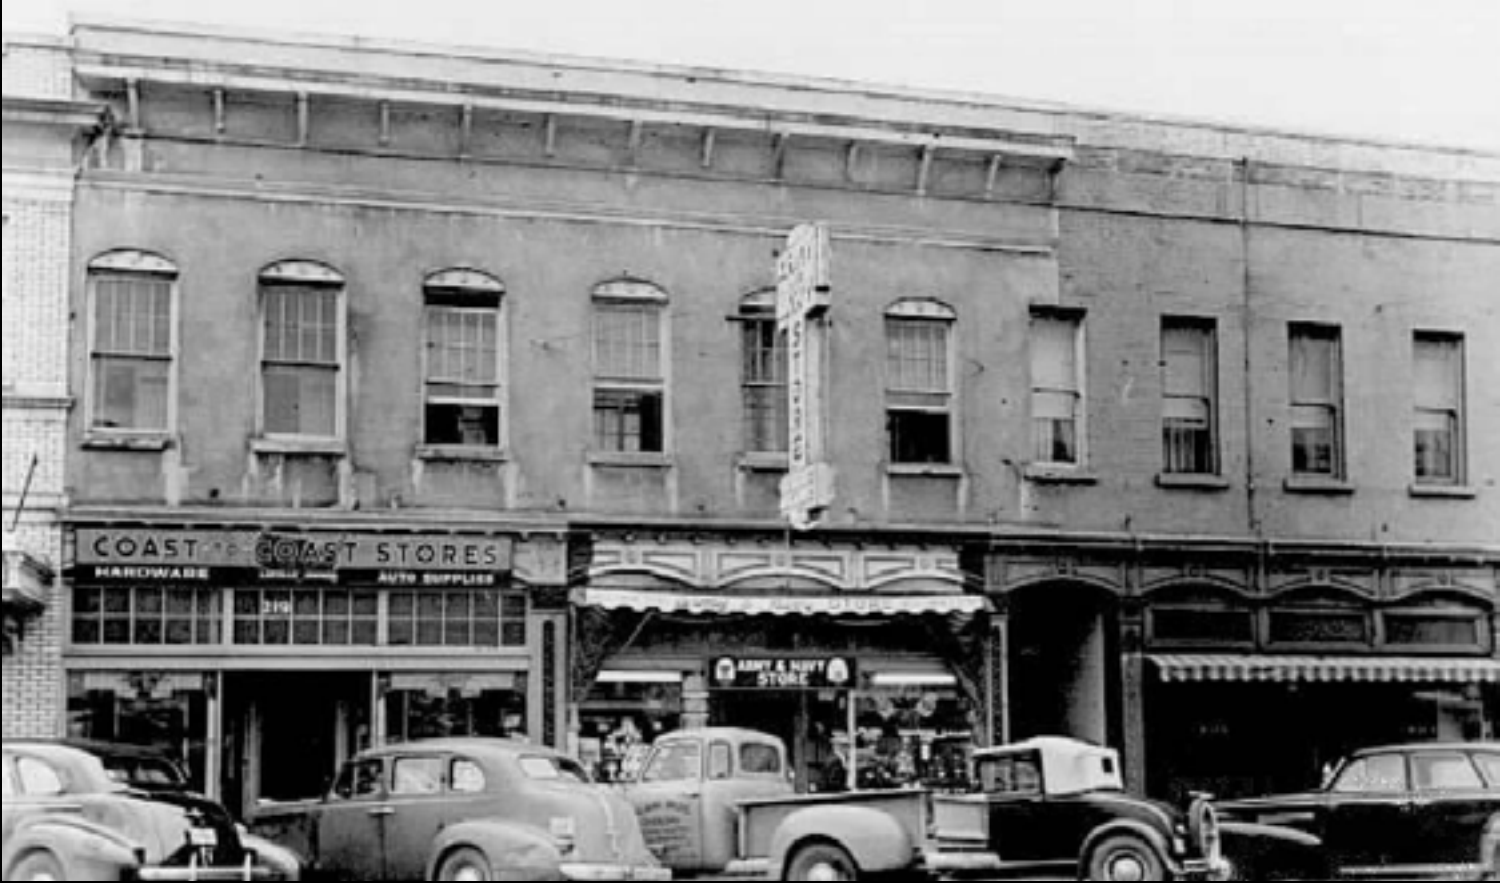
### Starkey/McCully Block in 1945

This is a photograph of part of the west side of Commercial Street N. between Court and Chemeketa streets in downtown Salem, Oregon. It was known as the Starkey-McCully Building, and was at 223-233 Commercial NE. The block was reportedly built in 1867 and is believed to be the oldest building in the area. It is of brick masonry with cast iron decoration from the Oregon Iron Works in Portland. Originally it housed several businesses on the main floor, and a hotel on the second. At the time of the photo it housed the Coast to Coast store, which was only there very briefly, and the Army & Navy clothing store. In later years the second floor windows of the left section were boarded up.

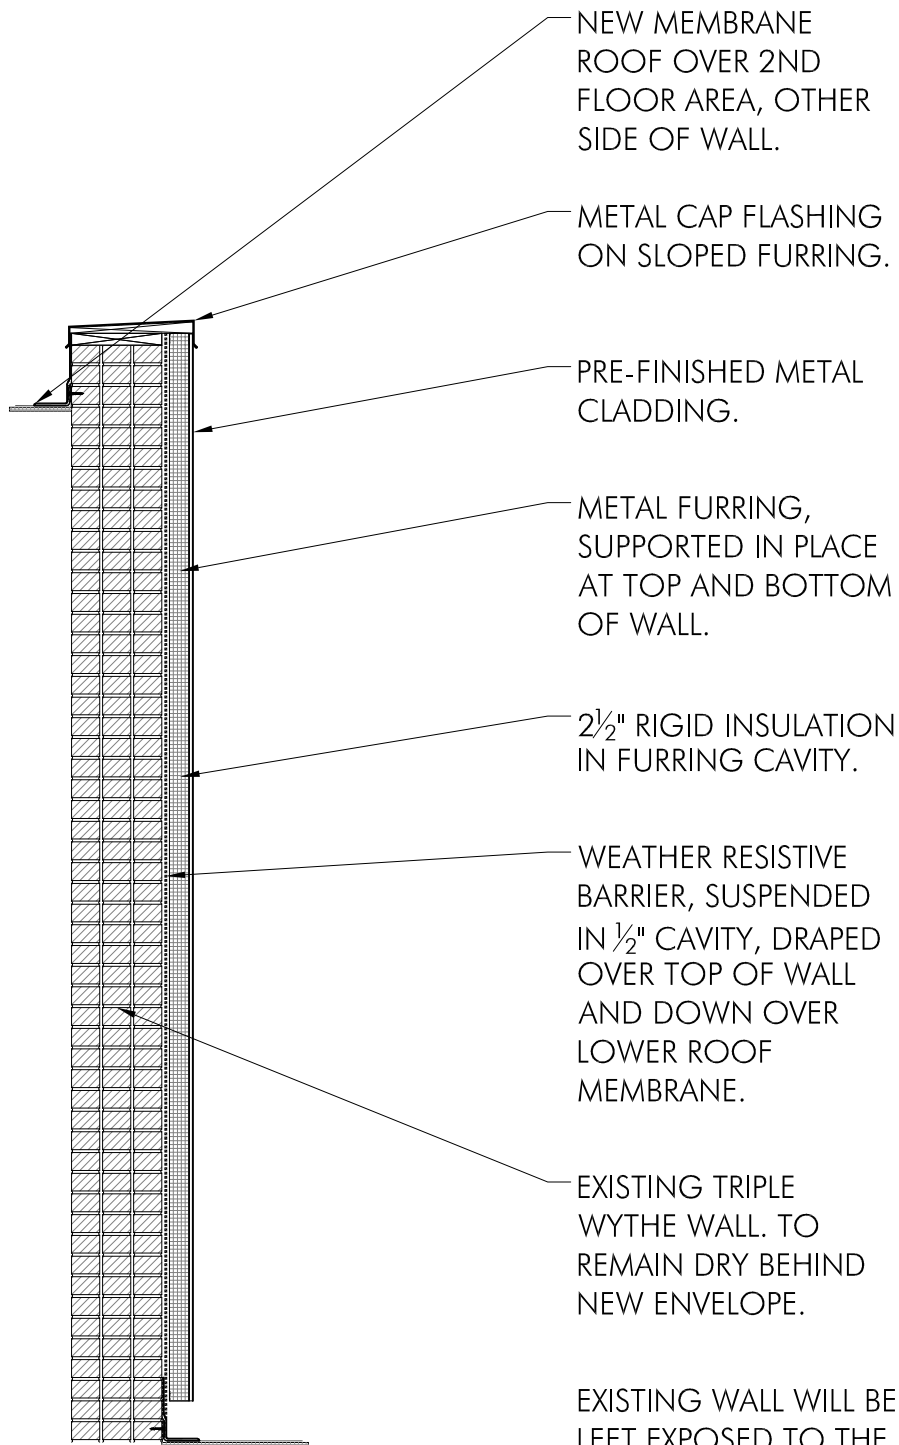
EXISTING WALL WILL BE  
LEFT EXPOSED TO THE  
INTERIOR TO ALLOW  
DIFFUSION OF  
MOISTURE CURRENTLY  
IN THE BRICK.  
MOISTURE CONTENT  
IN THE WALL WILL BE  
CONSISTENT WITH  
THE INDOOR  
ENVIRONMENT.

Rear Façade Siding: The HLC finds that the proposed new metal siding will be attached to an insulated metal frame attached to the exterior of the parged brick façade. This proposal is intended to help retain the original brick to the maximum extent possible, and prevent further water intrusion. However, any moisture currently within this masonry wall would be trapped within the brick, behind the metal siding, and potentially result in further deterioration of the 1867 brick wall, therefore the HLC finds that 230.040(f)(1)(D) has not been met for this portion of the proposal.
