NOTICE OF DECISION

HISTORIC DESIGN REVIEW CASE NO.: HIS18-18

SUMMARY: A proposal for in-kind replacement of 3 double-hung windows, replacement of the glazing within 7 windows, and in-kind replacement of 2 flagpoles on the fifth floor of the Franklin Building/Masonic Temple (1912).

**HISTORIC DESIGN REVIEW CASE NO. HIS18-18
DECISION**

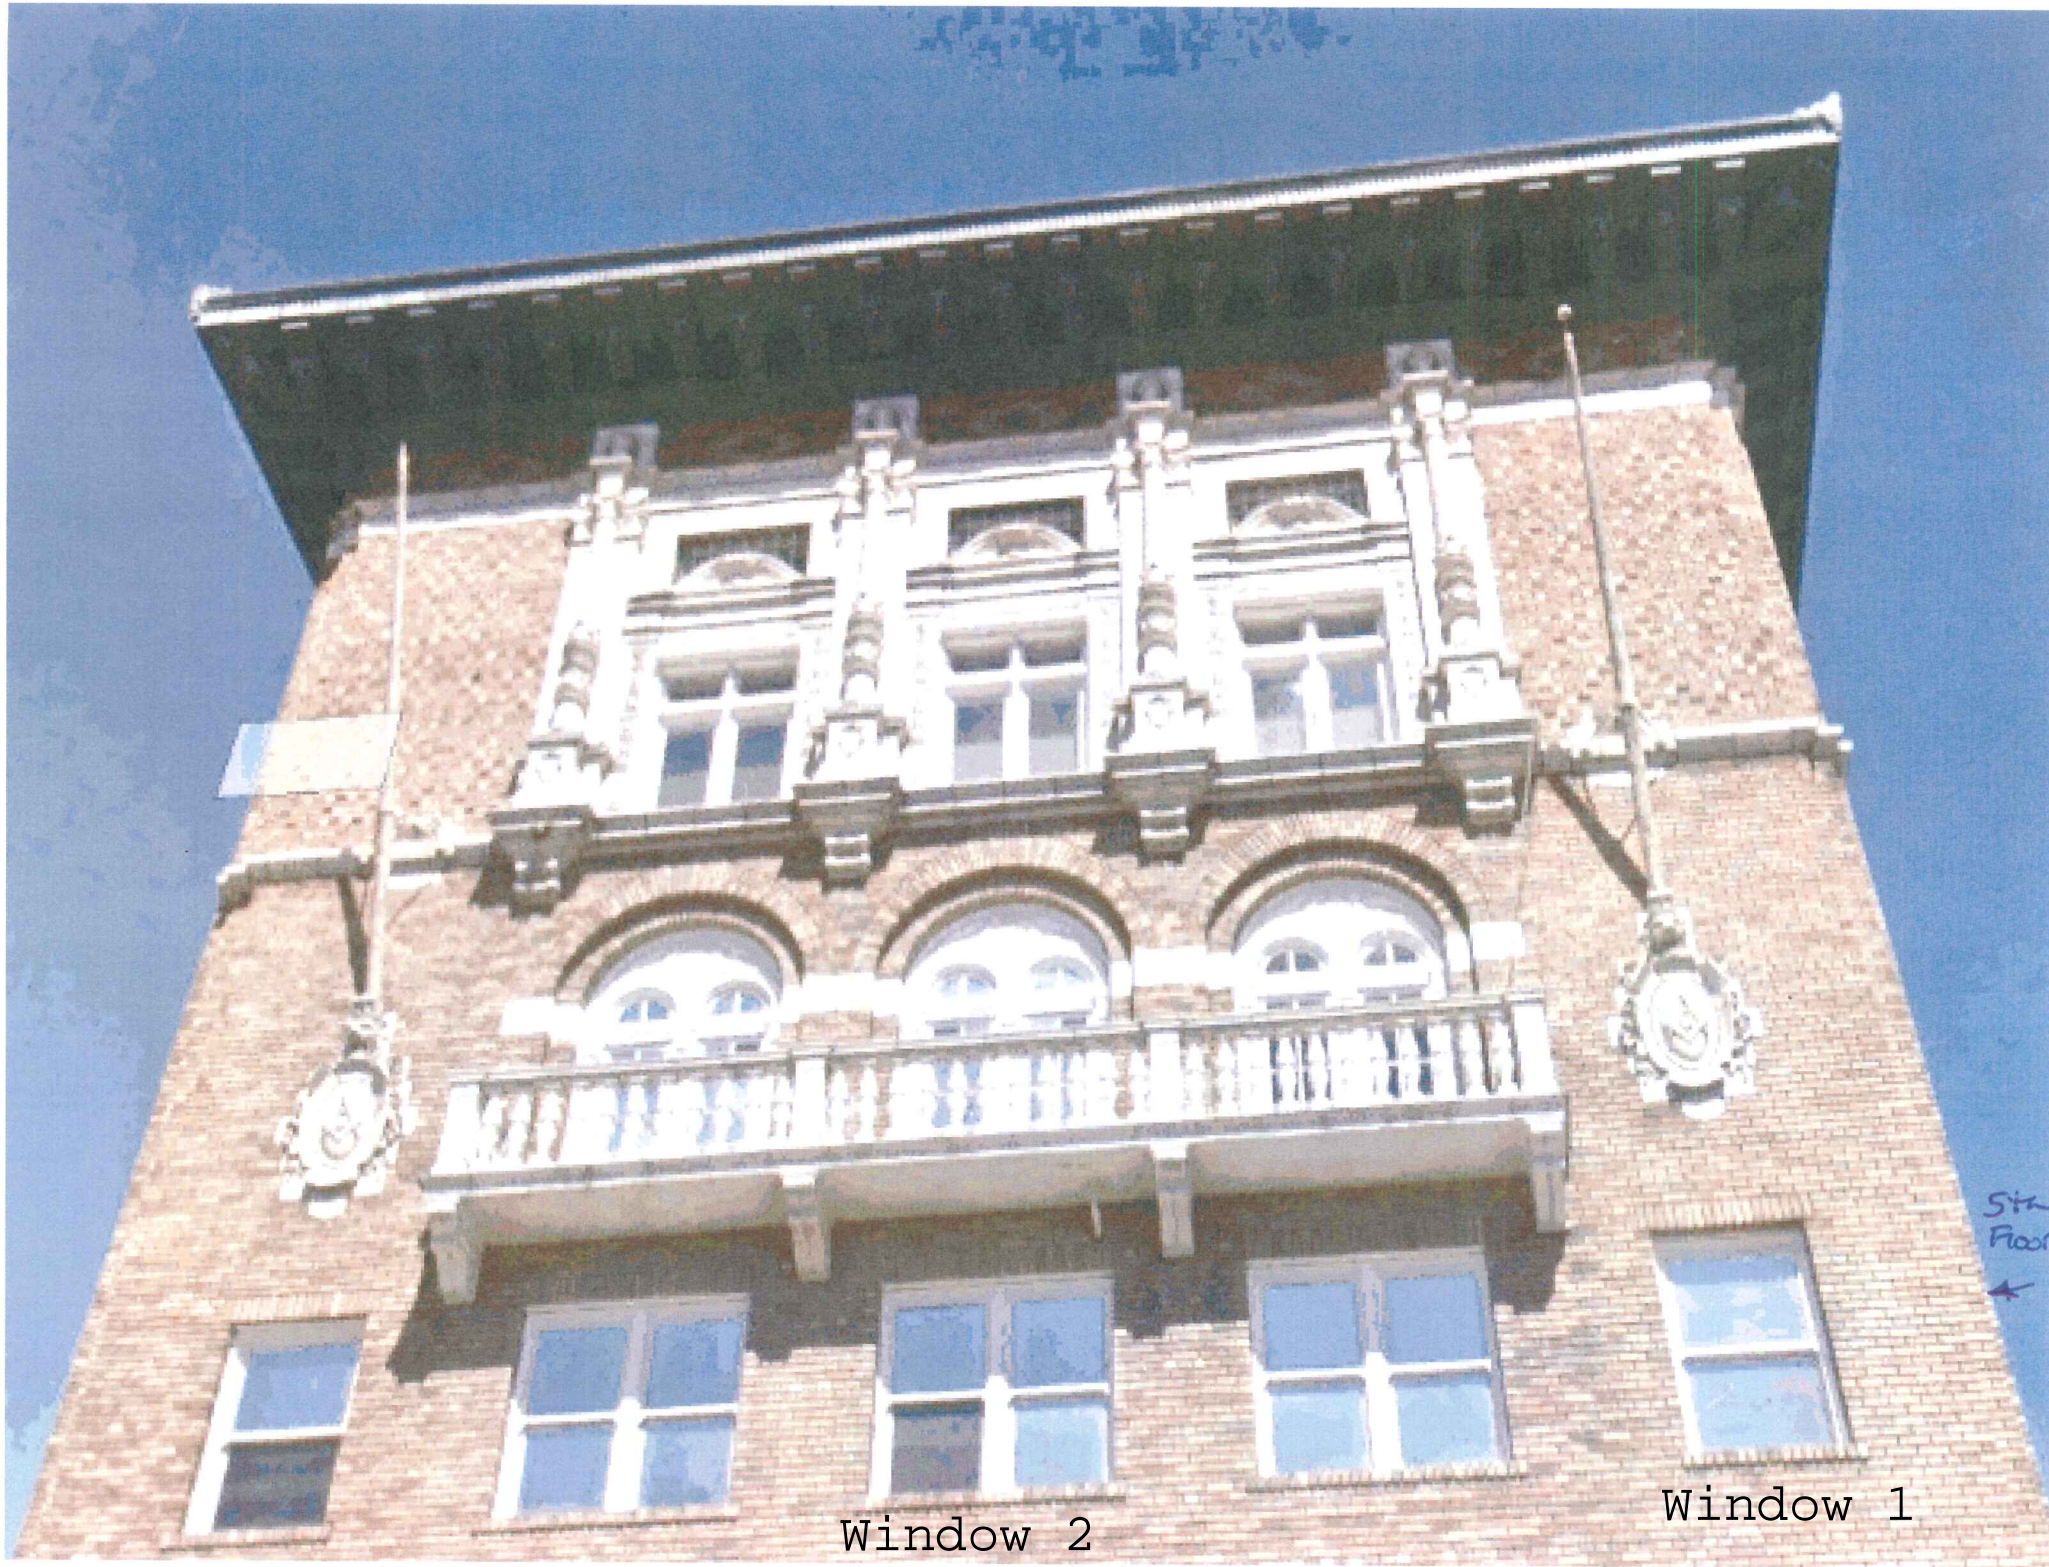
Six Floor
→

Window 2

Window 1

- Remove and replace 3 full broken wood sash double hung with like material and product.
- replace 7 broken seperated light on sill doors.
- Remove and replace 2 flag pulls with like materials.

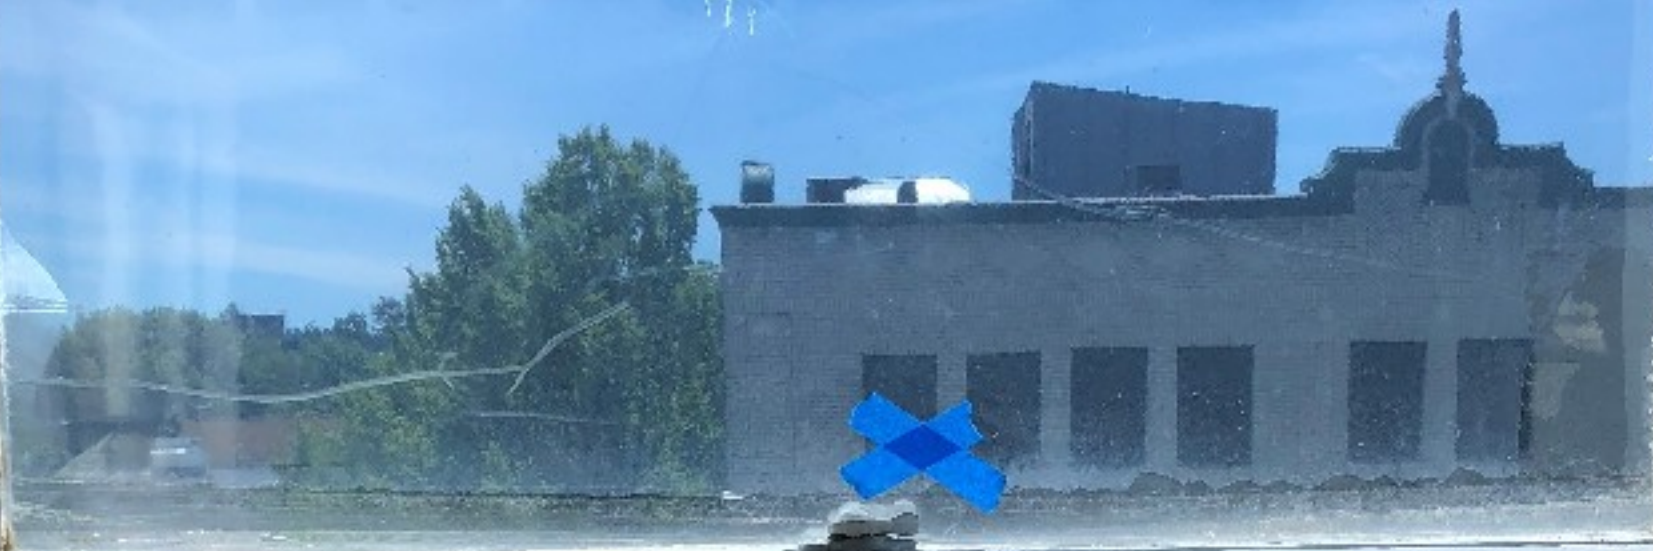
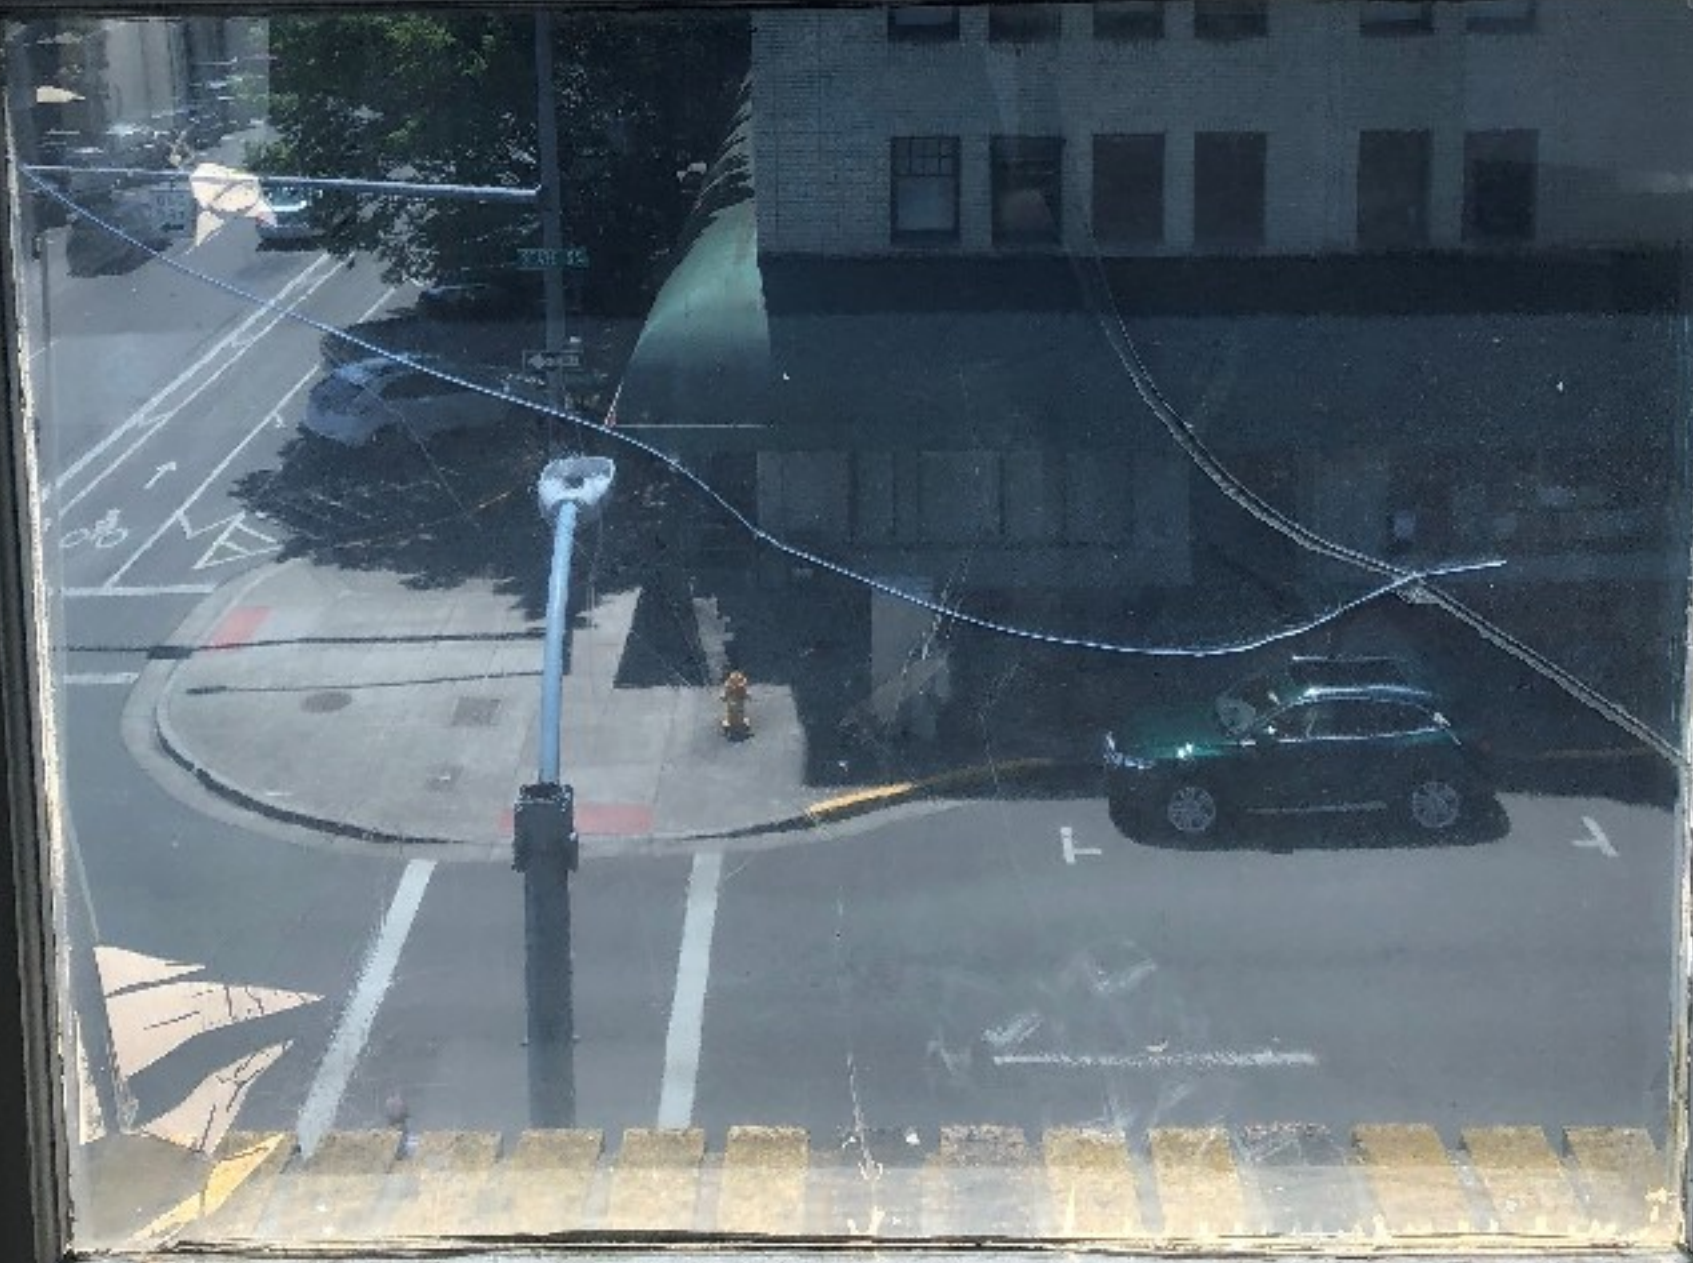
WINDOW 2

<p>Click to insert photo</p>	Location: <u>4th floor SE corner 4th south & 5th north</u>
	Window Description: <u>Broken, loose, loose</u>
	Stool: _____ <input type="checkbox"/> Remove paint <input type="checkbox"/> Repair <input checked="" type="checkbox"/> Replace
	Frame/Pulley/Stiles: _____ <input type="checkbox"/> Remove paint <input type="checkbox"/> Repair <input checked="" type="checkbox"/> Replace
	Sash/Muntins/Leading: _____ <input type="checkbox"/> Remove paint <input type="checkbox"/> Repair <input checked="" type="checkbox"/> Replace
	Trim: _____ <input type="checkbox"/> Remove paint <input type="checkbox"/> Repair <input checked="" type="checkbox"/> Replace
Dimensions of window:	Hardware Description: <u>Broken</u> <input type="checkbox"/> Remove paint <input type="checkbox"/> Missing
	Ropes/Chains: <u>N/A</u> <input type="checkbox"/> Replace
Remarks:	Weatherstripping: _____ <input checked="" type="checkbox"/> Replace

Overall Condition: Poor
