FOR THE MEETING OF: October 17, 2019
AGENDA ITEM: 5.a

CASE NO.: Historic Design Review Case No. HIS19-37

APPLICATION SUMMARY: A proposal to restore and repair the exterior of the Sweetland-Peck House, c1895.

LOCATION: 1552 Court Street NE

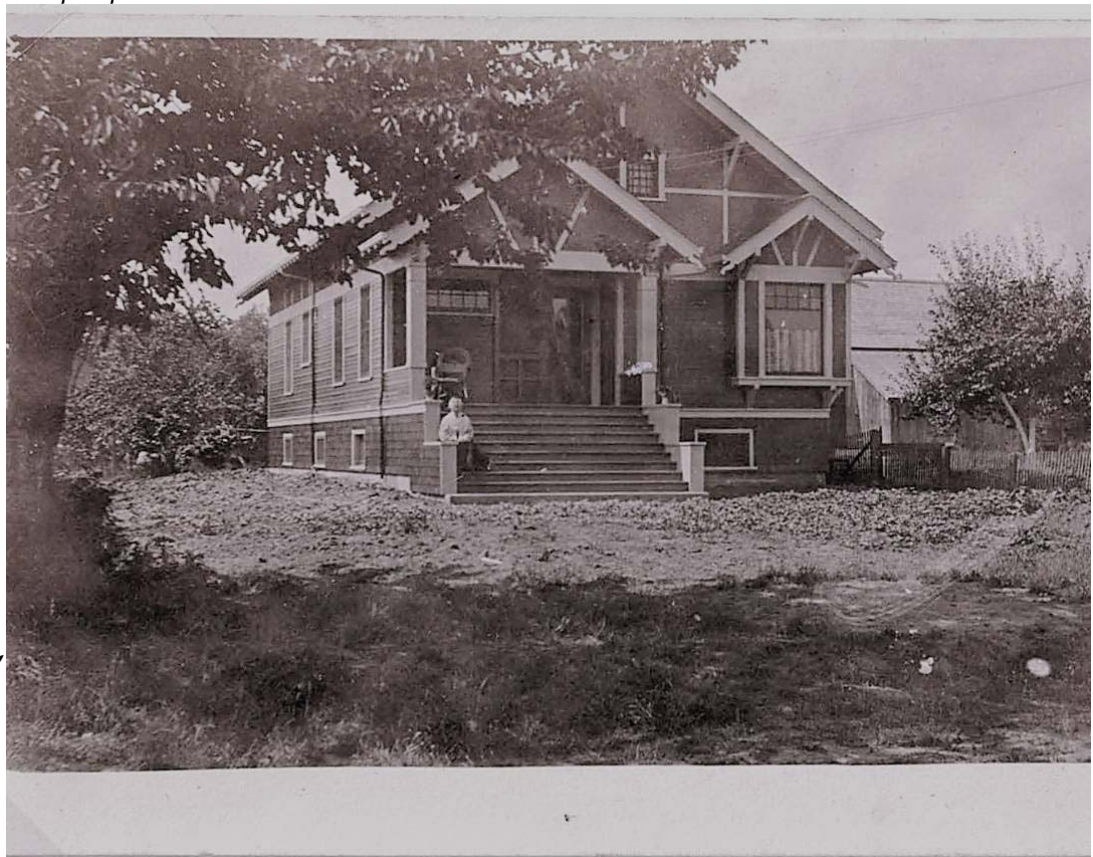
Figure 6: 1552 Court Street (after 1910)

The lack of foundation bears that out. Although a contractor was retained July 30,

2019, to assess the current state of the foundation, no work has been performed due to other commitments of the contractor.

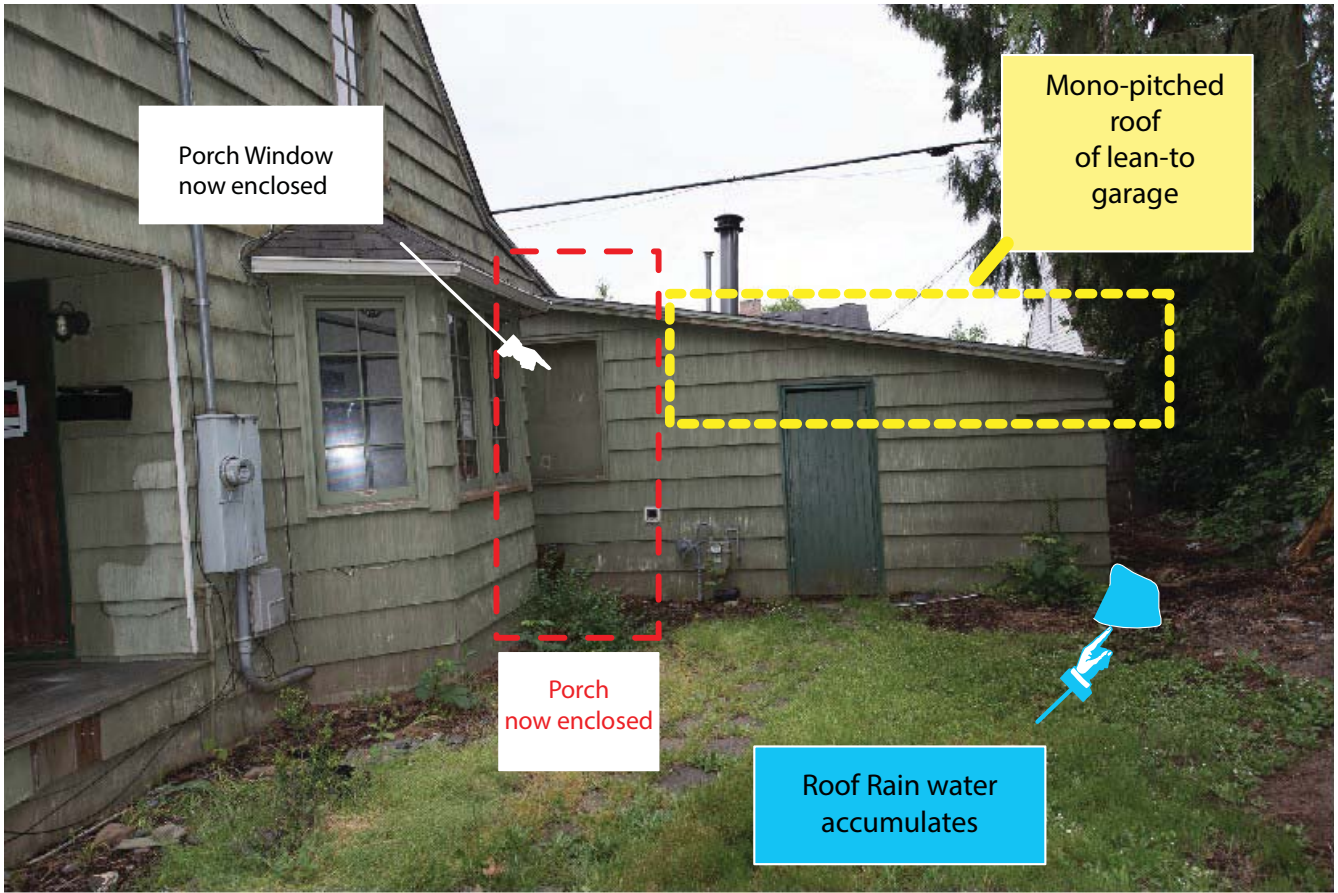
Figure 10: Peck Cottage Lean-to Garage

The areas where there had been porch windows or screens on the western porch are now boarded up. One, or both of these boards will be removed and replaced with a window, clear on the north side, frosted and/or safety glass on the south side facing the alley.

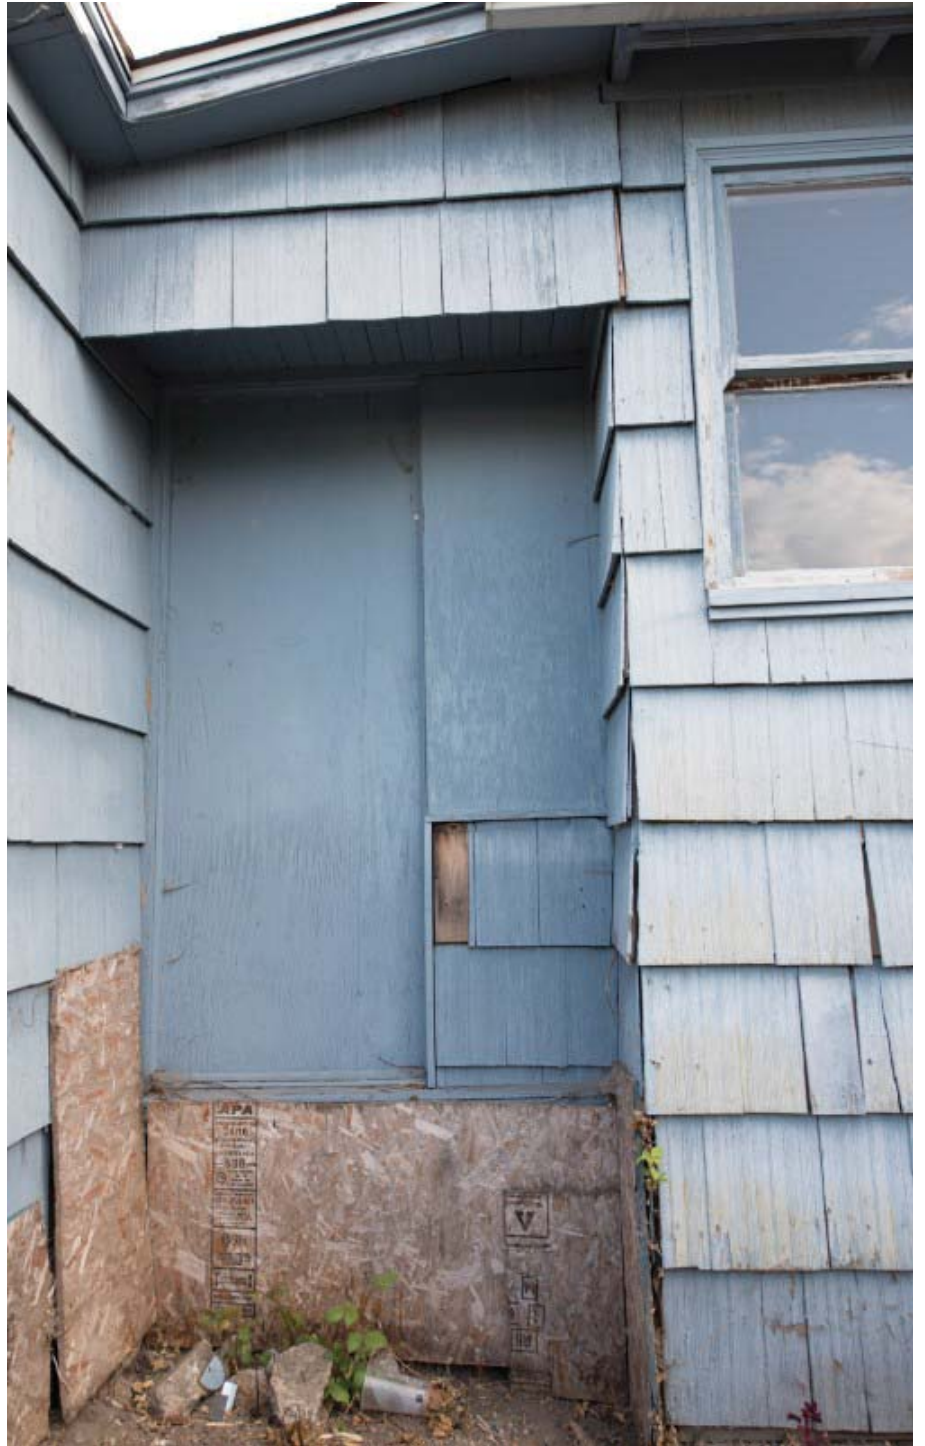
Figure 17: Southwest Porch Exterior From Alley

Off of the kitchen is what appears to have been a westward facing porch. The room was enclosed and then a garage was added. The spaces that would have had screens have been boarded in. We propose to either leave them boarded or to open them up with glass glazing and/or screens.

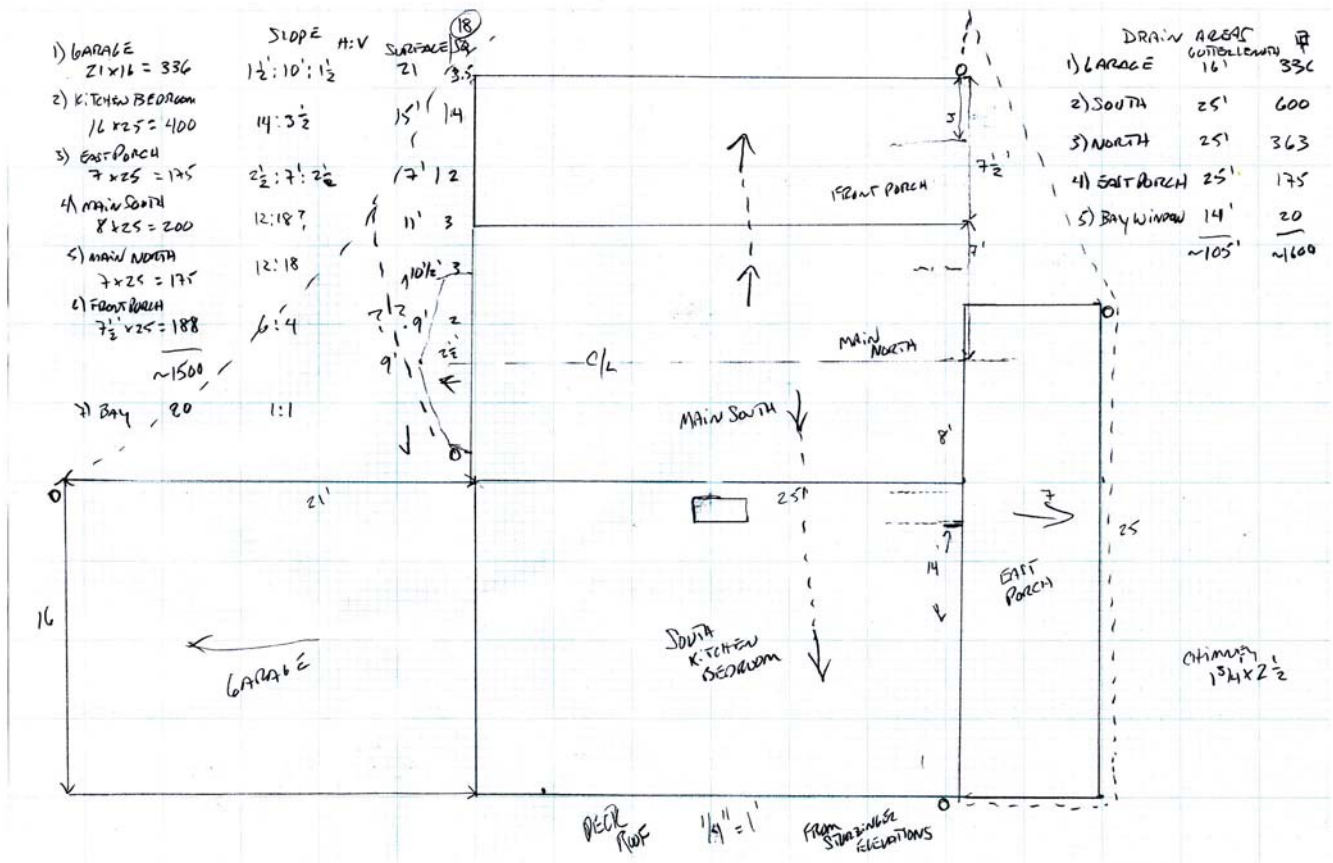
Figure 20: Peck Cottage Roof Plan & Drainage

Any existing downspouts simply drop the water at the foot of the house. We will connect black drainage tubing to the ends of downspouts and divert the waters to the front yard for drainage. Much of the house's foundation problems are probably due to the dumping of roof water at the base of the house.

There will be black corrugated pipes rising within 10" from the ground to capture the downspout flows. The water from all four roofing systems will be diverted via the black pipes to the front yard to an appropriate drainage trench that will be about 30 lineal feet designed in accordance with the Environmental Services Department for the City of Portland, pamphlet ES 0912 June 2009 *How To Manage Stormwater: Soakage Trenches*.⁴

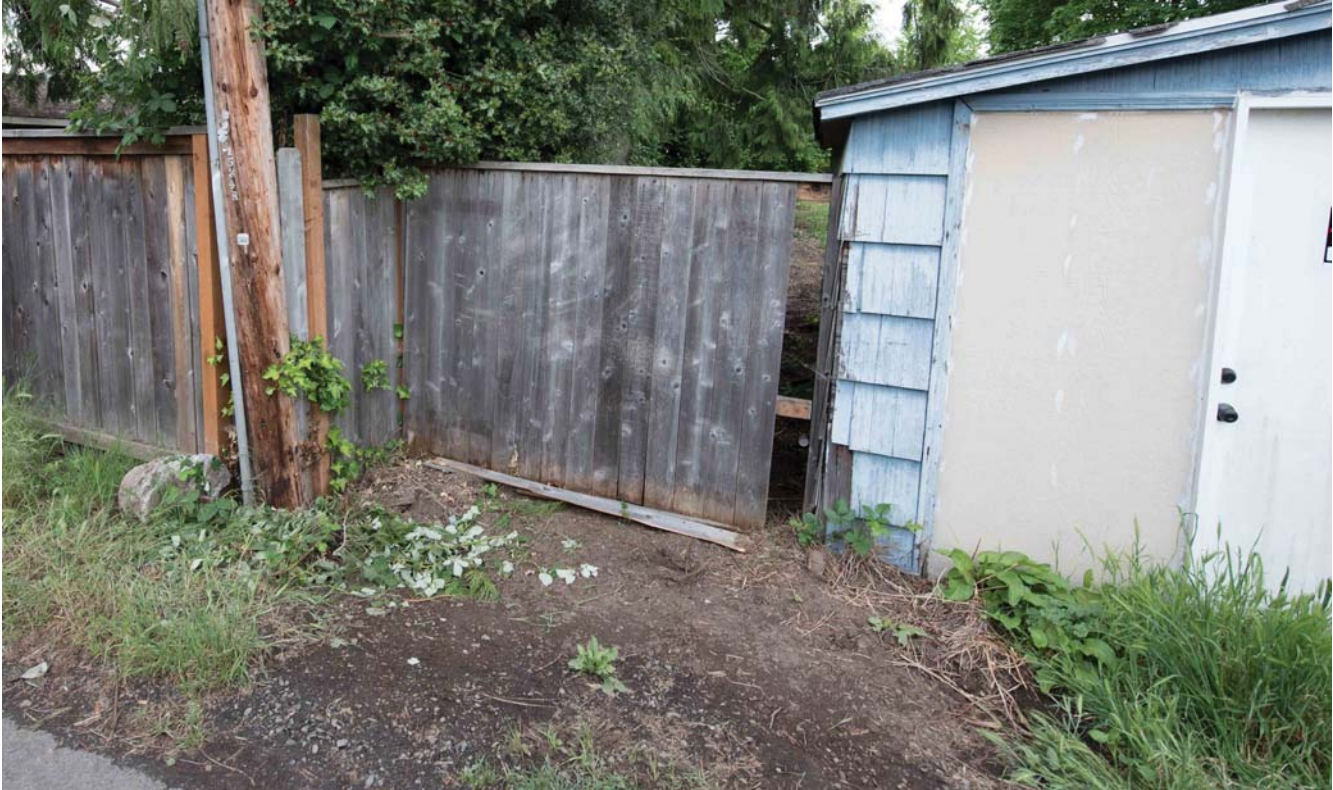
A goal is to continue the theme of the 1566 Court Street alley treatment: a planter bed of 18" to the 16' right-of-way with a fence. The planter bed was created by Penny Moore and enhances the alley corridor. There is a problem with the fence being so close to the house, and Ken Eatwell expressed concern for fire safety for the downstairs bedroom as a person trying to escape the house has to be able to enter the alley without impedance. There will be a gate or emergency exit as required. The planting bed down to the garage driveway will be continued. The area east of the garage driveway will remain crushed rock with grass block pavers or some material allow equipment to enter the yard through the 7' space between the garage and the property line.

Figure 25: Western 7' Wide Fence
There are two fences between the structure and the property lines facing the alley.

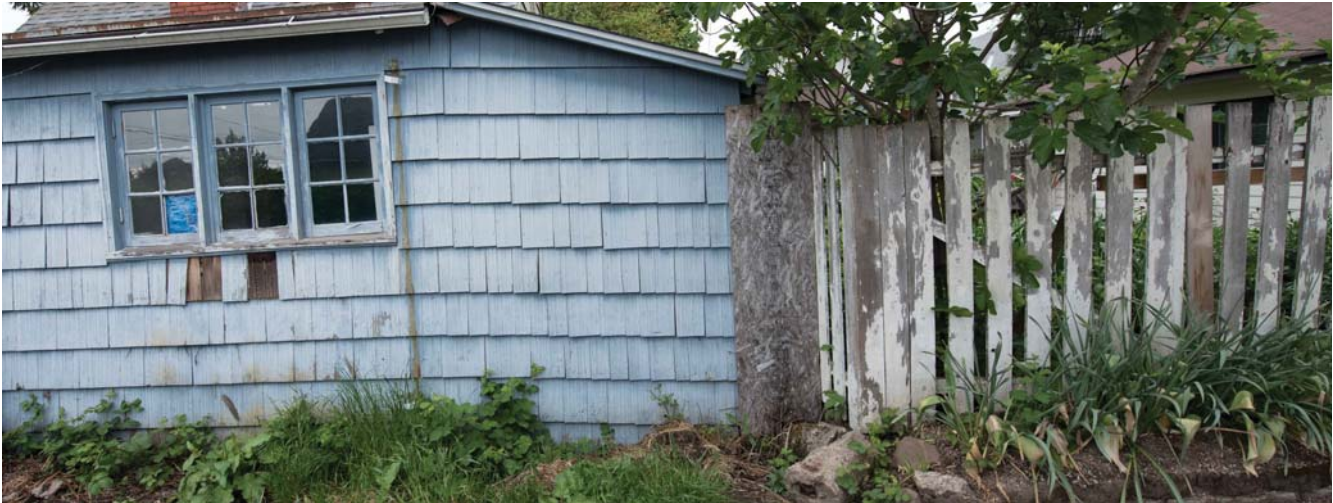
Figure 26: Eastern 2' Particle Board Connecting House with 1566's Open Slat Fence

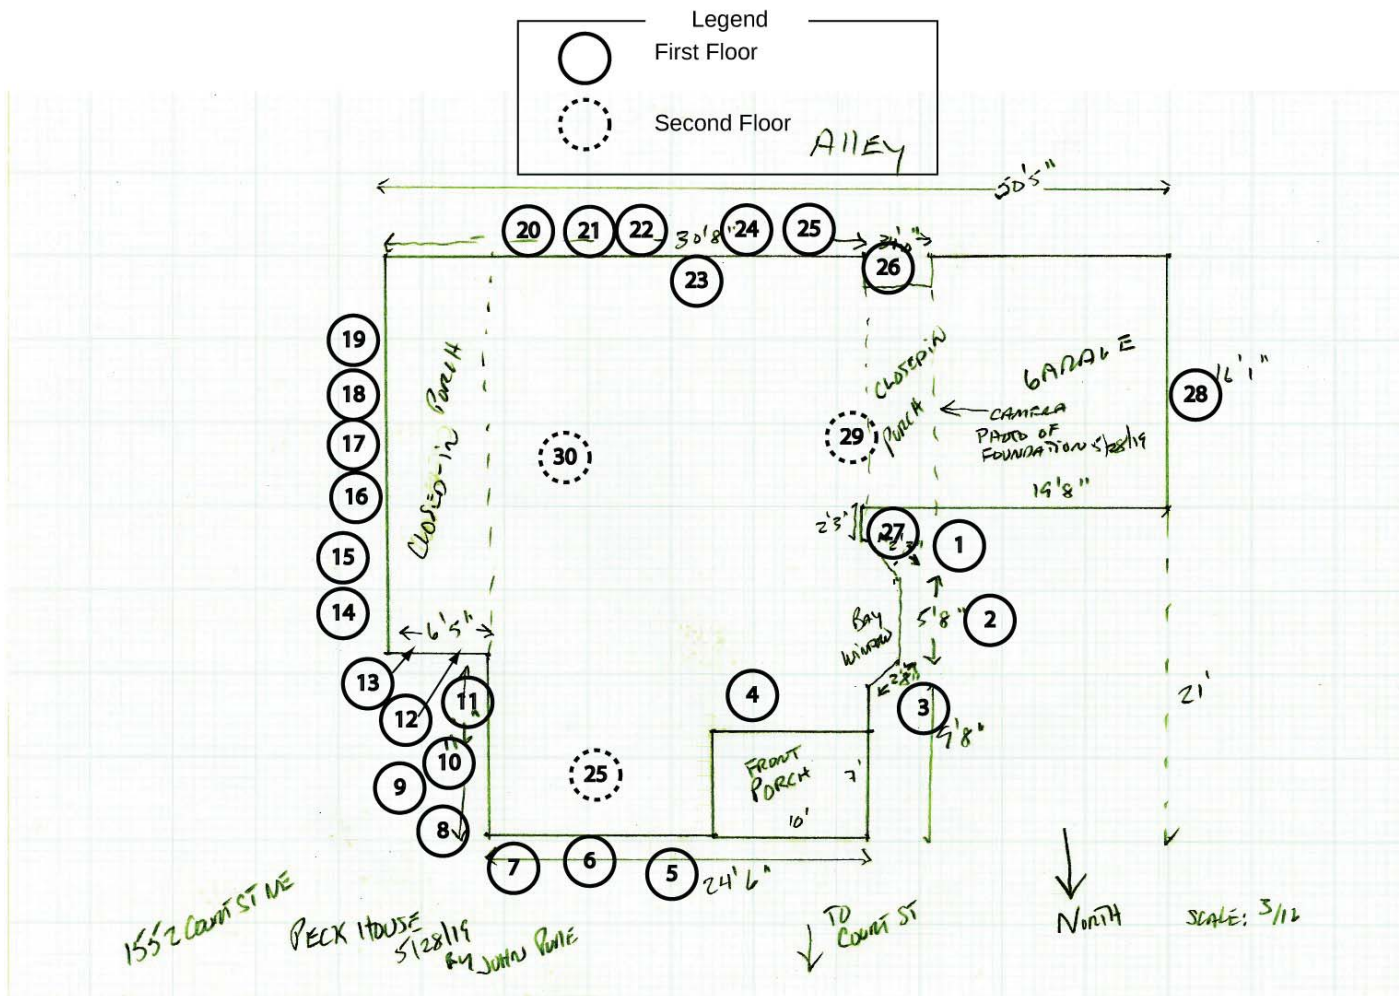
Figure 31: Peck Cottage Windows

The windows are of several types: 1) casement, 2) casement with a crank 3) double hung and 4) fixed. The windows on the south facade are in the worst condition. I was provided a window evaluation form from staff which is very thorough and when filled in easily consume at least one page. Given that there are 31 windows and this application is nearing 30 page apart from windows, I am requesting that the window treatment be bifurcated and deferred to a later hearing. Given the extensive amount of repairs I anticipate and the delays I am encountering with tradespeople, e.g. 5 weeks for a contractor to commence an assessment of the foundation and 6 weeks for a heating contractor to install a heat pump, I would like to defer focus on the windows until later. Some of the windows have plastic in place of the glazing, unfortunately it is not a simple task of just removing the plastic and inserting a glass pane. Some of the windows have missing mullions or the frame of the window is so weathered that replacement of the entire window may be a preferred alternative. We replaced a vinyl kitchen window with a double hung window at 1566 and the cost was \$3,350.00. The Toolbox program help defer the expense with an award of \$1,000. While the 1566 window is probably a larger job than any given window in the Peck Cottage, it still is a major economic undertaking to “do it right.”

Some of the worst examples of the window conditions are:

I want to be able to leverage any ToolBox grants and tax incentives, applications for which will require thorough documentation. My intent is to “repair rather than replace” or “replace in kind” depending on the severity of the damage.

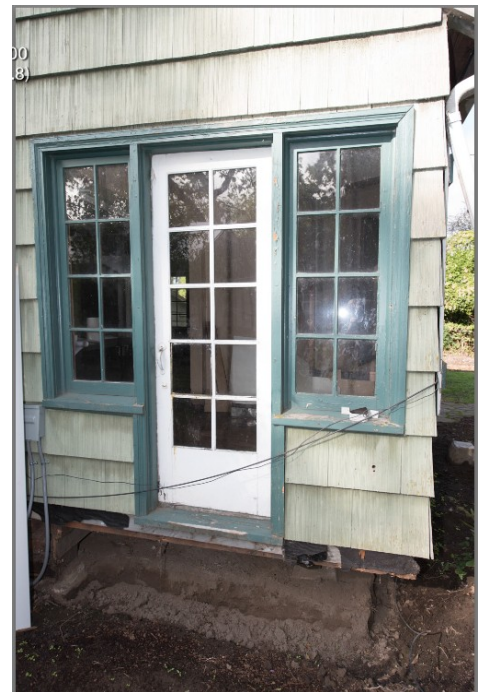
Figure 1: Eastern Façade -- October, 2019

- 2) a) replacement landing for east facade is being postponed for later consideration pending further design details, b) replacement landing for north porch is being postponed for later consideration pending further design details. Following are photos of the current façades. There was no landing on the eastern façade when Petitioner acquired the property in May. There was and remains a temporary landing created by the former owners on the front porch. Since the filing of the application, Petitioner caused the lower skirt to be removed to expose the foundation; the foundation support was in need of immediate repair and temporary piling has been placed to preserve the structure. A permanent concrete foundation is in the final stages of design and will be submitted shortly to the City of Salem for foundation repair.
