CASE NO.: Historic Design Review Case No. HIS18-04

APPLICATION SUMMARY: A proposal to replace the failing front porch and bay window foundation, porch and steps; replace the non-historic rear upper deck and lower sunporch steps, hand railing and balustrades; and replace 24 windows on the Daniel S. Yoder House (c.1891).

LOCATION: 1811 Chemeketa Street NE

Daniel S Yoder House
1811 Chemeketa St NE
Salem, OR 97301

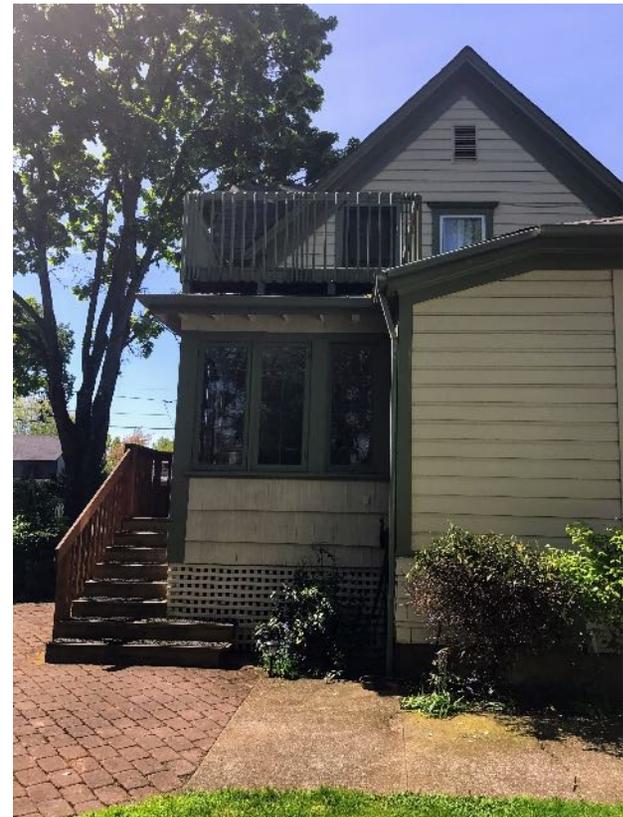
By the leaded glass windows, the sunporch looks to have been added somewhere around the 1930's. A deck and balcony above were added at the same time. Sometime in the early 1980's prior to listing on the Historic Register, both were updated.

The estimated time frame for the improvements comes from both the style of railings used on the deck and the pier and post system used as a foundation.

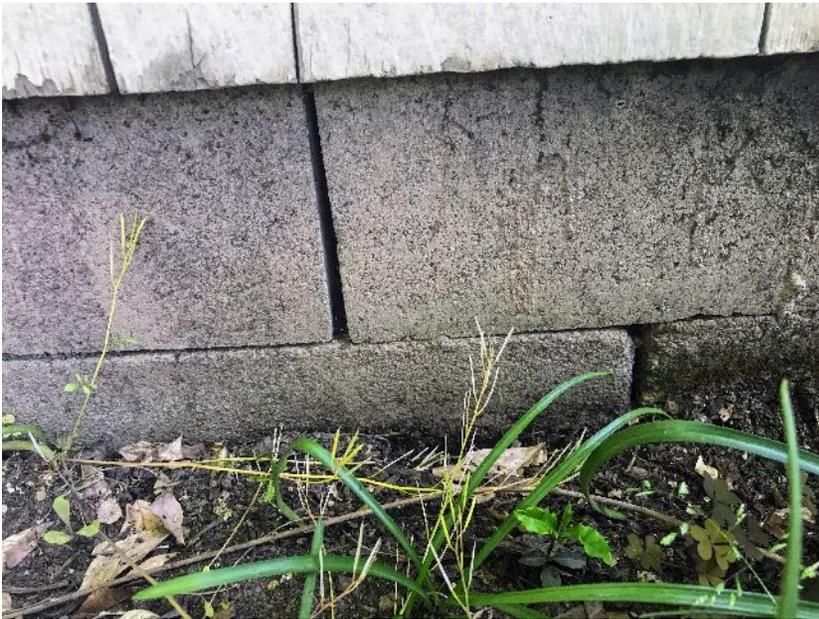
Old exterior view of the front porch foundation

This is the area in the worst condition. The front porch appears to have had a foundation replacement sometime that was done in a substandard manner.

The porch and bay window foundation is dry stack cinderblock with no concrete or other stabilizing materials except chicken wire. The footing that the block rest on is not sufficient to prevent settling.

New exterior view will match the look of the main house foundation as shown here.

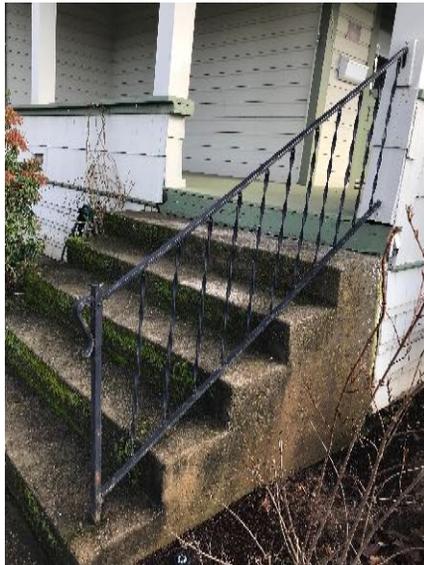
Old concrete stairs and railings

The design of the stairs is a contributing factor to the ongoing damage to the porch. There is no continuous foundation behind the stairs. The stairs themselves are used as unattached support for the front porch. This picture shows the porch sliding away from the concrete stairs.

New stairs and railings (proposed).
This photo is from another home
in the historic district.

Note: Consistent with the SRC 230, the materials used will be cedar and fir.

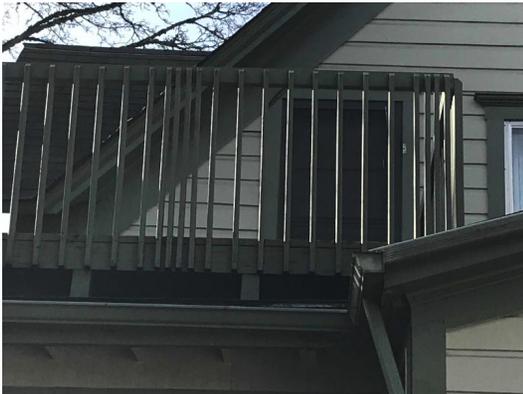
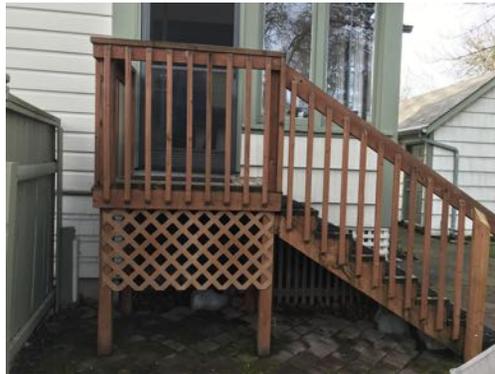
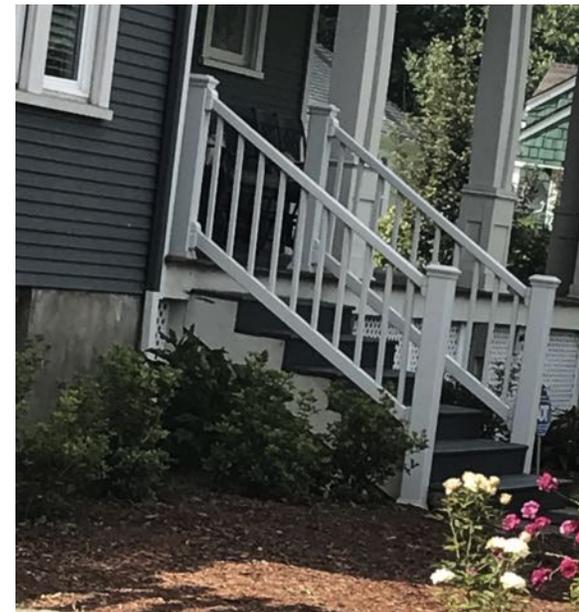
- The stairs leading to the sunporch are in the same style as the railings on the upper deck. We propose replacing both sets of railings using the same style and materials as the front porch.
