SEISMIC RESILIENCY ANALYSIS REPORT

B&V PROJECT NO. 406828

City of Salem

AUGUST 2023

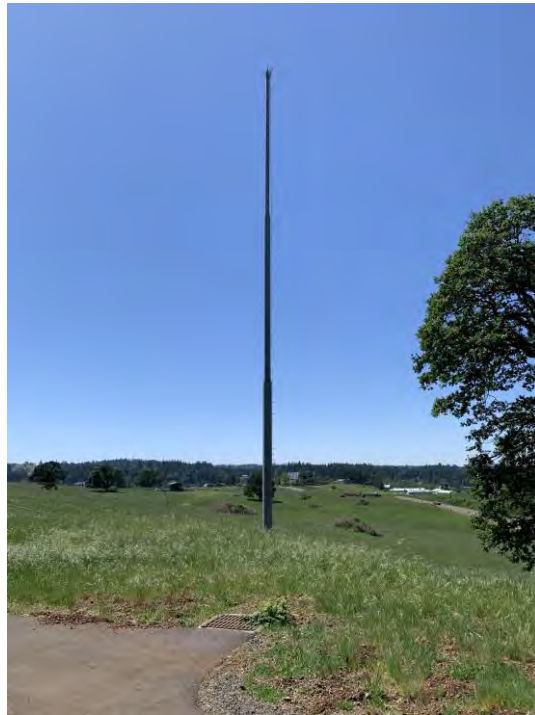
Figure 3.204 SCADA Antenna

| Potential Deficiencies | Description |
|---|---|
| Nonstructural | <ul style="list-style-type: none"> • Water system piping within the control building is not adequately seismically braced (see Figure 3.200). • Valves in line with the water system piping are not braced (see Figure 3.201). • The pressure tank for the irrigation system is not anchored at the base (see Figure 3.202). • Vertical pump motors are not braced above the center of gravity of the motors (see Figure 3.203). • There does not appear to be adequate flexibility in the piping that is attached to the pumps to accommodate potential relative movement between the piping and the pump, and to prevent the piping from adding additional load to the pump anchorage. • Backup batteries in the battery cabinet (for operation of the seismic valves) may not be adequately restrained. • The horizontal arm of the SCADA antenna may not be adequately connected to the supporting pole to prevent the antenna from being misaligned or damaged after an earthquake (see Figure 3.204). • The ceiling framing of the chlorine room inside the control building does not appear to provide adequate connections to transfer seismic forces from the ceiling to the masonry walls below. Also, the wood ledger attachment to the masonry wall is not detailed to avoid cross-grain bending (see Figure 3.205). • The electrical “room” partial height masonry walls are not laterally braced (see Figure 3.206). • Two ladders are unrestrained (see Figure 3.207) and may topple into and potentially damage valves or other components during an earthquake. • No anchorage was observed between the electrical transformer and concrete support pad (see Figure 3.208). |
