DRAFT—Grant Neighborhood Reconnaissance-Level Survey Update

Submitted to: City of Salem

Submitted by: Historical Research Associates, Inc. Brooke Best, MS Libby Provost, MA

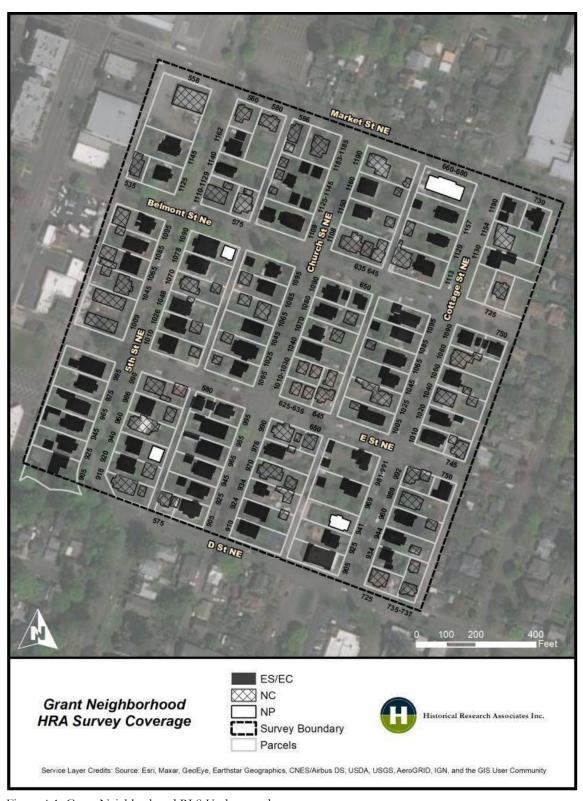
The project survey area, a small portion of the larger Grant Neighborhood, contains 108 resources (Figure 4-1). Of these, nine were previously recorded in the OHSD: 905 5th St. NE (Broer Residence); 905 Church St. NE (George H. Sanders House); 1109 Church St. NE; 905 Cottage St. NE (Bethel Baptist Church); 925 Cottage St. NE (Bethel Baptist Parsonage); 969 Cottage St. NE (Arnold Roethlen House); 981 Cottage St. NE; 992 Cottage St NE; and 1113 Cottage St. NE (Roth House). The resources recorded in the OHSD as Bethel Baptist church and parsonage are today known as Evergreen Presbyterian Church, which was determined eligible for listing in the NRHP during the undertaking (see Section 1.2). All previously surveyed buildings except 992 Cottage St. NE were recorded as eligible.

Figure 4-1. Grant Neighborhood RLS Update results map.

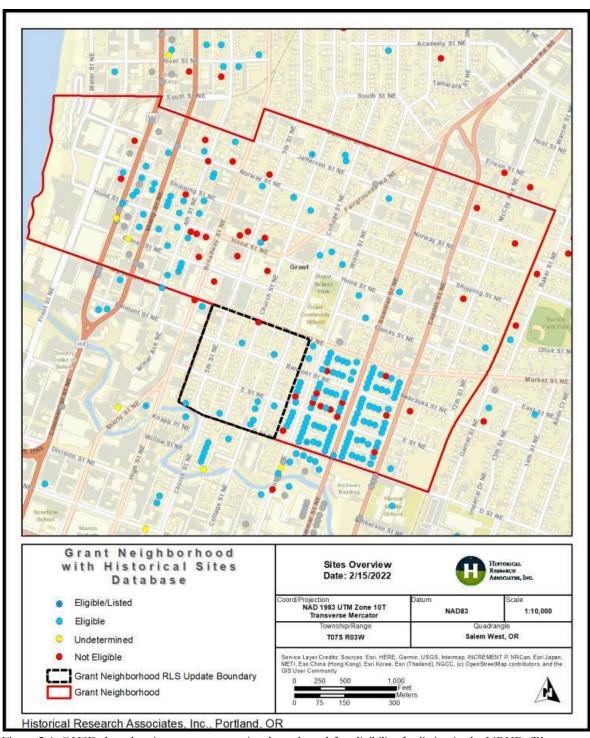
Figure 5-1. OHSD data showing resources previously evaluated for eligibility for listing in the NRHP. (Blue: eligible; red: not eligible; yellow: undetermined; and gray: demolished.) Note the concentration of eligible resources in the southeast corner of the map; these buildings comprise The Oaks 2006 RLS.

Due to the concentration of 1890–1939 houses, there may be a case for significance in a boundary that includes the project survey area combined with The Oaks 2006 RLS area (combined they are roughly bound by Madison St. NE to the north, 12th St. NE to the east, D St. NE to the south, and Broadway St. NE to the west). This period of construction includes 94 percent of resources in The Oaks RLS and 89 percent of resources surveyed in the project area (Oregon SHPO 2022; Appendix B). The high concentration of eligible/contributing resources appear to have potential for eligibility as a historic district under Criterion C for Architecture, with a period of significance of 1890–1939. The area may also be eligible under Criterion A, for Community Planning and Development; however, the period of significance is as yet undefined. Note that HRA did not confirm that buildings included in The Oaks 2006 RLS still retain sufficient integrity to convey significance, nor did this project include in-depth research into the development of The Oaks.
