SEISMIC RESILIENCY ANALYSIS REPORT

B&V PROJECT NO. 406828

City of Salem

AUGUST 2023

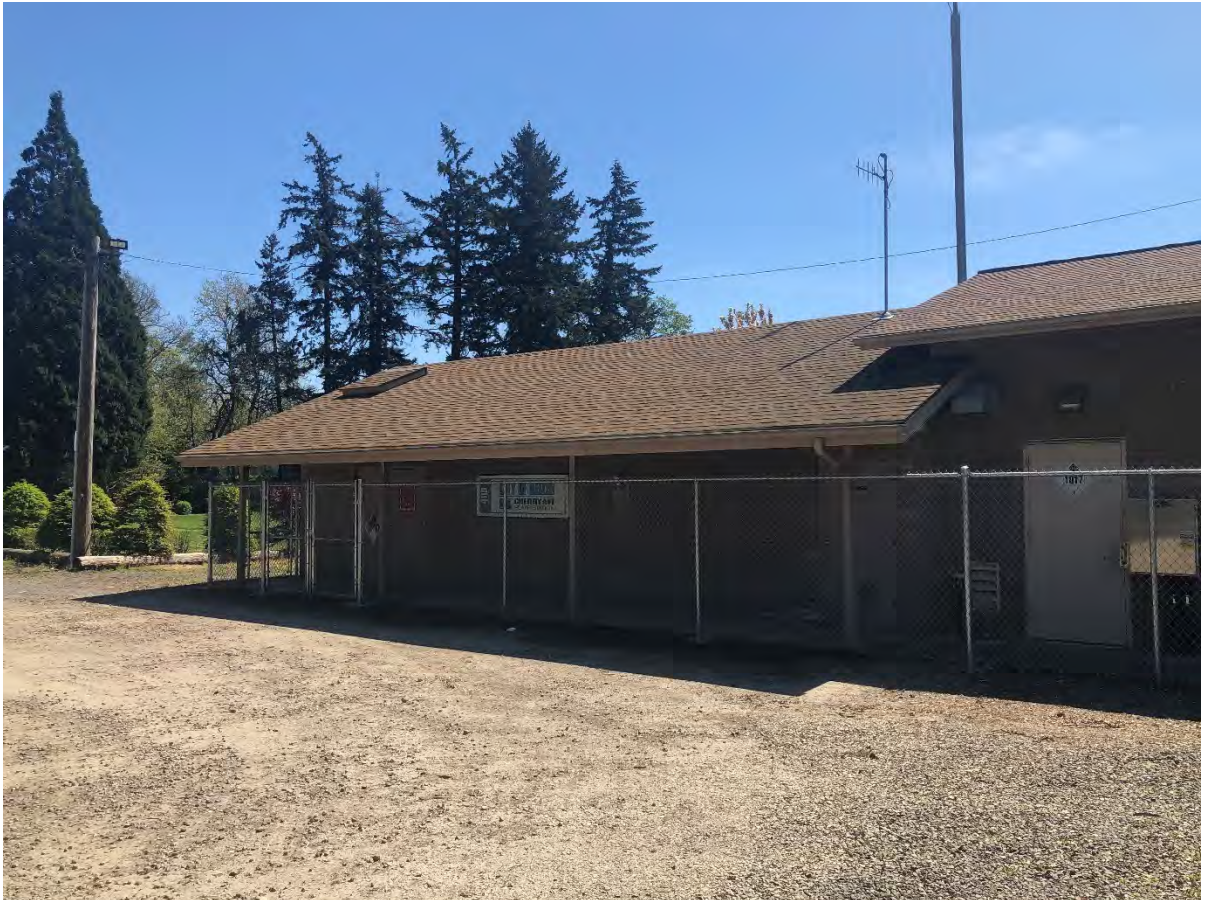
Exhibit 3-1: Photo of Salem-Keizer Intertie/Cherry Avenue Booster PS During Site Visit

If subsurface conditions underlying the pump station are similar to what was encountered in the nearby exploration, then the potential for liquefaction and associated hazards is considered to be moderate, which is consistent with the regional seismic mapping.

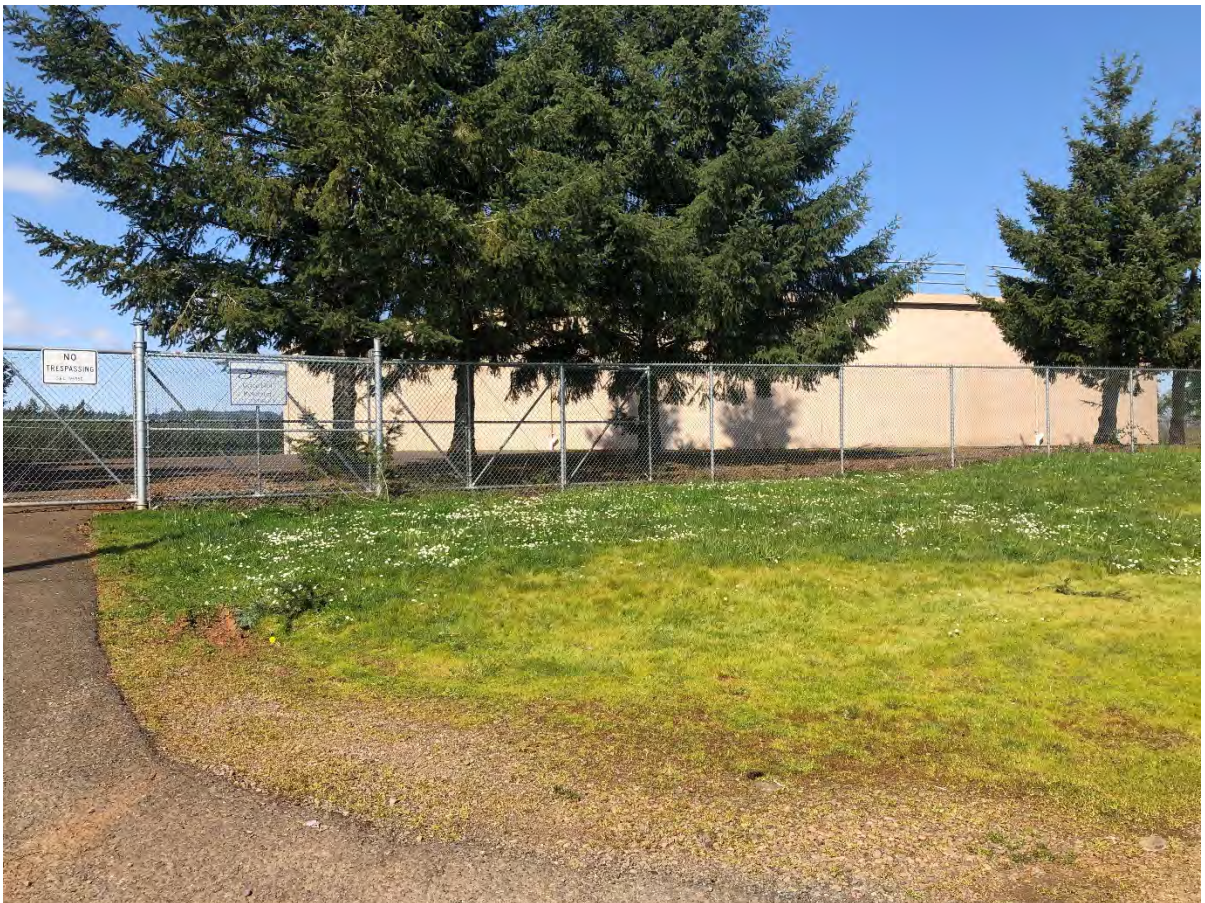
Exhibit 3-2: Photo of Grice Hill Reservoir During Site Visit

If subsurface conditions underlying the reservoir are similar to what was encountered in the nearby explorations, the potential for permanent ground deformation from liquefaction and seismic slope instability is low, which is consistent with the regional seismic geohazard mapping.

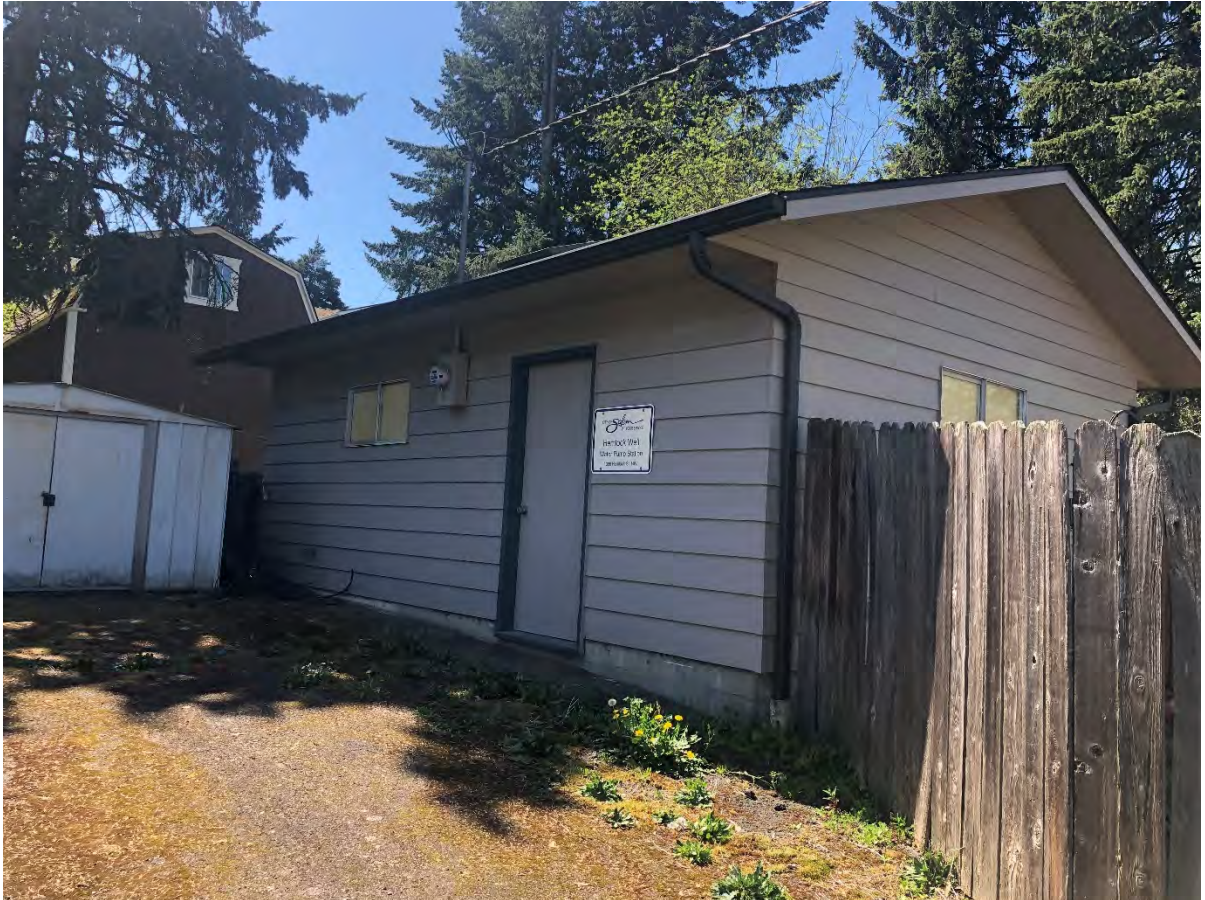
Exhibit 3-3: Photo of Hemlock Well During Site Visit

Hemlock well is located near 1398 Hemlock Street NW. During our site reconnaissance, we observed that the site is on relatively flat ground with no observable geologic hazards. Based on the geologic mapping, the site is underlain by volcanic rock. Therefore, the regional seismic hazard mapping does not indicate permanent ground deformations from liquefaction induced settlement or seismic slope instability.

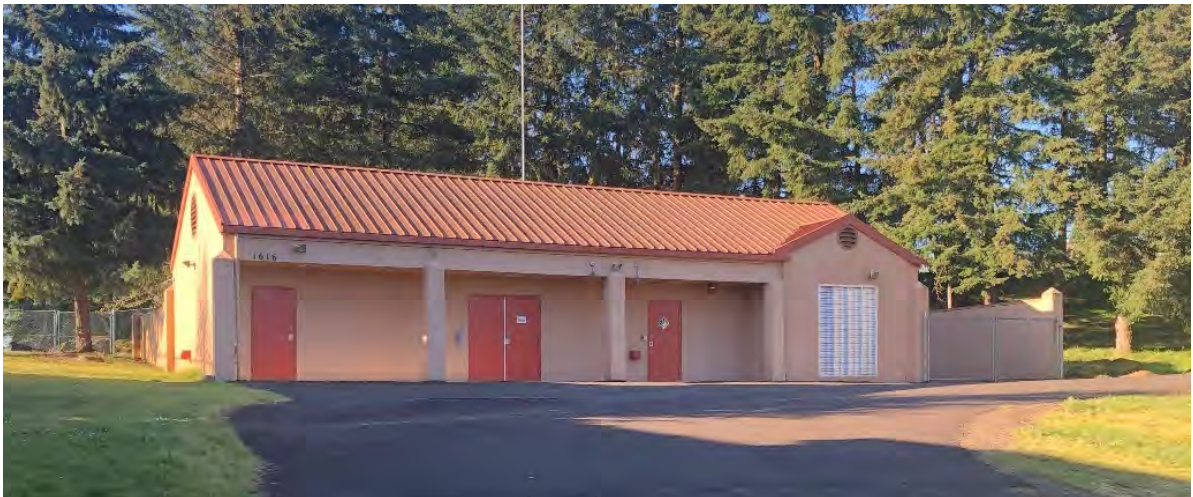
Exhibit 3-4: Photo of Mountain View Reservoir and Pump Station During Site Visit

If the subsurface conditions underlying the reservoir are similar to what was encountered in the nearby explorations, then the potential for liquefaction and associated hazards is considered to be low, which is consistent with the regional seismic mapping and the available. Therefore, the primary geologic hazard identified at this site for the Cascadia Subduction Zone event is strong ground motions.

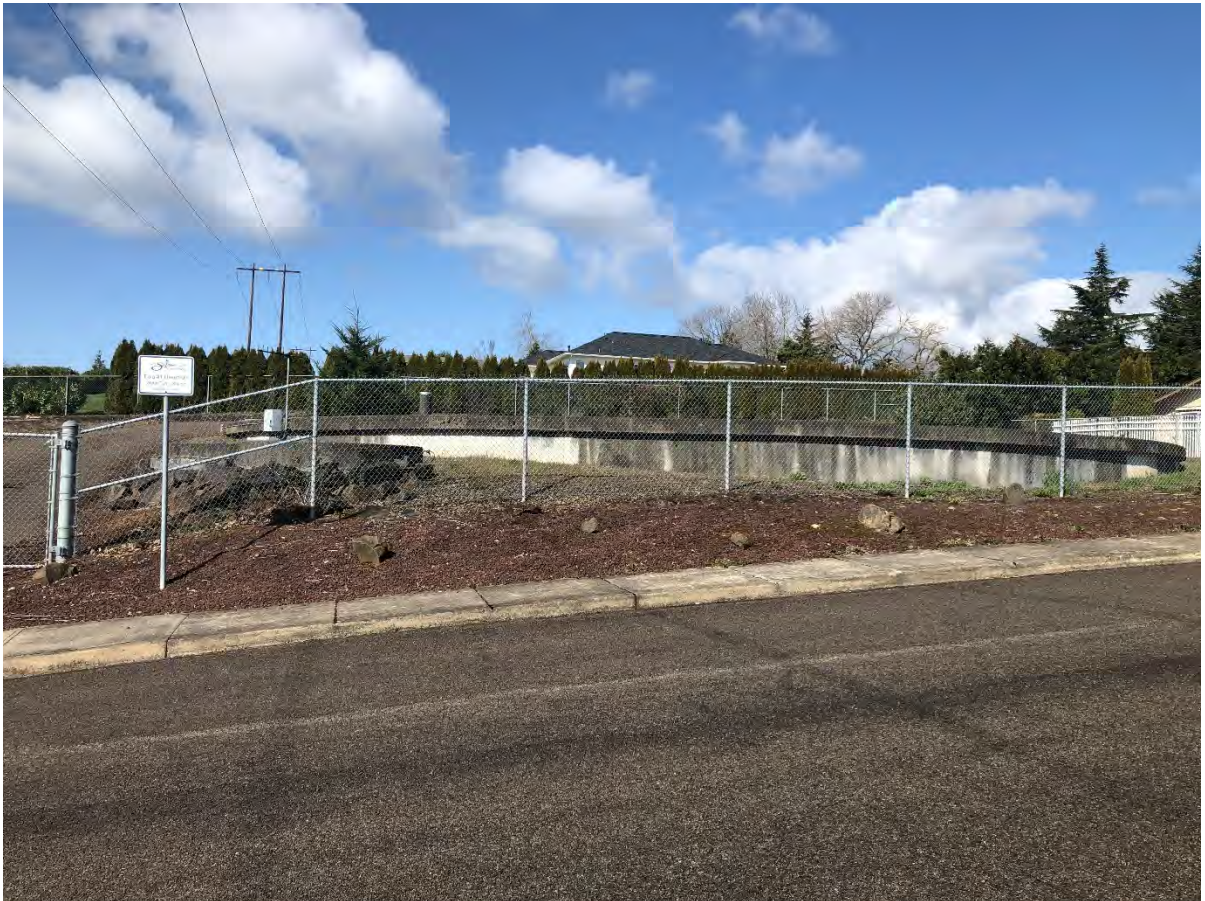
Exhibit 3-5: Photo of EOLA 1B Reservoir During Site Visit

During the site visit, we observed that the reservoir is approximately 450 feet north of the mapped headscarp of a landslide above Doaks Ferry Road. However, at the reservoir, the ground is only gently-sloping to the south, and no on-site slope instability, such as road cracking, was observed.

Subsurface information was not available for the EOLA reservoir. Based on the geologic mapping, the site is underlain by volcanic rock. Therefore, the regional seismic hazard mapping does not indicate permanent ground deformation from liquefaction induced settlement or seismic slope instability. However, because of the proximity of the reservoir to an existing landslide, we recommend site specific geotechnical data be considered to further assess the geohazards. If the City has existing as-built information or geotechnical borings at this reservoir we request that they be provided to the project team to better assess the seismic geohazards.

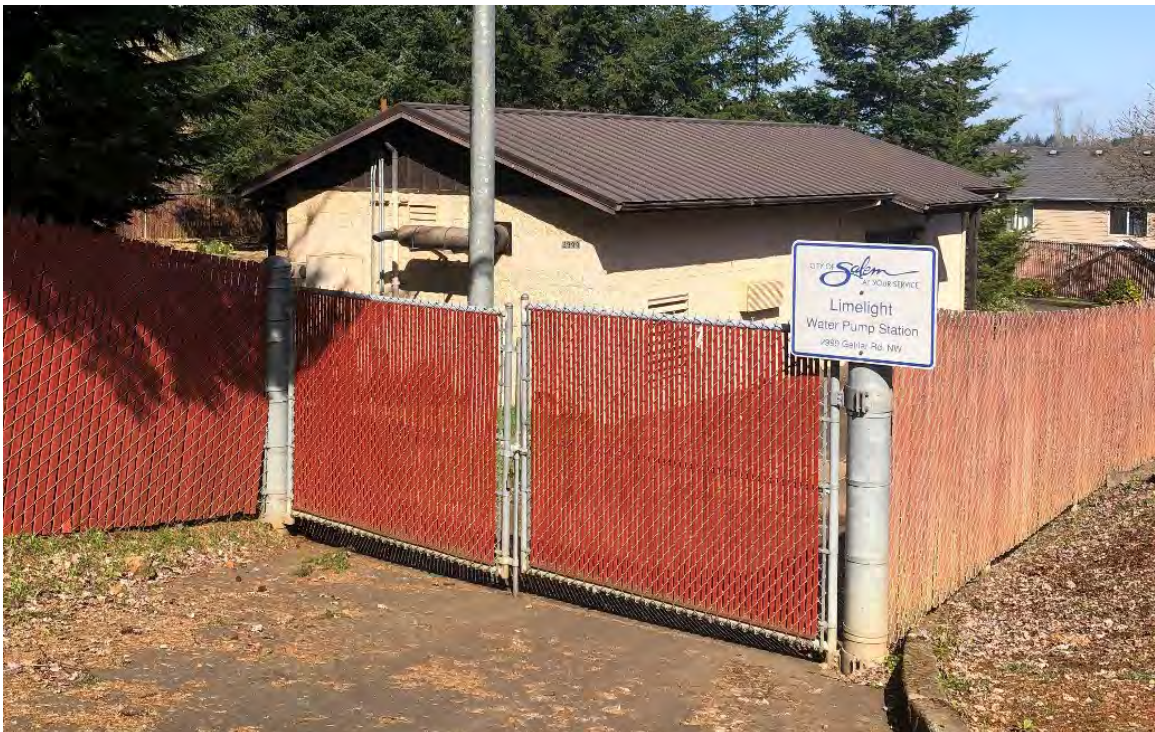
Exhibit 3-6: Photo of Limelight Pump Station During Site Visit

Limelight Pump Station is a reinforced masonry structure with a flexible roof diaphragm located just north of Glen Creek Reservoir. Built in 1998, the structure rests on a 6-inch reinforced concrete slab. Housing three pumps, the pump station has a total capacity of 5.18 million gallons per day. During our site reconnaissance, no evidence of slope instability or other geologic hazards were observed.

Existing subsurface information was not available for this pump station. Based on the geologic mapping, the site is underlain by volcanic rock. Therefore, the regional seismic hazard mapping does not indicate permanent ground deformations from liquefaction induced settlement or seismic slope instability.

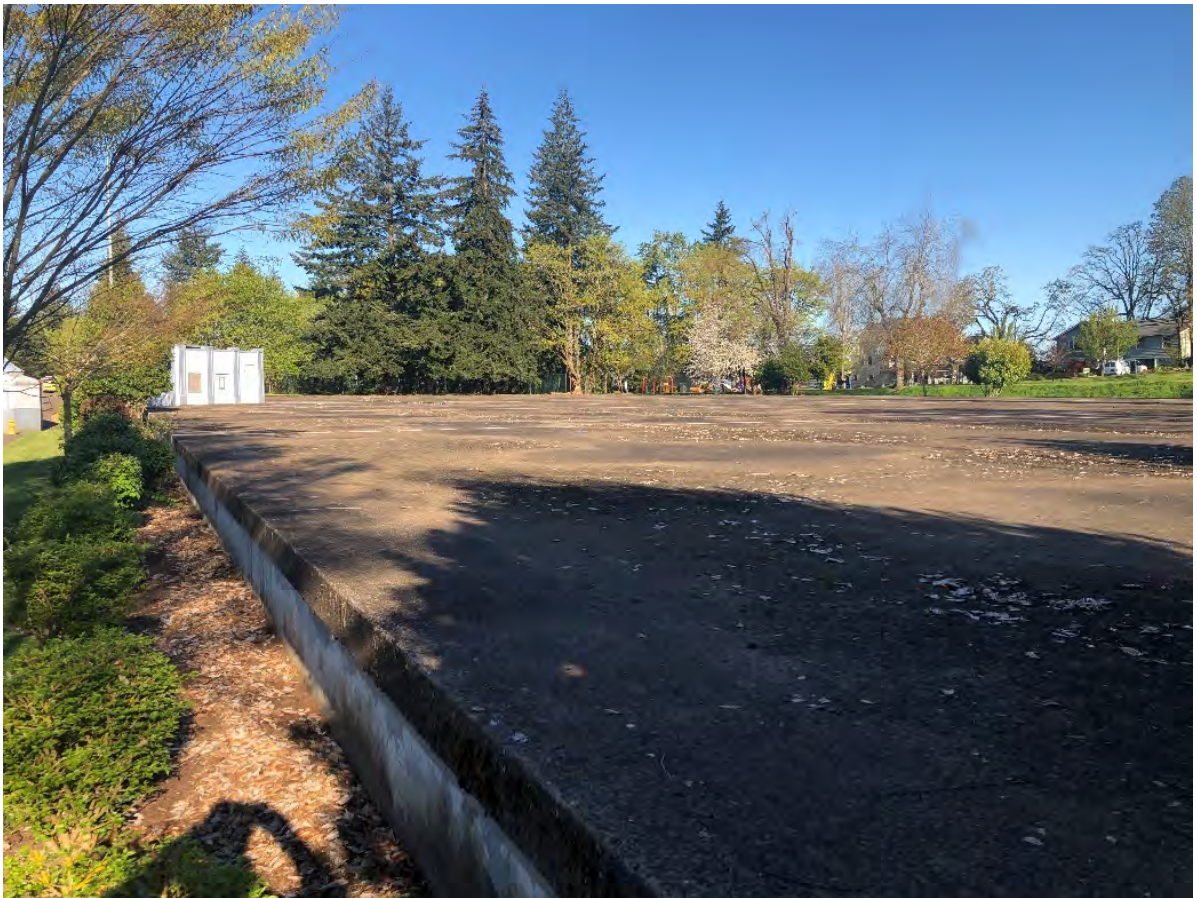
Exhibit 3-7: Photo of Fairmont Reservoir During Site Visit

With approximately 2 feet of the reservoir exposed above the ground surface, it could not be fully observed during our site visit. In the immediate vicinity around the reservoir, the ground is flat, and there are no signs of slope instability.

Subsurface information was not available for this reservoir. Based on the geologic mapping, the site is underlain by volcanic rock. Therefore, the regional seismic hazard mapping does not indicate permanent ground deformation from liquefaction induced settlement or seismic slope instability. The primary geologic hazard identified at this site for the Cascadia Subduction Zone event is strong ground motions.

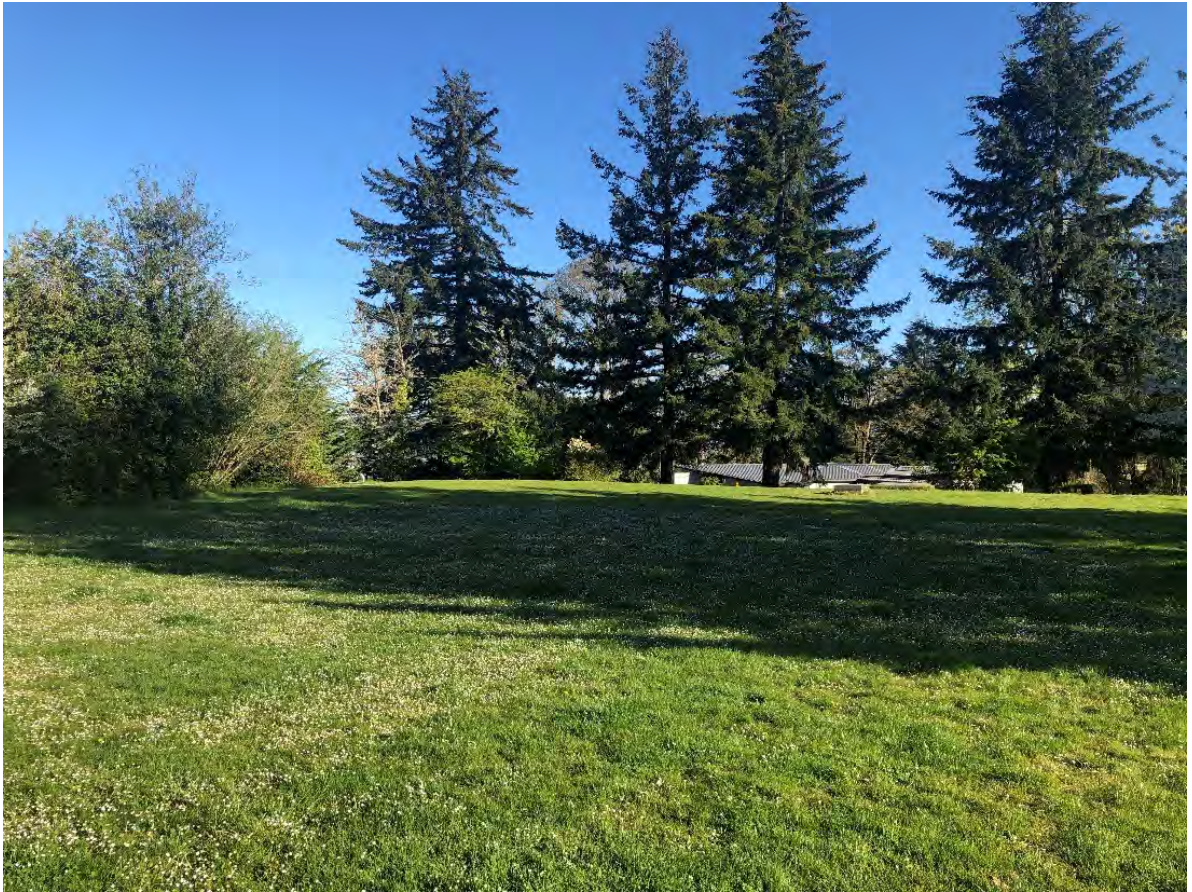
Exhibit 3-8: Photo of Candalaria Reservoir During Site Visit

The tank is buried and could not be observed during the site visit. However, we observed the slopes in the immediate vicinity around the reservoir and our reconnaissance did not reveal signs of on-site slope instability nor did we observe evidence of soil creep. Based on our site visit, existing subsurface information provided to us and assumed groundwater conditions from publicly available resources, we consider the potential for seismic related permanent ground deformation due to liquefaction or seismic slope instability at this site to be low, which is consistent with the regional seismic hazard mapping. The primary geologic hazard identified at this site for the Cascadia Subduction Zone event is strong ground motions (i.e., ground shaking).

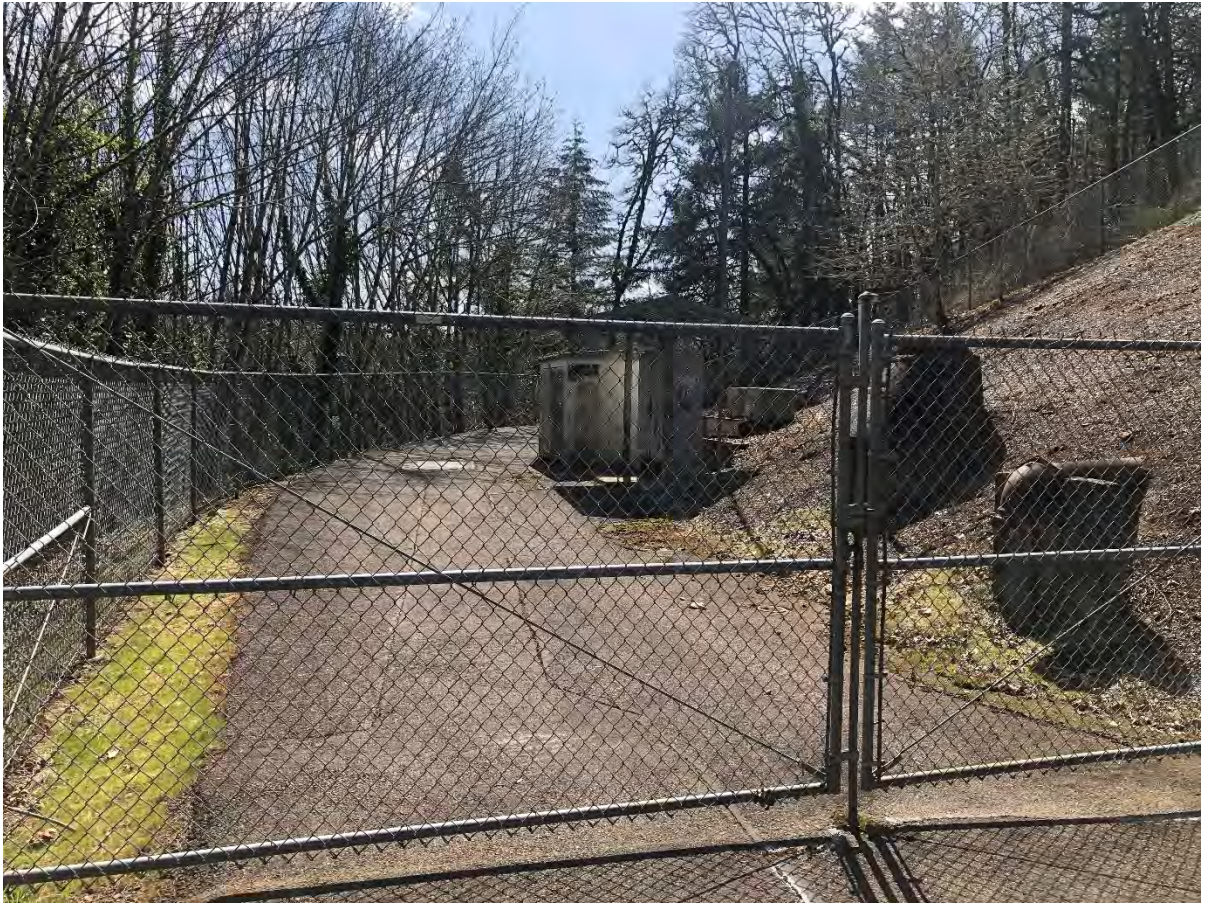
Exhibit 3-9: Photo of Croisan Lower Pump Station During Site Visit

Subsurface information was not available for this pump station. Based on the geologic mapping, the site is near the contact between volcanic rock and the mapped landslide. The values included in Table 1 are based on the pump station being located in landslide deposits.

If the City has existing as-built information or geotechnical borings at this pump station, we request that they be provided to the project team to better assess the seismic geohazards.

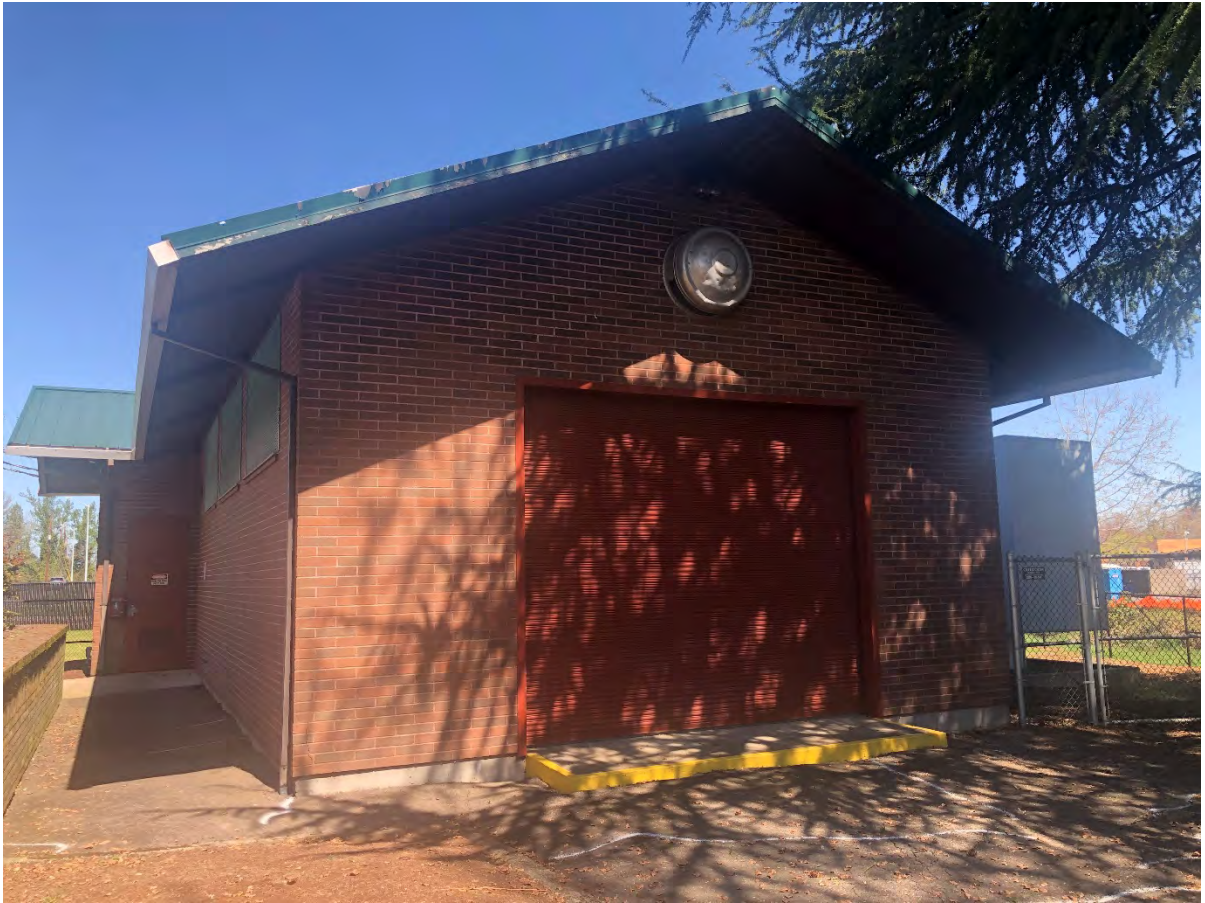
Exhibit 3-11: Photo of Edwards Pump Station During Site Visit

Because the predicted settlements in the HAZUS model are based on the assumption that the pump station is underlain by gravel which appears not to be correct based on the closest available well log, the hazard may not be adequately defined by the hazard mapping. The actual potential for liquefaction and movement to the nearby creek would be a function of the plasticity of the fine-grained material above the gravel. If the fine-grained material has consistent medium or high plasticity the liquefaction potential may be low. However, if layers of saturated, low plasticity silt or loose sand are also present, a liquefaction hazard may be present. Additionally, portions of the subgrade in the pavement next to the building appear to be negatively affected by past uncontrolled water releases at the pump station. If the areas of disturbed soil or voids extend below the building foundations, then portions of the foundations may have significantly less subgrade support than at locations where undisturbed native soil is present during both seismic and static conditions. Due to uncertainties associated with the liquefaction potential and subgrade we consider the potential for permanent ground deformation to be moderate to high during a seismic event.

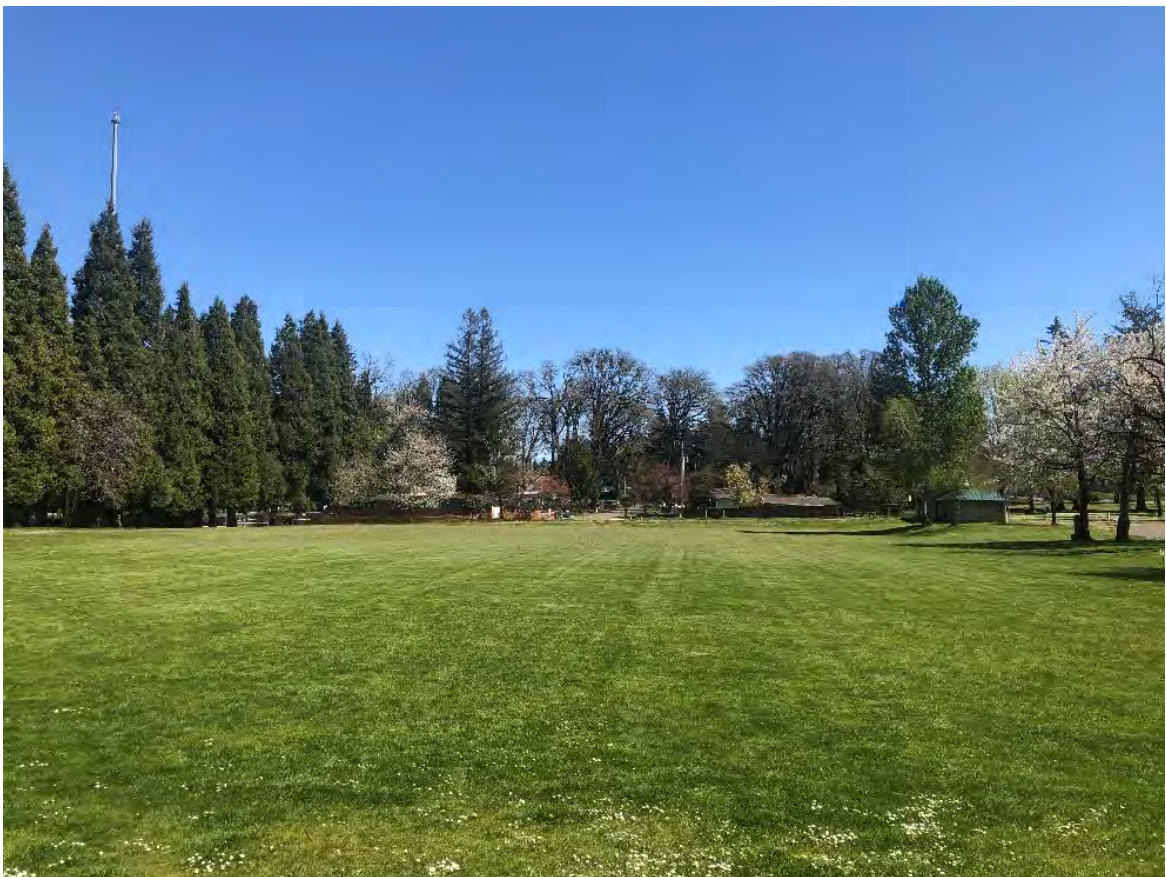
Exhibit 3-13: Photo of Woodmansee Park During Site Visit

underground aquifer so that it can be used during times of the year where usage is higher. The ASR system is currently under construction, undergoing improvements and expansions to the system. As it currently stands, the ASR capacity is 8.71 million gallons per day. Because the ASR wells are located on relatively flat ground, there were no observed geologic hazards during our site reconnaissance.

Existing subsurface information was not available for this pump station. Based on the geologic mapping, the site is underlain by volcanic rock. Therefore, the regional seismic hazard mapping does not indicate permanent ground deformations from liquefaction induced settlement or seismic slope instability.

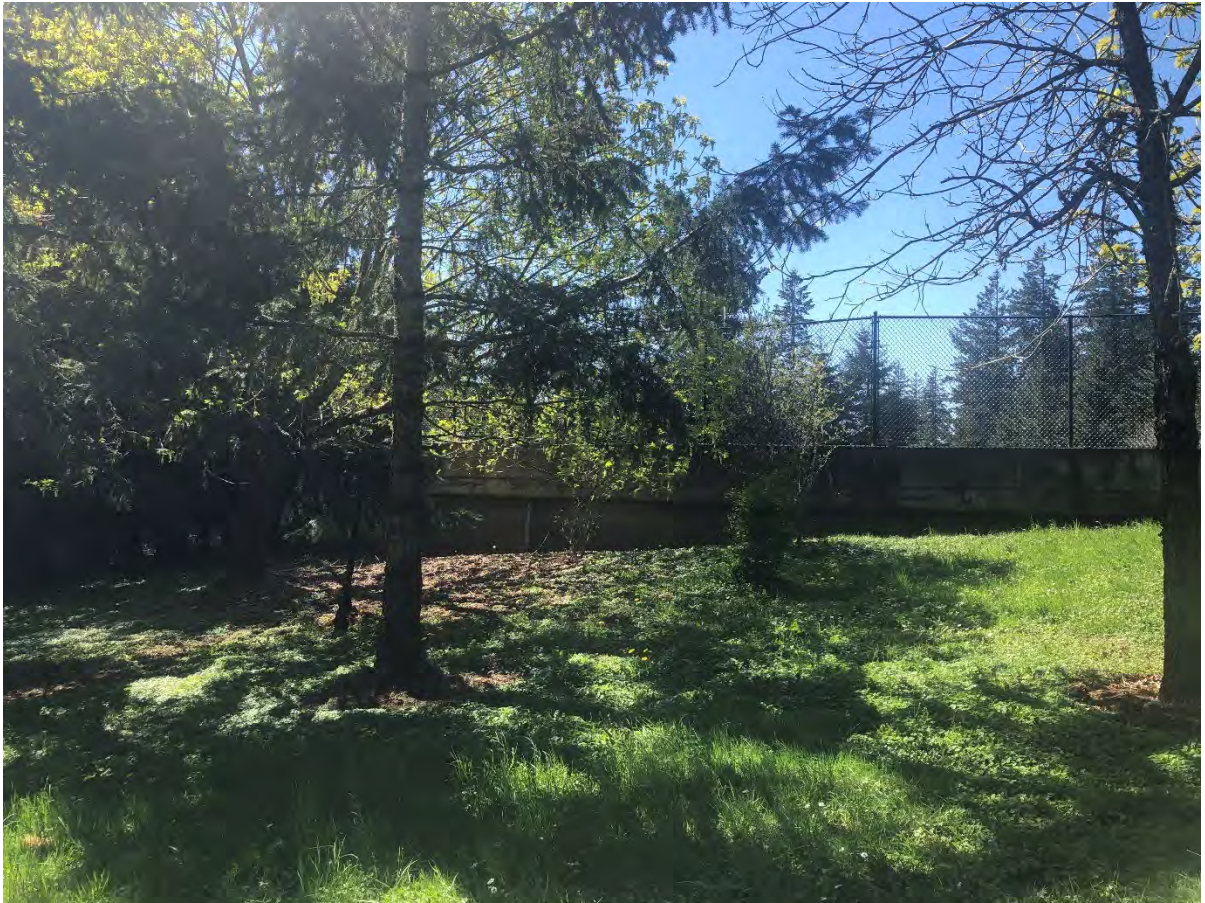
Exhibit 3-14: Photo of Lone Oak Reservoir During Site Visit

If subsurface conditions underlying the reservoir are similar to what was encountered in the nearby explorations, then we consider the potential for liquefaction and associated hazards to be low, which is consistent with the regional seismic mapping.

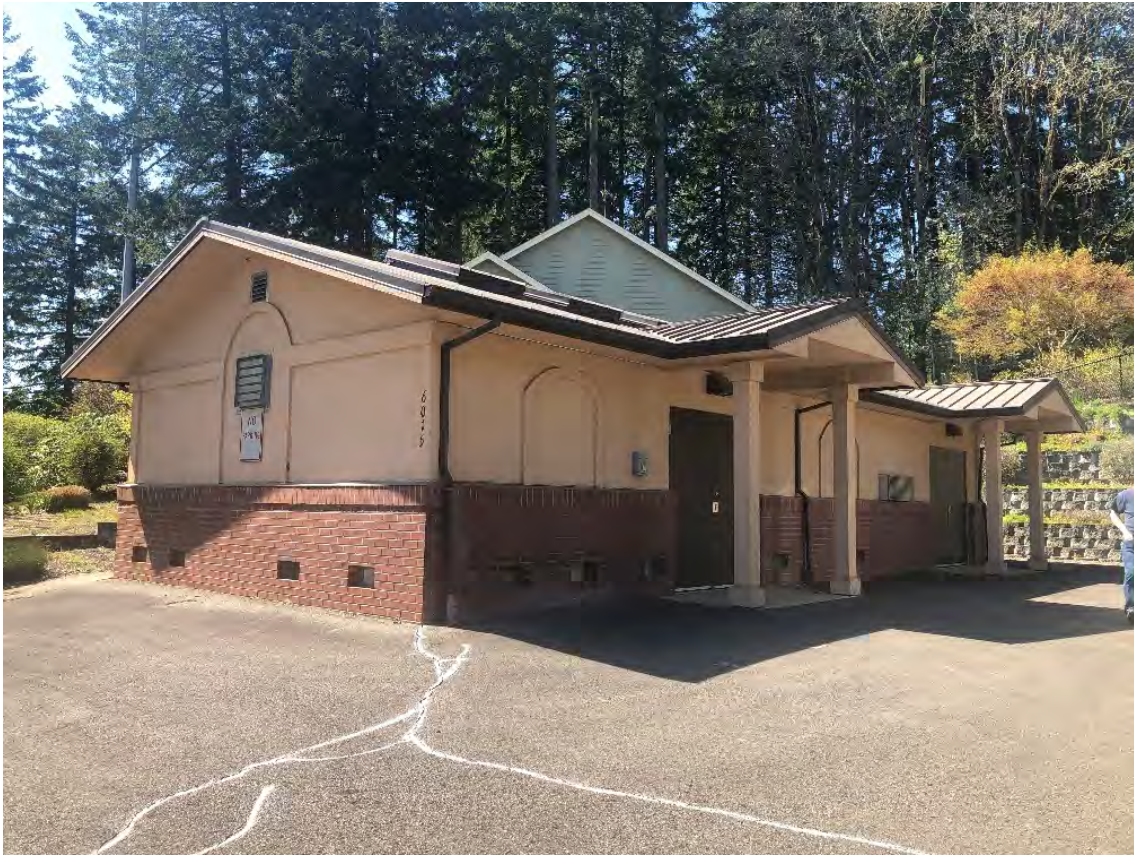
Exhibit 3-15: Photo of Creekside Pump Station During Site Visit

Creekside Pump Station is located just south of Lone Oak Reservoir. The pump station, constructed in 1998, contains three pumps and has a capacity of approximately 6 million gallons per day. The pump station sits on relatively flat ground at the bottom of a hill. During site reconnaissance, no signs of slope instability were observed.

Existing subsurface information was not available for this pump station. Based on the geologic mapping, the site is underlain by volcanic rock. Therefore, the regional seismic hazard mapping does not indicate permanent ground deformations from liquefaction induced settlement or seismic slope instability.

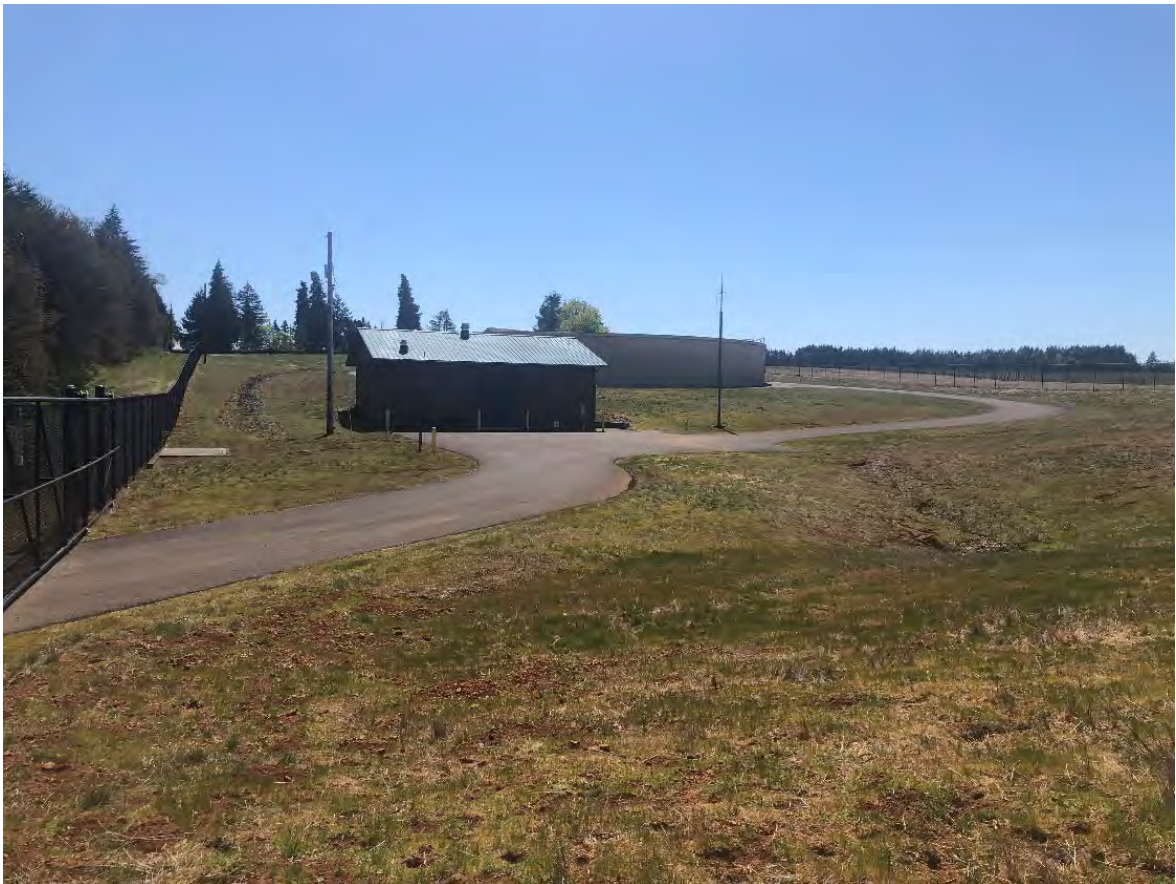
Exhibit 3-16: Photo of Champion Hill Reservoir During Site Visit

Champion Hill Reservoir is a 2.3-million-gallon reinforced concrete reservoir. The reservoir is located just south of the Salem city limits and is surrounded by vineyards. In the area around the tank, the ground is gently-sloping to the south. However, no signs of slope instability or soil creep were observed during our site reconnaissance.

Existing subsurface information was not available for this reservoir. Based on the geologic mapping, the site is underlain by volcanic rock. Therefore, the regional seismic hazard mapping does not indicate seismic related hazards as an issue for this site.

If the reservoir is potentially founded on silty soil overlying rock and perched water was present, then the silt may be susceptible to liquefaction depending on its plasticity. However, if the static groundwater is similar to the nearby water wells, then the potential for liquefaction and associated seismic hazards is considered to be low, which is consistent with the regional seismic mapping. If the City has existing as-built information or geotechnical borings at this reservoir, we request that they be provided to the project team to better assess the seismic geohazards.

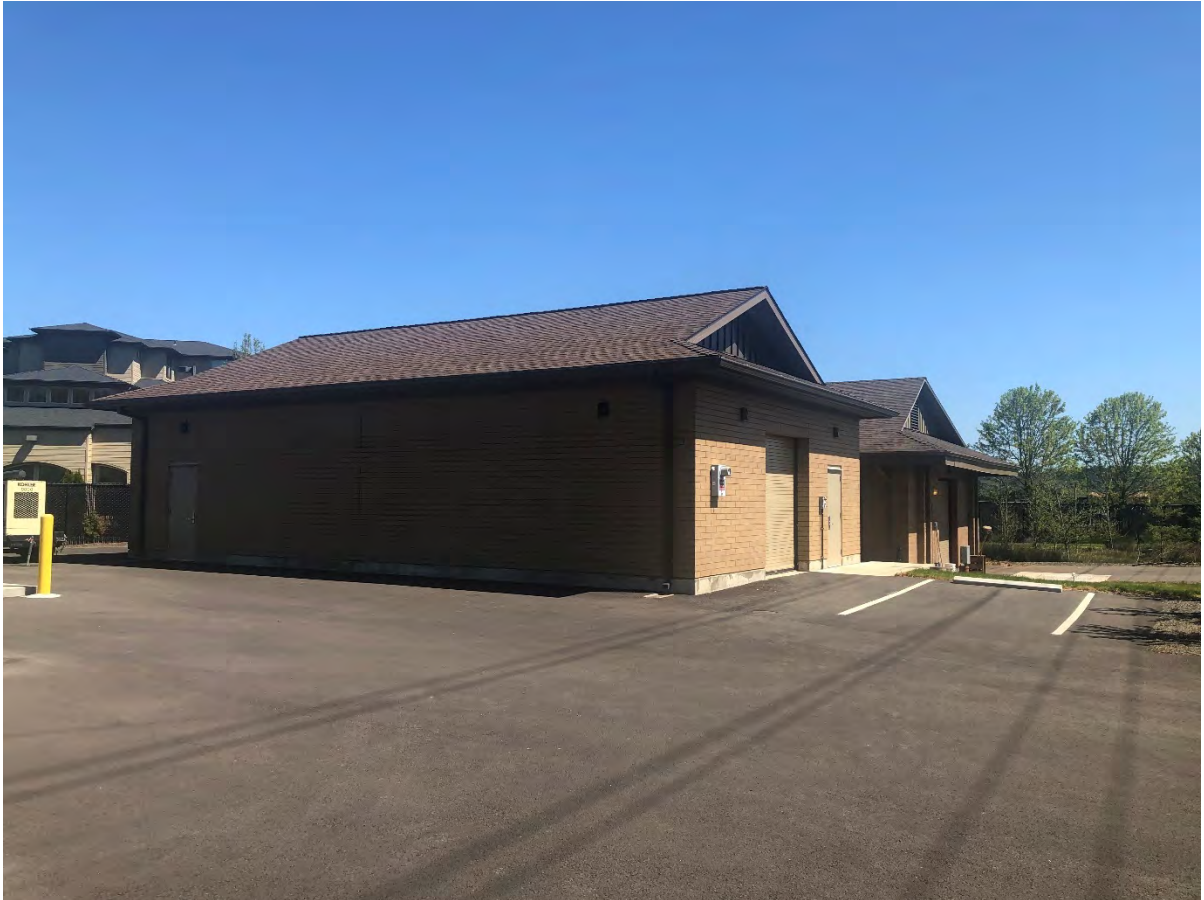
Exhibit 3-17: Photo of Boone Road Pump Station During Site Visit

day are inside two structures on site. The pump station sits on flat ground and there were no observed slope or geologic hazards observed during our site reconnaissance.

Existing subsurface information was not available for this pump station. Based on the geologic mapping, the site is underlain by terrace deposits. However, the mapped terrace deposits in this area are mapped as coarse-grained deposits with a very low liquefaction hazard.

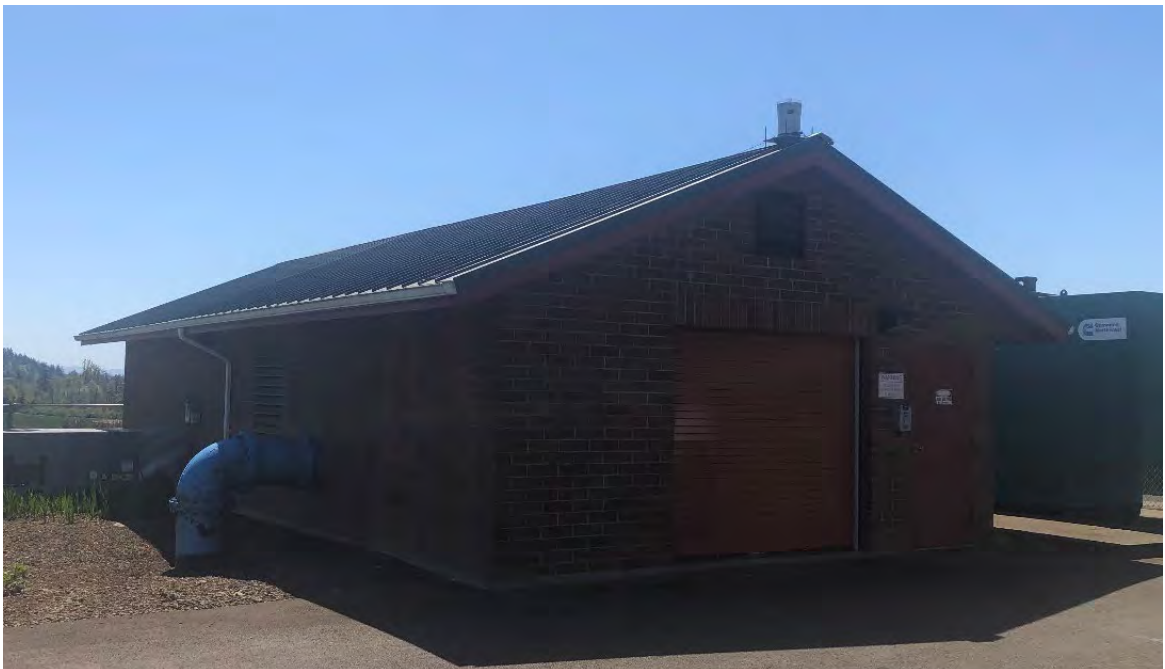
Exhibit 3-18: Photo of Deer Park Pump Station During Site Visit

Deer Park Pump Station sits on an 8-inch-thick reinforced concrete slab foundation. The pump station, which was built in 1982, houses three pumps with a total capacity of approximately 5 million gallons per day. The pump station is on relatively flat ground and no geologic hazards were observed during our site reconnaissance.

If subsurface conditions underlying the pump station are similar to what was encountered in the nearby exploration, then we consider the potential for liquefaction and associated hazards to be low, which is consistent with the regional seismic mapping.

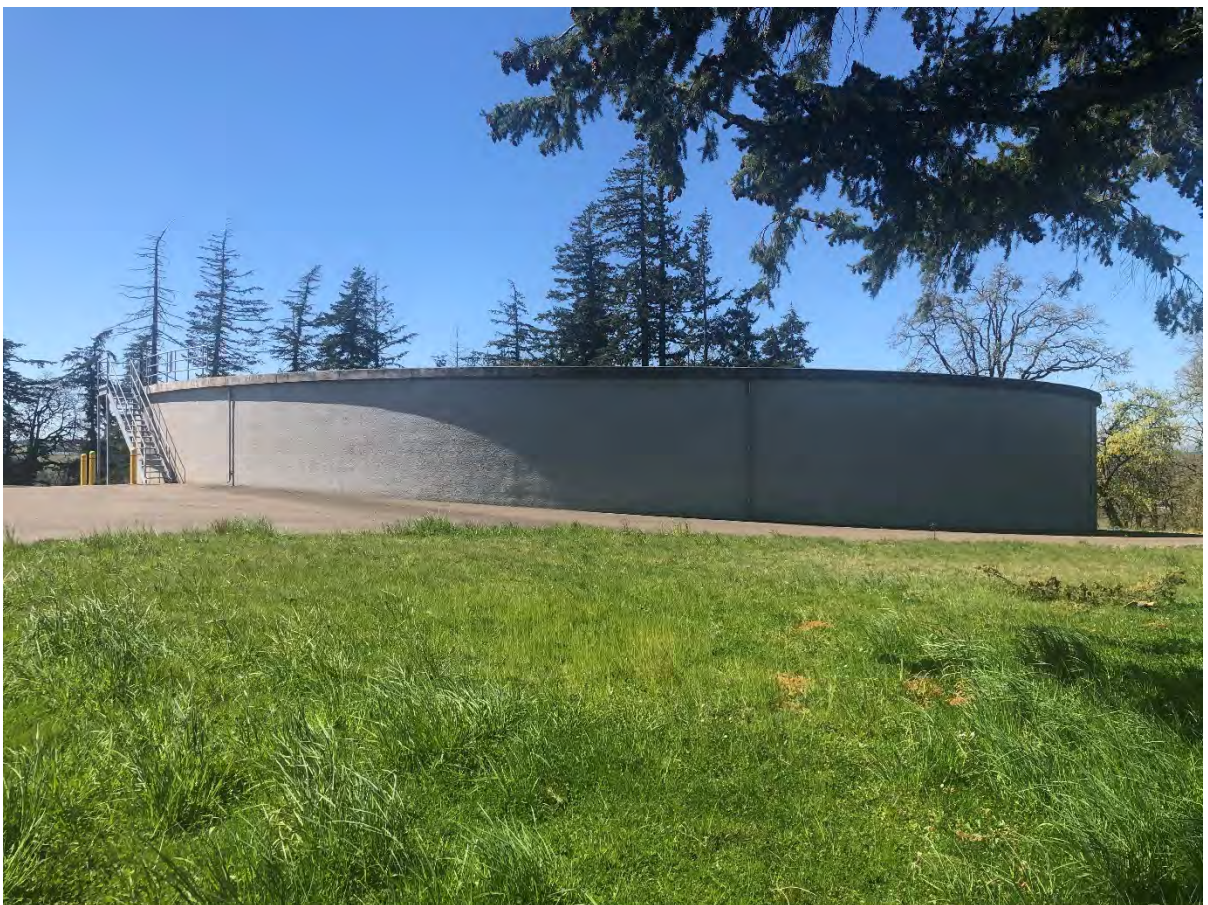
Exhibit 3-19: Photo of Mill Creek Reservoir During Site Visit

If subsurface conditions underlying the reservoir are similar to what was encountered in the nearby explorations, the potential for permanent ground deformation from liquefaction and seismic slope instability is low, which is consistent with the regional seismic mapping. The primary hazard at the site is strong ground motions.

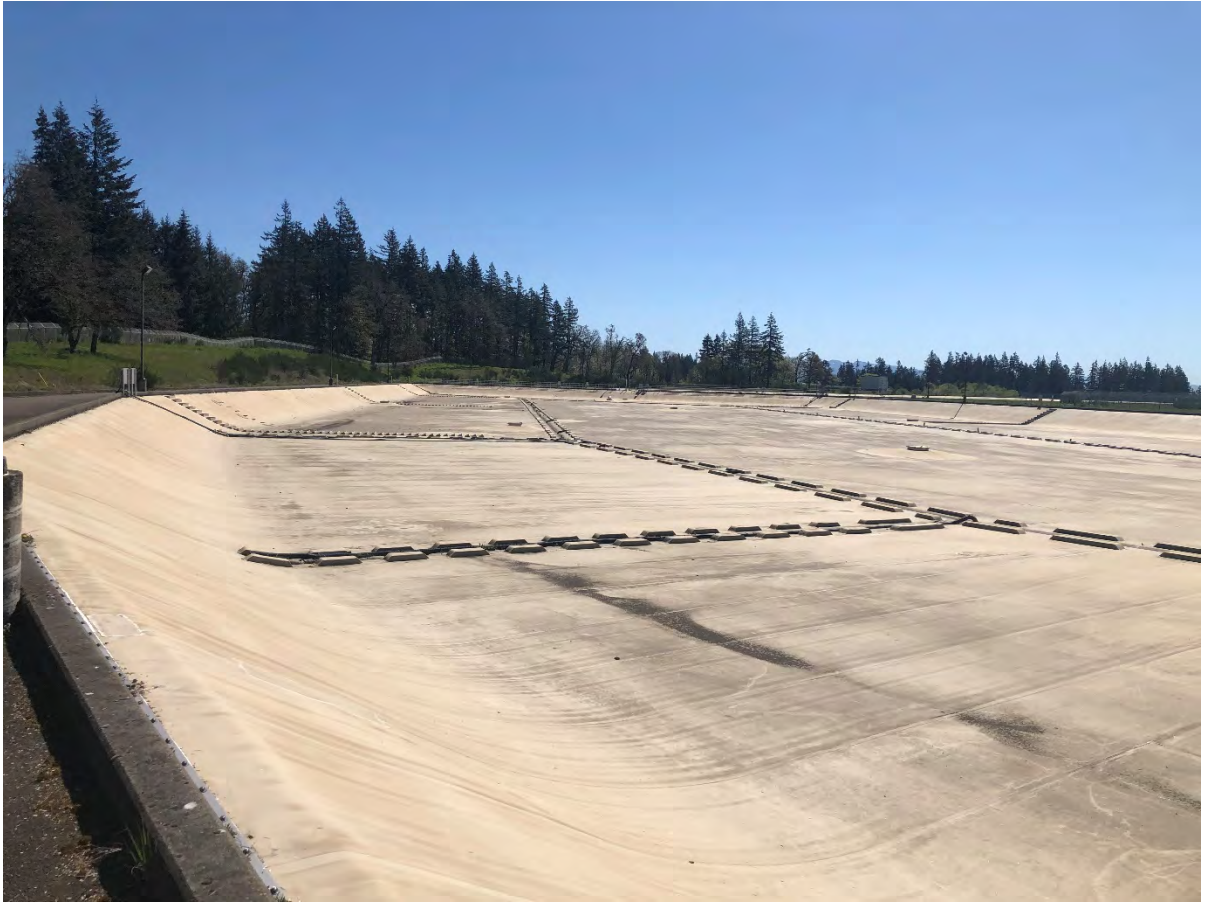
Exhibit 3-20: Photo of Franzen Reservoir During Site Visit

According to a 2008 memorandum prepared by the City of Salem, two slump failures occurred within the cut slope of the west cell of the reservoir. Each failure was approximately halfway down the slope from the top of the reservoir. Each slumped area is about 10 feet x 10 feet in size. Based on information contained within the memorandum, the failures were discovered when the plastic liner was removed for routine maintenance. No definitive cause of failure was stated in memorandum; however, the memo indicates that the original geotechnical engineer for the 2004 upgrades of the reservoirs (Barry Meyers) visited the site and that based on the type of failure groundwater was not anticipated to be the cause. The memo also indicates that a similar failure occurred at or near the site during the first year of the reservoir's operation. We understand that the failures were repaired. During our site visit the reservoir was covered, and we did not observe evidence slope instability; however, the reservoir cut walls were covered with a plastic liner. No information was available on how the cells were repaired at the time of this report.

Based on our site visit and existing subsurface information provided to us, the potential for liquefaction induced settlement of the native soils beneath the reservoir is low, which is consistent with the regional seismic mapping. However, because the failures on the embankment wall have occurred during static conditions (i.e. no-ground motion) it is our opinion the potential for permanent ground deformation from seismic slope instability is not adequately captured in the HAZUS model. Additional slope modeling outside of the of the current scope of the seismic geohazard evaluation would be required to better quantify the hazard, but it is our qualitative assessment based on the historic slumping the potential

for seismic slope instability of the embankment may be moderate to high.
