SEISMIC RESILIENCY ANALYSIS REPORT

B&V PROJECT NO. 406828

City of Salem

AUGUST 2023

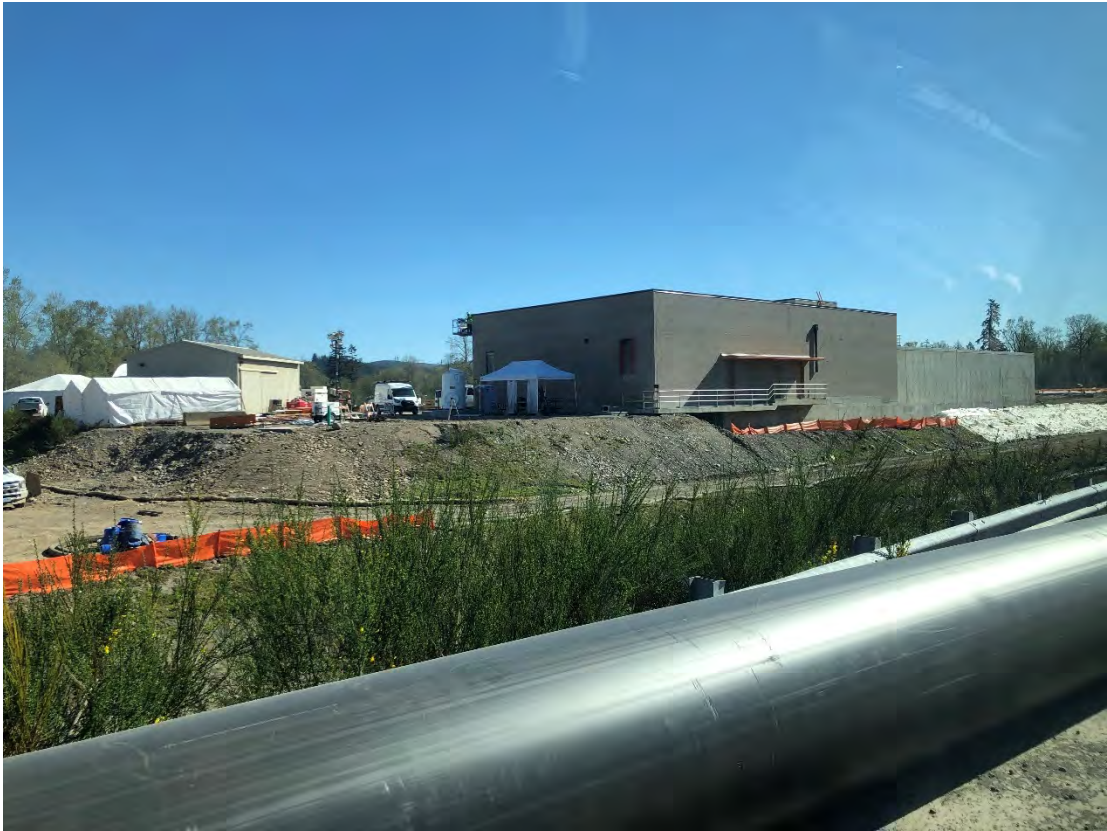
Exhibit 3-22: Photo Showing Area Near New Ozone Facility

Based on the geologic map, the site is underlain by alluvial soils. Therefore, the regional seismic geohazard mapping indicates high liquefaction and other associated hazards (i.e. lateral spreading) are present at this site.

Liquefaction potential analysis of the available boring logs did not identify a liquefaction hazard for the Cascadia Subduction Zone ground motions considered in this study. Therefore, the seismic geohazard mapping overestimates the liquefaction induced settlement on those portions of the island where borings are available. However, in areas where there are no borings to indicate a low liquefaction hazard, we recommend that the liquefaction geohazard information indicated on the seismic geohazard maps be assumed.

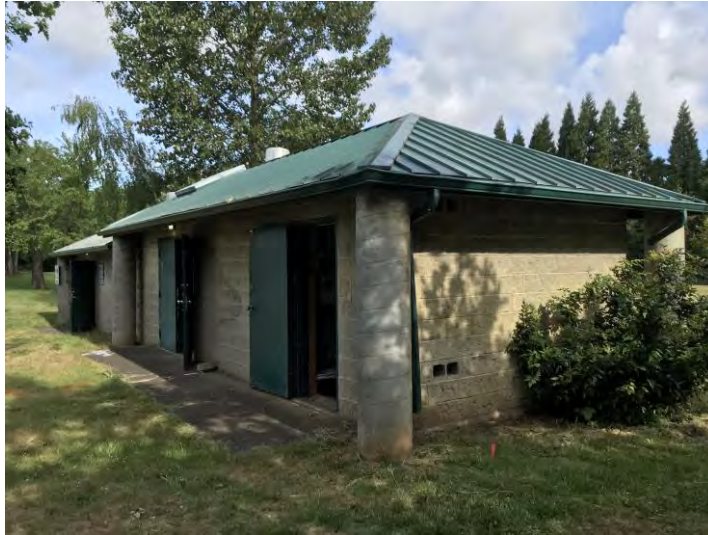
Figure 3.1 ASR #1 and #2 Pump Station

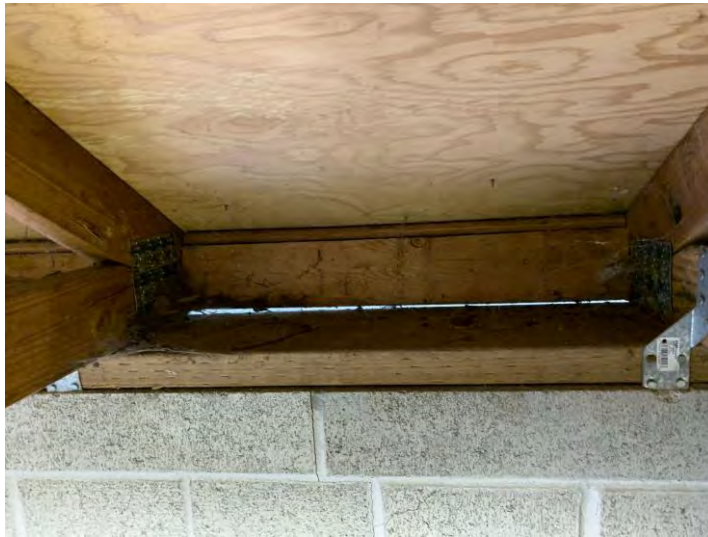
Figure 3.2 Inadequate Connection between Blocking and Masonry Wall Top Plate

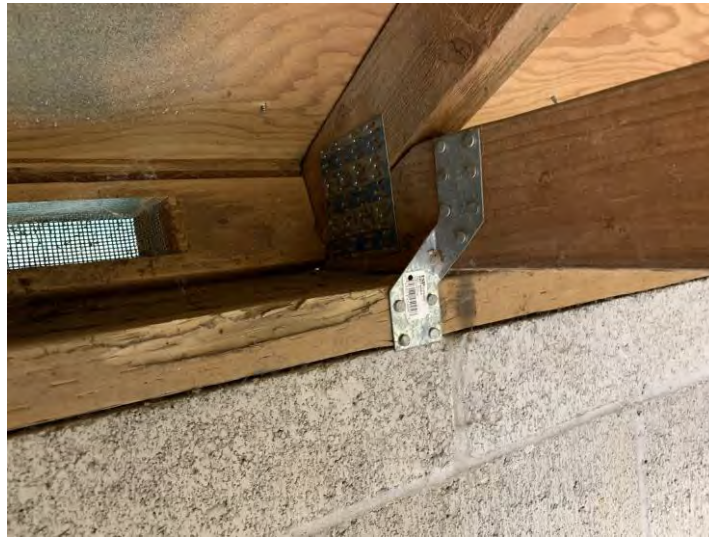
Figure 3.3 Roof Truss to Masonry Wall Top Plate Connection

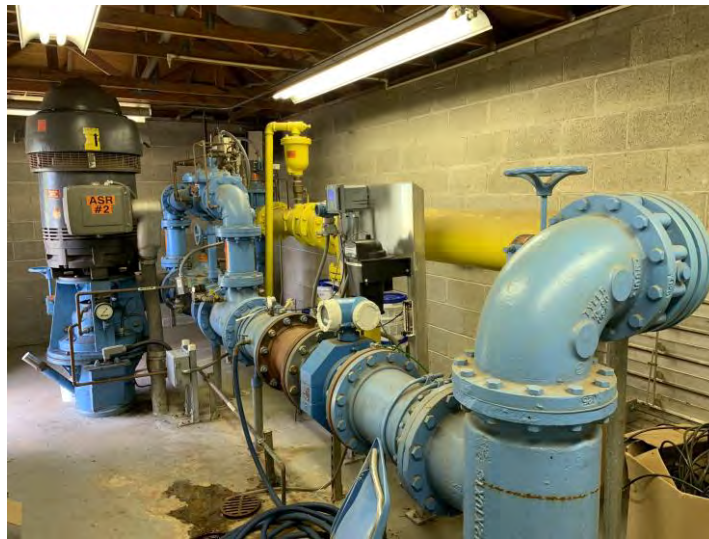
| Potential Deficiencies | Description |
|---|---|
| Nonstructural | <ul style="list-style-type: none"> • Water system piping within the pump station is not braced (see Figure 3.4) • Valves in line with the water system piping are not braced (see Figure 3.4). • The air relief valve is not braced and is only supported by rigid small diameter piping (see Figure 3.4). • Vertical pump motors are not braced above the center of gravity of the motor (see Figure 3.5). • There does not appear to be adequate flexibility in the piping that is attached to the pumps to accommodate potential relative movement between the piping and the pump, and to prevent the piping from adding additional load to the pump anchorage. • Electrical cabinets do not appear to be anchored or braced to the wall near the top of the cabinets to prevent them from tipping over during an earthquake. • Light fixtures in the pump station do not include lens covers (see Figure 3.6). • Electrical conduits, hung from the roof and connected to the top of wall-mounted electrical panels, may not have adequate flexibility to account for differential movement between the floor and the pump station roof (see Figure 3.7). • The horizontal arm of the SCADA antenna may not be adequately connected to the supporting pole to prevent the antenna from being misaligned or damaged after an earthquake (see Figure 3.8). • A 4-inch split-face CMU veneer was added to the original ASR #1 structure as part of construction of the ASR #2 addition. Original design drawings do not indicate the use of veneer ties and it was not clear if veneer ties were installed based on field observations of the gap between the original 8-inch CMU walls and 4-inch CMU veneer (see Figure 3.9). • The six architectural concrete pillars around the perimeter of the pump station may not have adequate capacity to resist seismic forces (see Figure 3.10). The number of vertical reinforcing bars is unclear in the original design drawings and no tie reinforcing is indicated. • No anchorage was observed between the electrical transformer and concrete support pad (see Figure 3.11). |

Figure 3.4 Unbraced Piping, Valves, and Air Relief Valve

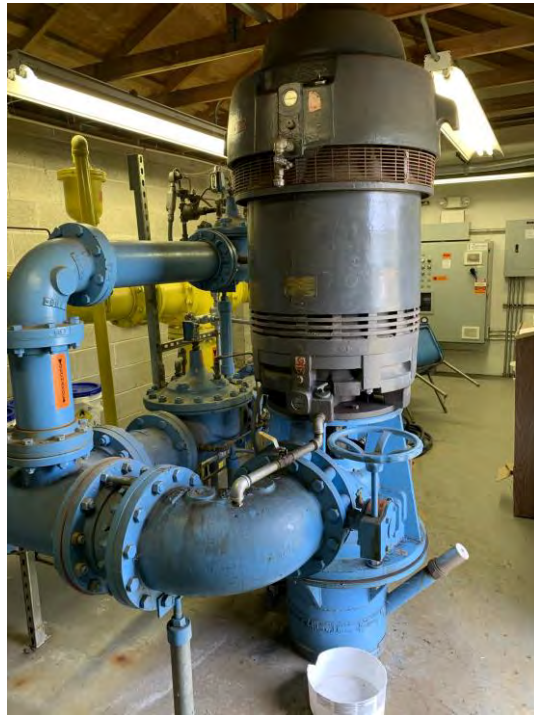
Figure 3.5 Unbraced Pump Motor

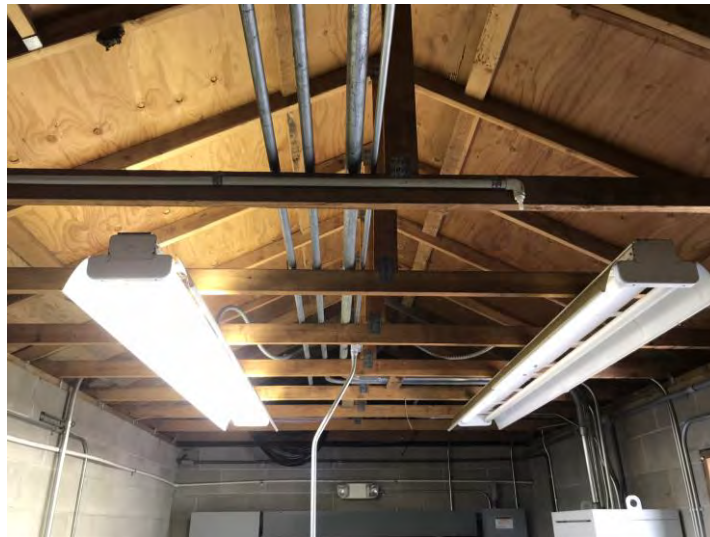
Figure 3.6 Light Fixtures without Lens Covers

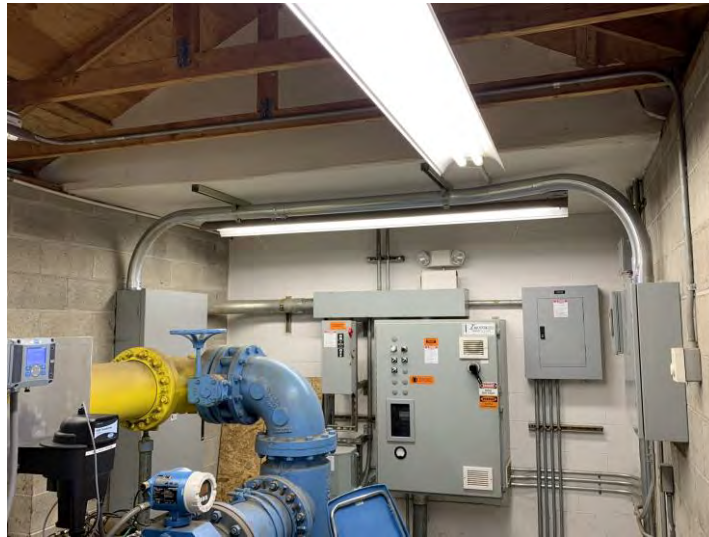
Figure 3.7 Conduit Top Connection to Electrical Panels without Flexible Connection

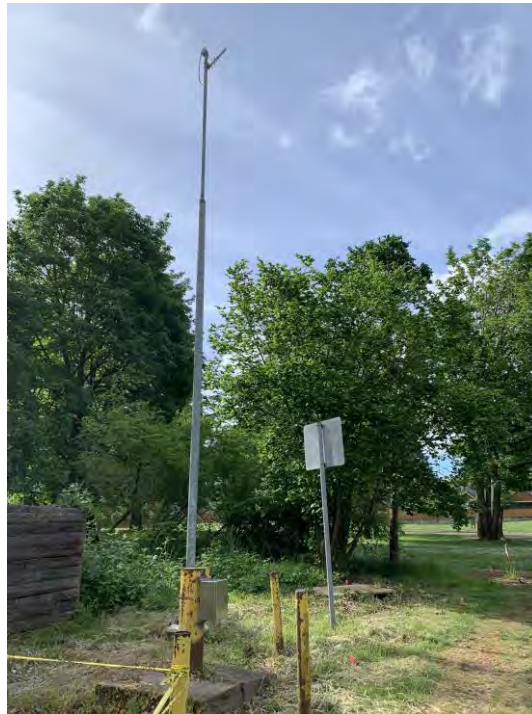
Figure 3.8 SCADA Antenna

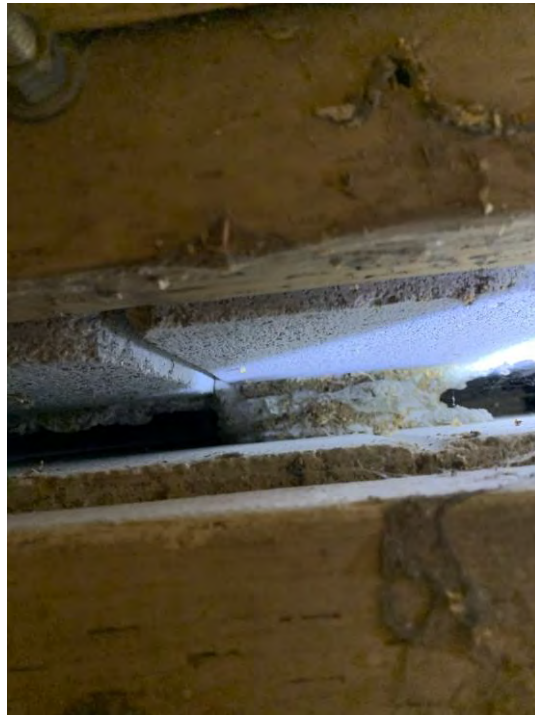
Figure 3.9 Unknown Masonry Veneer Ties to Backup Masonry Wall

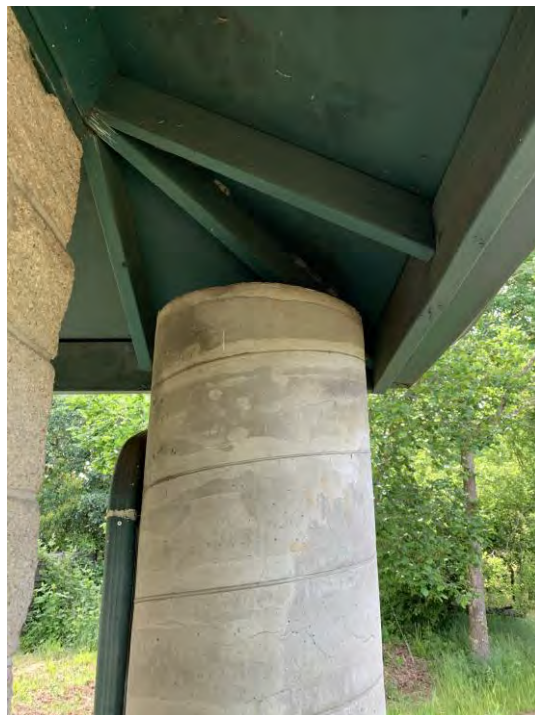
Figure 3.10 Architectural Concrete Pillar

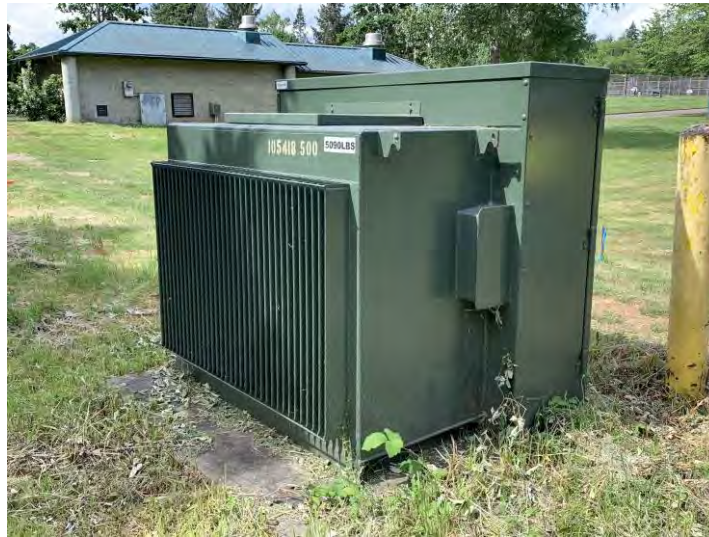
Figure 3.11 Unanchored Electrical Transformer

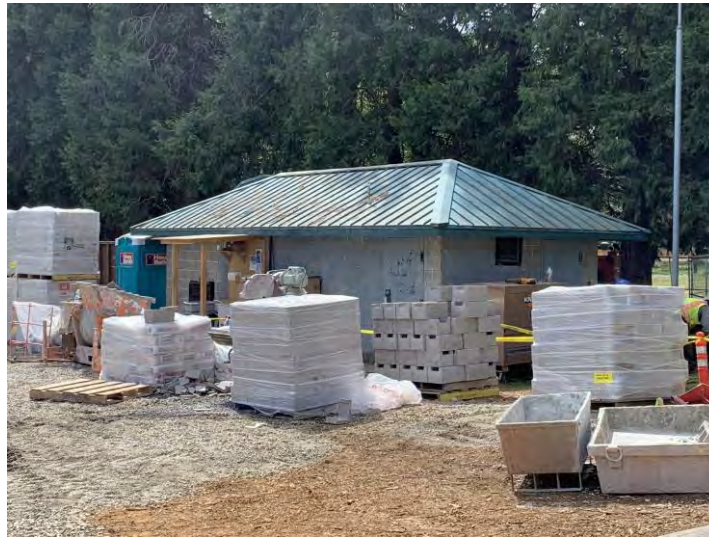
Figure 3.12 ASR #4 Pump Station

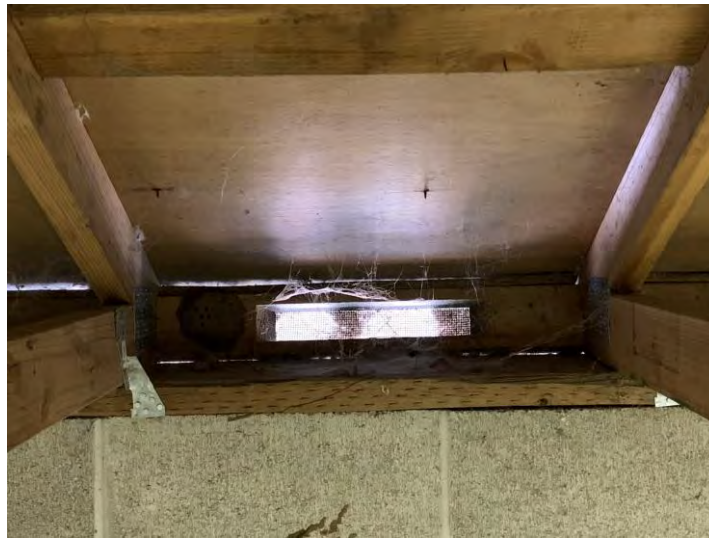
| Potential Deficiencies | Description |
|---|--|
| Structural | <ul style="list-style-type: none"> • The roof plywood sheathing nailing schedule was not provided in the available original design drawings. • A positive connection does not appear to be provided between the sloped truss blocking and masonry wall top plate. Therefore, the load path is incomplete to transfer in-plane shear forces from the roof diaphragm to the masonry walls (see Figure 3.13). • The roof access hatch (for pump motor replacement) immediately adjacent to the east masonry wall creates a large opening in the diaphragm near a shear wall. This opening reduces the capacity of the diaphragm to transfer seismic forces to the shear wall below. • Out-of-plane bracing for the perimeter and interior masonry walls is not adequate. The roof trusses are attached to the top plate of the perimeter masonry walls with hurricane ties, which are intended to provide capacity to primarily resist uplift, not to resist wall out-of-plane demands (see Figure 3.14). Additionally, blocking in approximately every third bay has a long vent slot that limits its capacity to transfer seismic forces from the roof diaphragm to the masonry wall. • Adequate cross ties between diaphragm chords are not provided in both directions. • No trim reinforcing is indicated at the sides of door and other openings in the original design drawings. |

Figure 3.13 Inadequate Connection between Blocking and Masonry Wall Top Plate

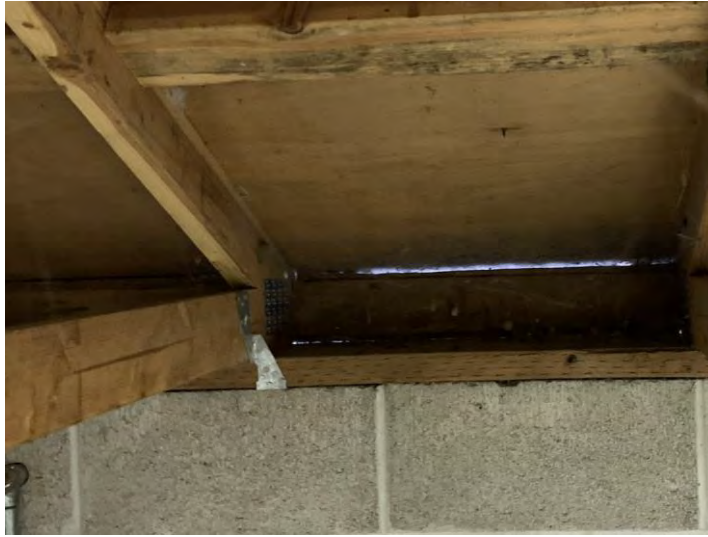
Figure 3.14 Roof Truss to Masonry Wall Top Plate Connection

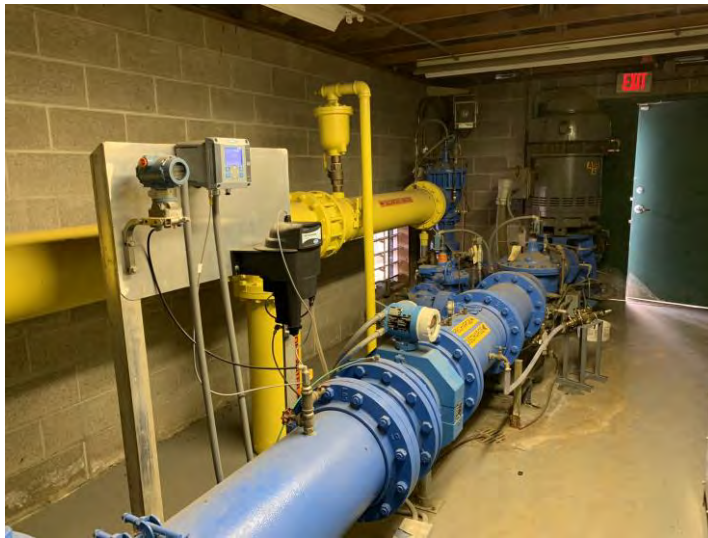
| Potential Deficiencies | Description |
|---|--|
| Nonstructural | <ul style="list-style-type: none"> • Water system piping within the pump station is not braced (see Figure 3.15). • Valves in line with the water system piping are not braced (see Figure 3.15). • The air relief valve is not braced and is only supported by rigid small diameter piping (see Figure 3.15). • The vertical pump motor is not braced above the center of gravity of the motor (see Figure 3.16). • There does not appear to be adequate flexibility in the piping that is attached to the pump to accommodate potential relative movement between the piping and the pump, and to prevent the piping from adding additional load to the pump anchorage. • The pump station control cabinet does not appear to be anchored to the floor or wall (see Figure 3.17). • Light fixtures in the pump station do not include lens covers (see Figure 3.18). • No anchorage was observed between the electrical transformer and concrete support pad (see Figure 3.19). |

Figure 3.15 Unbraced Piping, Valves, and Air Relief Valve

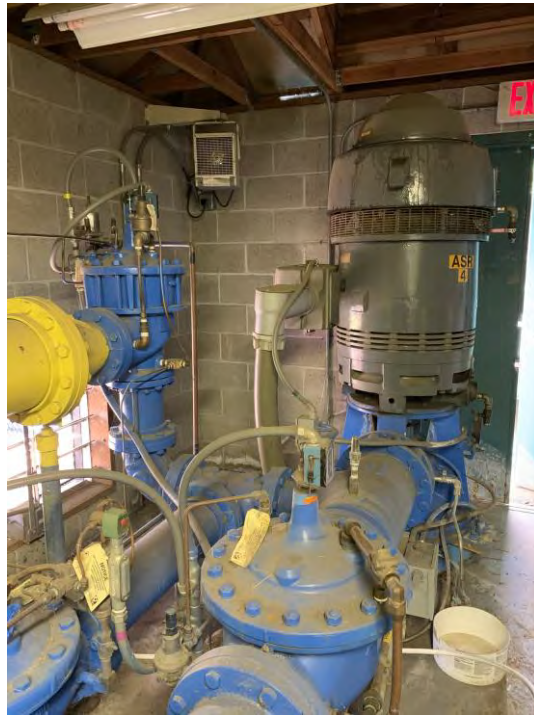
Figure 3.16 Unbraced Pump Motor

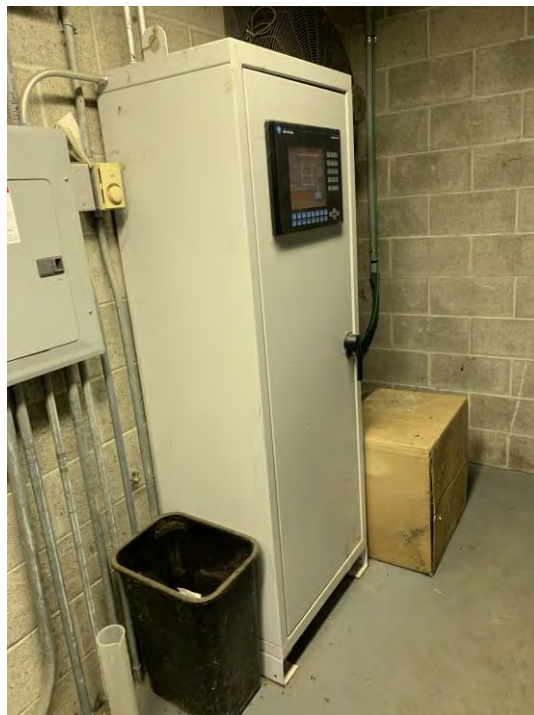
Figure 3.17 Unanchored Control Cabinet

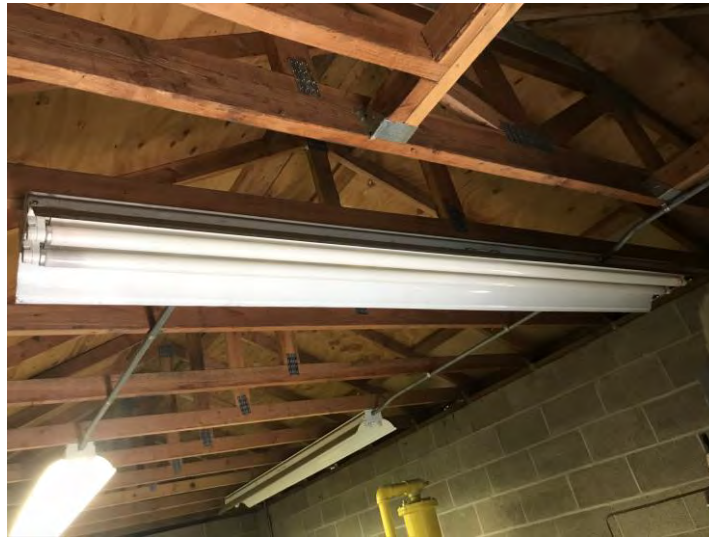
Figure 3.18 Light Fixtures without Lens Covers

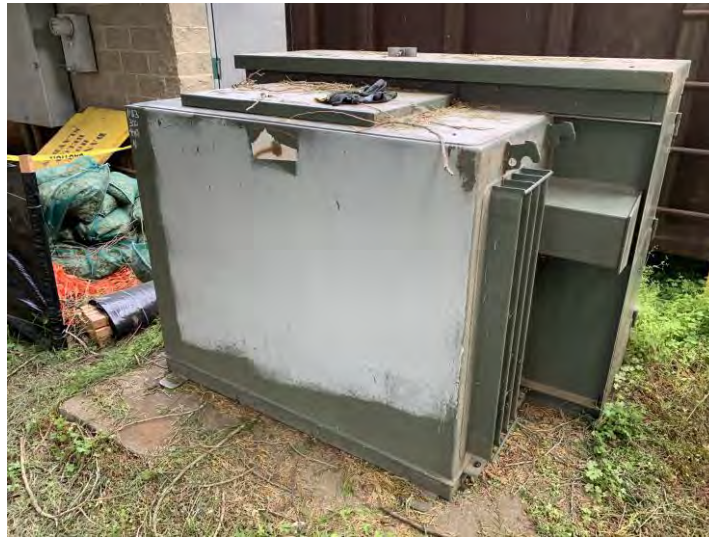
Figure 3.19 Unanchored Electrical Transformer

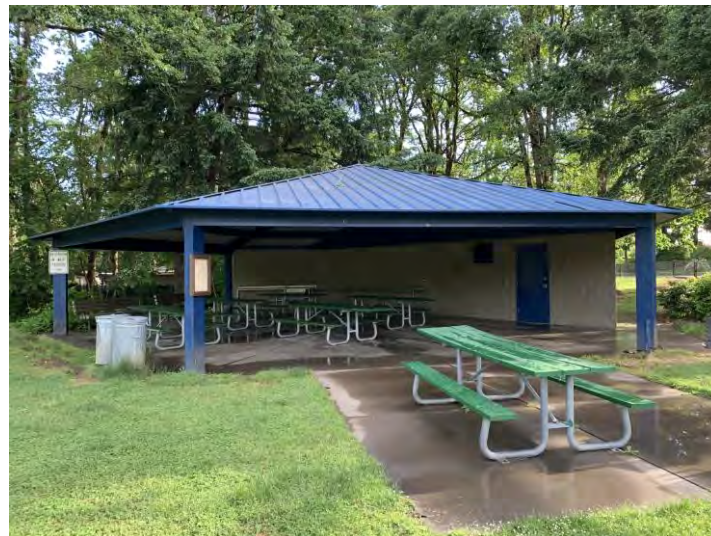
Figure 3.20 ASR #5 Pump Station

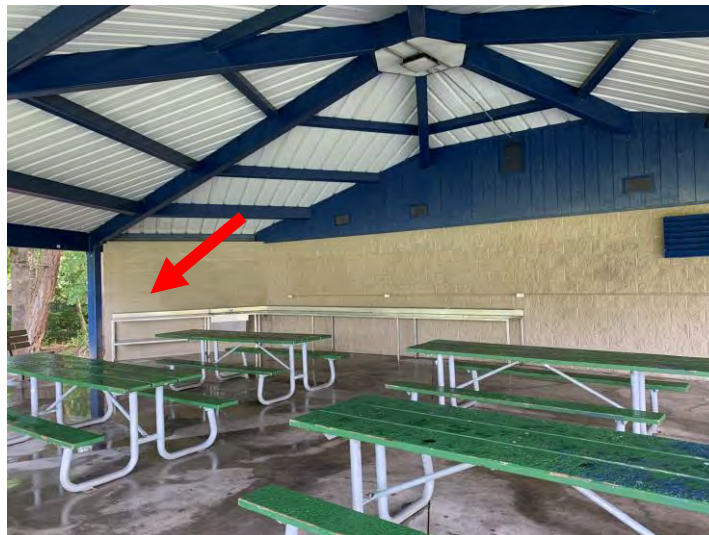
Figure 3.22 Free-Standing Masonry Wall without Bracing

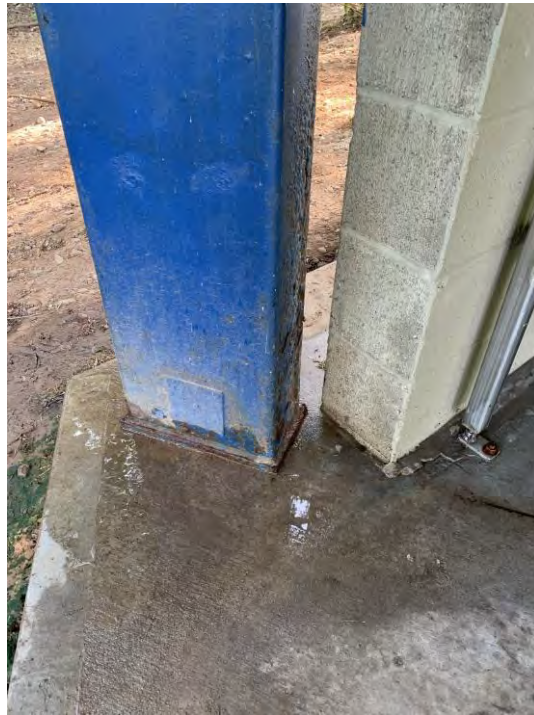
Figure 3.23 Corrosion Damage at Northern-Most Pavilion Steel Column

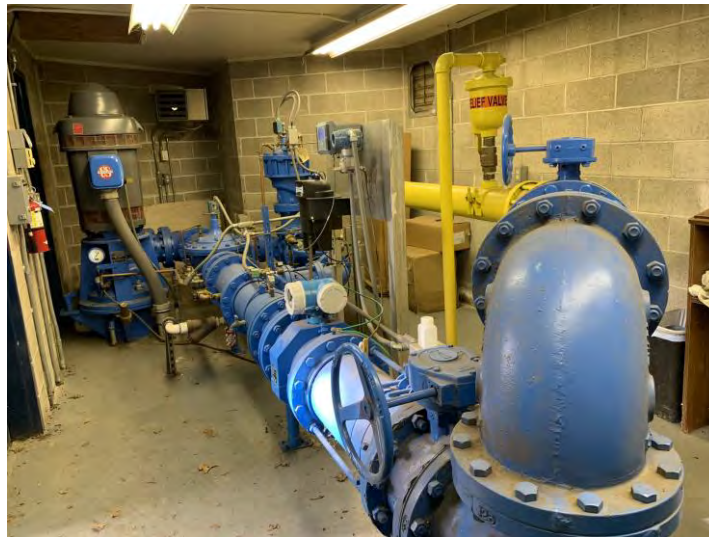
| Potential Deficiencies | Description |
|---|--|
| Nonstructural | <ul style="list-style-type: none"> • Water system piping within the pump station is not braced (see Figure 3.24) • Valves in line with the water system piping are not braced (see Figure 3.24). • The air relief valve is not braced and is only supported by rigid small diameter piping (see Figure 3.25). • The vertical pump motor is not braced above the center of gravity of the motor (see Figure 3.26). • There does not appear to be adequate flexibility in the piping that is attached to the pump to accommodate potential relative movement between the piping and the pump, and to prevent the piping from adding additional load to the pump anchorage. • Electrical conduits, hung from the roof and connected to the top of floor- and wall-mounted electrical panels and cabinets, may not have adequate flexibility to account for differential movement between the floor and the pump station roof (see Figure 3.27). • The pump station controls cabinet does not appear to be anchored to the floor or wall (see Figure 3.28). • Light fixtures in the pump station do not include lens covers (see Figure 3.29). • No anchorage was observed between the electrical transformer and concrete support pad (see Figure 3.30). |

Figure 3.24 Unbraced Piping, Valves, and Air Relief Valve

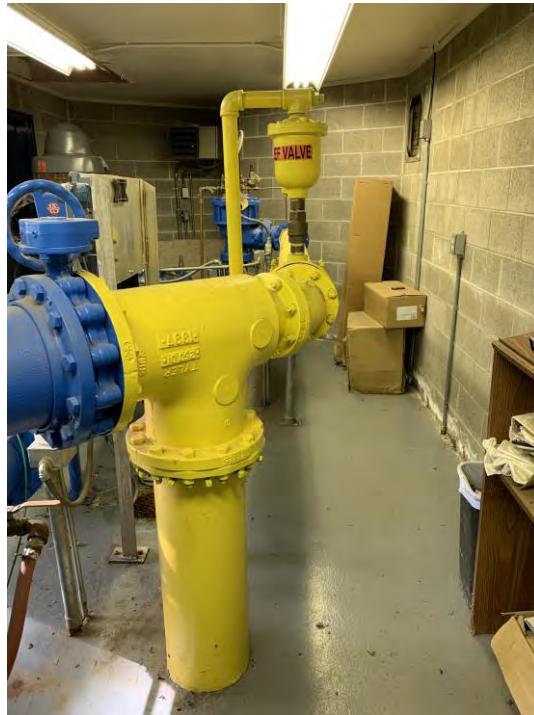
Figure 3.25 Unbraced Air Relief Valve

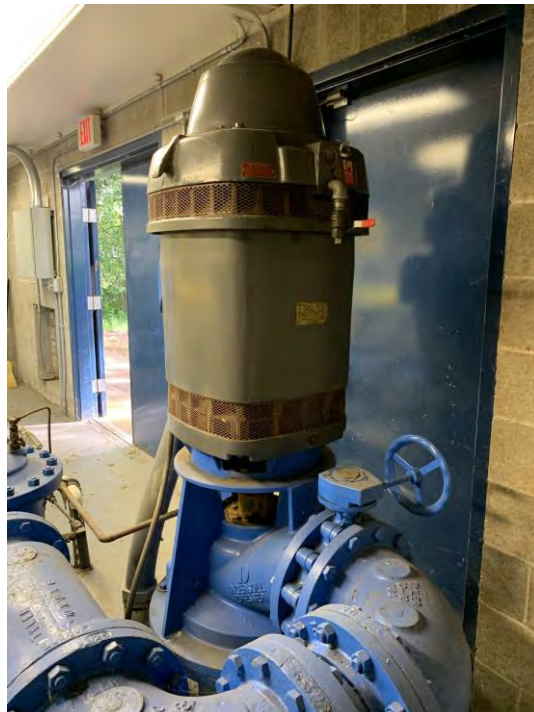
Figure 3.26 Unbraced Pump Motor

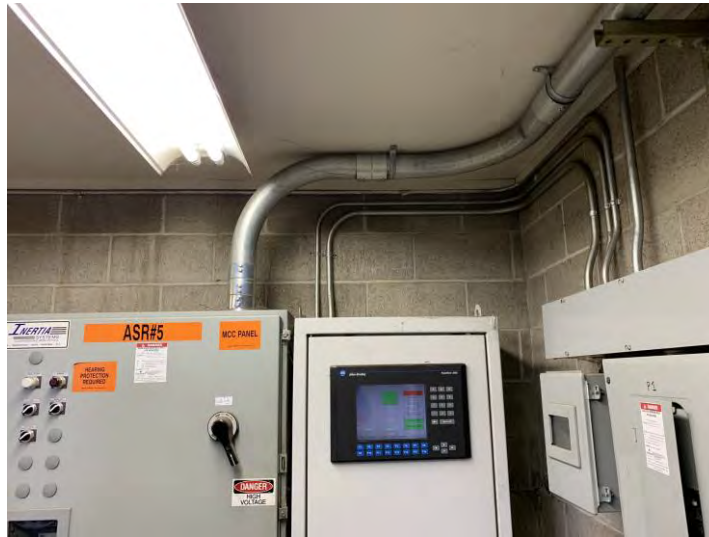
Figure 3.27 Conduit Top Connection to Motor Control Center without Flexible Connection

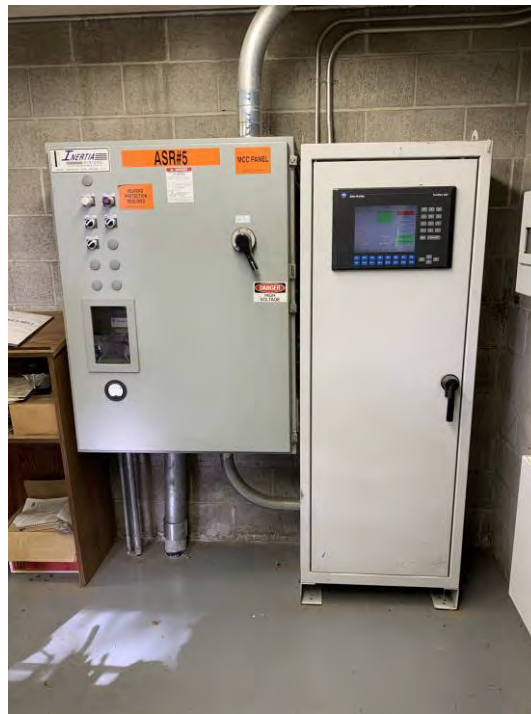
Figure 3.28 Unanchored Control Cabinet

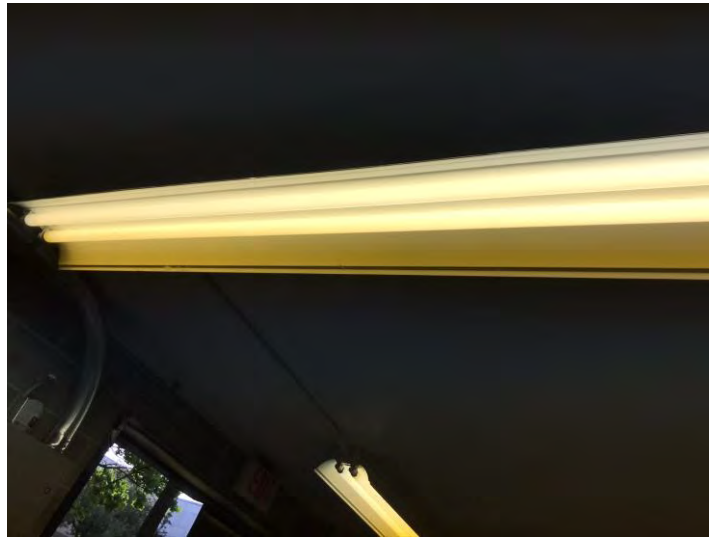
Figure 3.29 Light Fixtures without Lens Covers

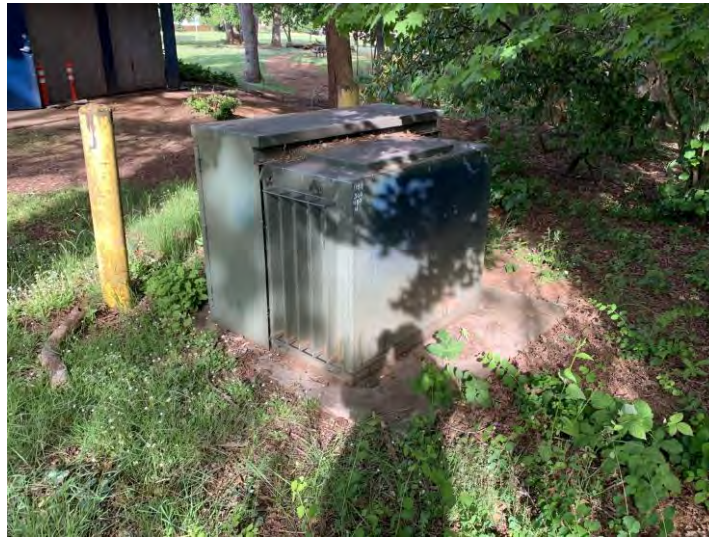
Figure 3.30 Unanchored Electrical Transformer

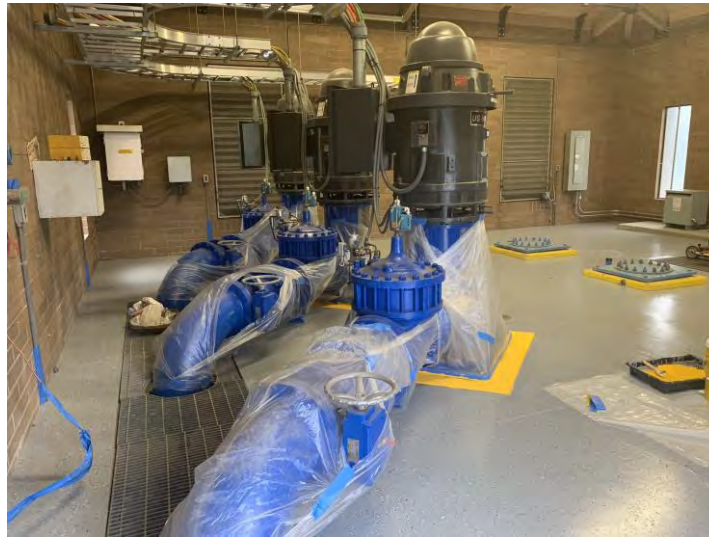
| Potential Deficiencies | Description |
|---|---|
| Nonstructural | <ul style="list-style-type: none"> • Water system piping within the pump station is not braced (see Figure 3.33) • Valves in line with the water system piping are not braced (see Figure 3.33). • Vertical pump motors are not braced above the center of gravity of the motor (see Figure 3.34). • There does not appear to be adequate flexibility in the piping that is attached to the pumps to accommodate potential relative movement between the piping and the pump, and to prevent the piping from adding additional load to the pump anchorage. • The cable tray does not appear to have adequate longitudinal bracing (see Figure 3.35). In some locations the anchors for the transverse bracing appear to be improperly installed in a masonry head joint (see Figure 3.36). • Light fixtures in the pump station do not include lens covers (see Figure 3.37). • Metal floor grating lacks clip connecting the grating to the steel support framing (see Figure 3.38). • The horizontal arm of the SCADA antenna may not be adequately connected to the supporting pole to prevent the antenna from being misaligned or damaged after an earthquake (see Figure 3.39). |

Figure 3.33 Unbraced Piping and Valves

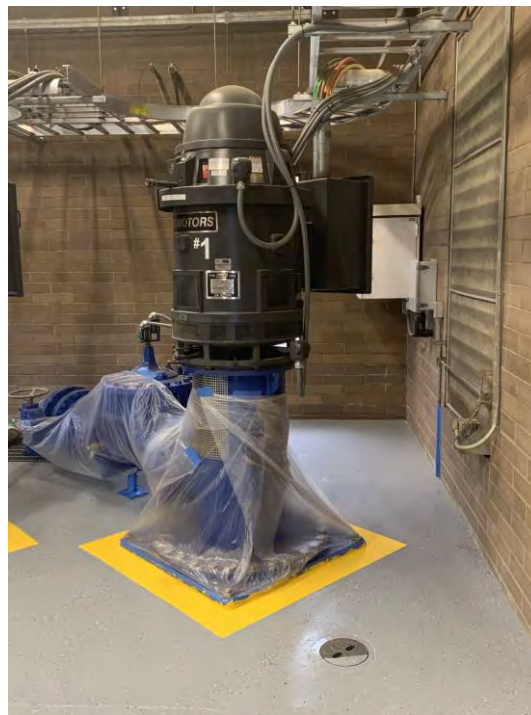
Figure 3.34 Unbraced Pump Motor

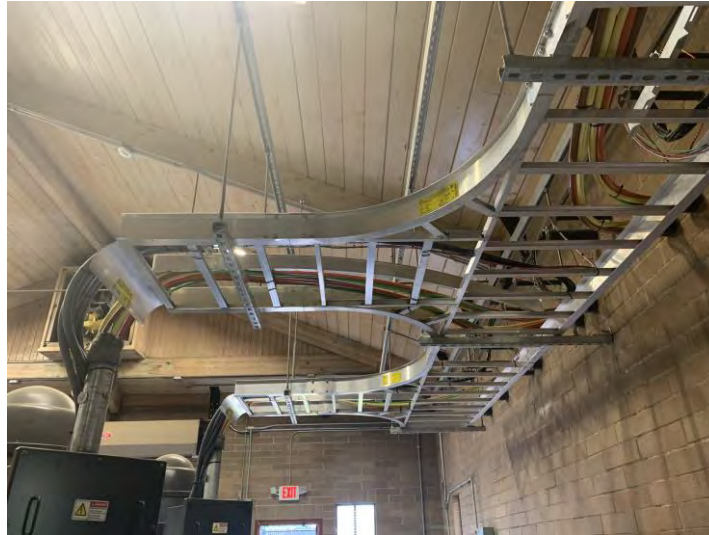
Figure 3.35 Cable Tray Lacks Longitudinal Bracing

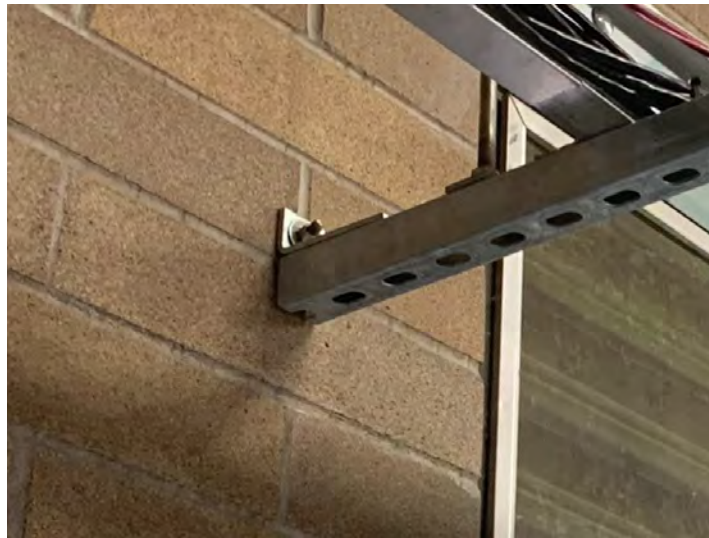
Figure 3.36 Cable Tray Transverse Brace with Anchor Installed in Masonry Head Joint

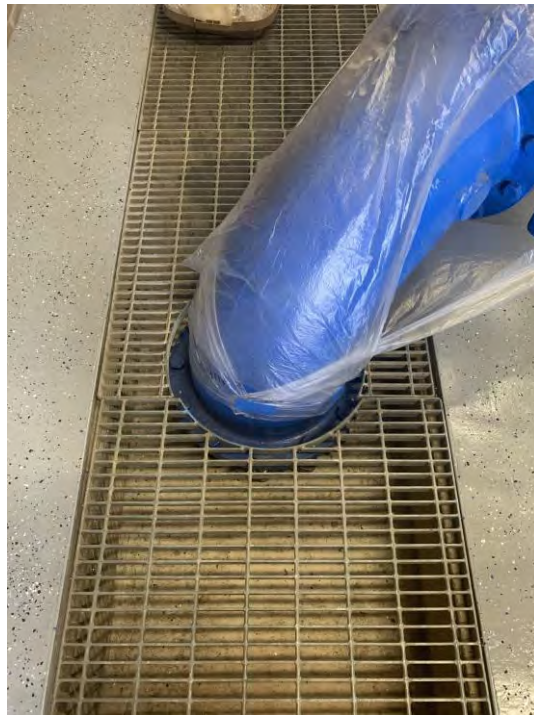
Figure 3.38 Grating without Clip Connection to Supporting Steel Framing

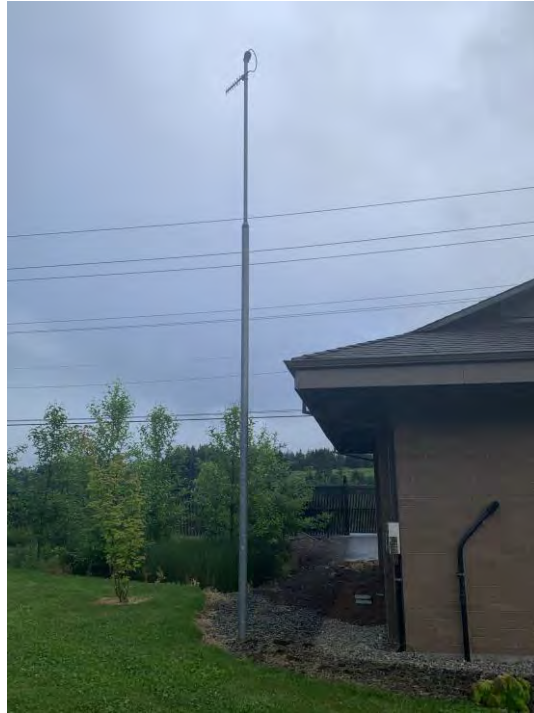
Figure 3.39 SCADA Antenna

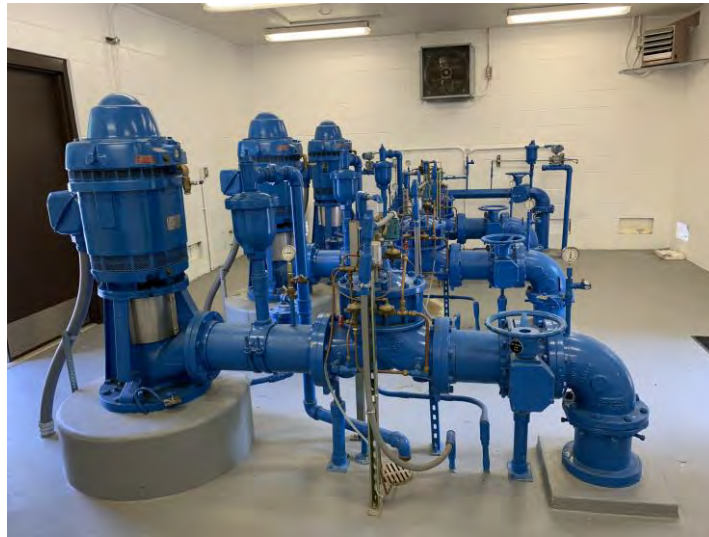
| Potential Deficiencies | Description |
|---|--|
| Nonstructural | <ul style="list-style-type: none"> • Water system piping within the pump station is not braced (see Figure 3.42). • Valves in line with the water system piping are not braced (see Figure 3.42). • Air relief valves are not braced and are only supported by rigid small diameter piping (see Figure 3.43). • Vertical pump motors are not braced above the center of gravity of the motor (see Figure 3.44). • There does not appear to be adequate flexibility in the piping that is attached to the pumps to accommodate potential relative movement between the piping and the pump, and to prevent the piping from adding additional load to the pump anchorage. • Anchorage of electrical cabinets to the housekeeping pads was not visible from the outside of the cabinets and may not be adequate. Details for how the housekeeping pad is reinforced and connected to the slab on grade are not provided in the available original design drawings and may not be adequate. Additionally, electrical cabinets do not appear to be anchored or braced to the wall near the top of the cabinets to prevent them from tipping over during an earthquake. • The emergency generator air intake support frame, muffler, and exhaust pipe do not appear to be adequately anchored/braced (see Figure 3.45, Figure 3.46, and Figure 3.47). • No anchorage was observed between the electrical transformer and concrete support pad (see Figure 3.48). |

Figure 3.42 Unbraced Piping and Valves

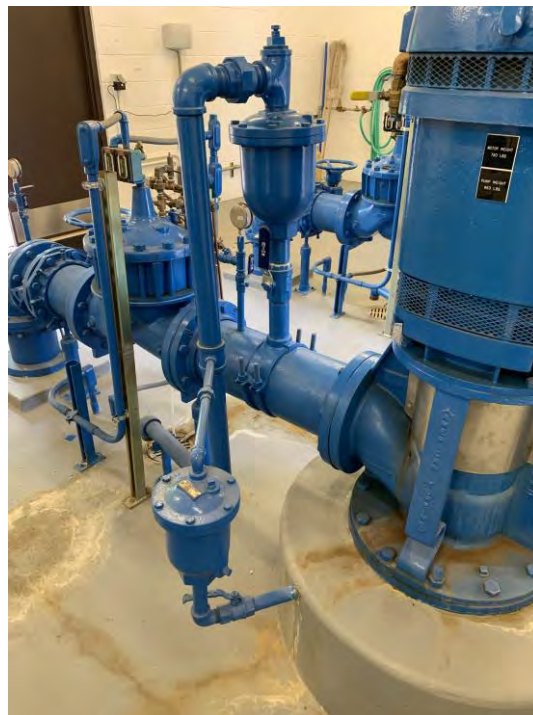
Figure 3.43 Unbraced Air Relief Valves

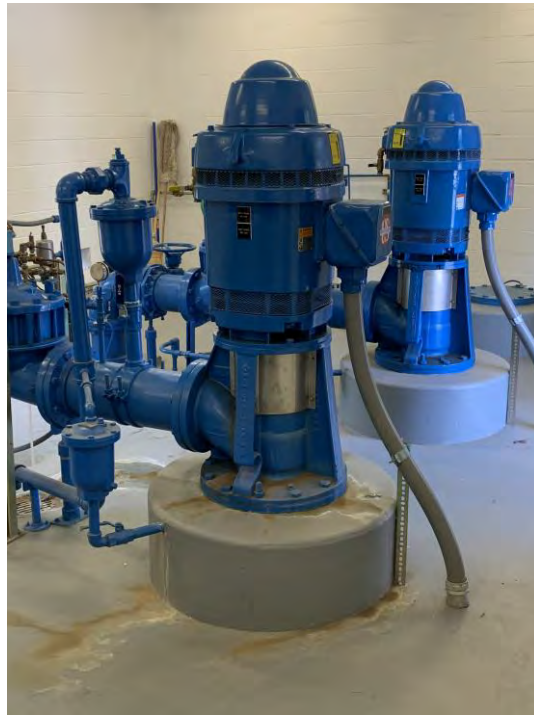
Figure 3.44 Unbraced Pump Motor

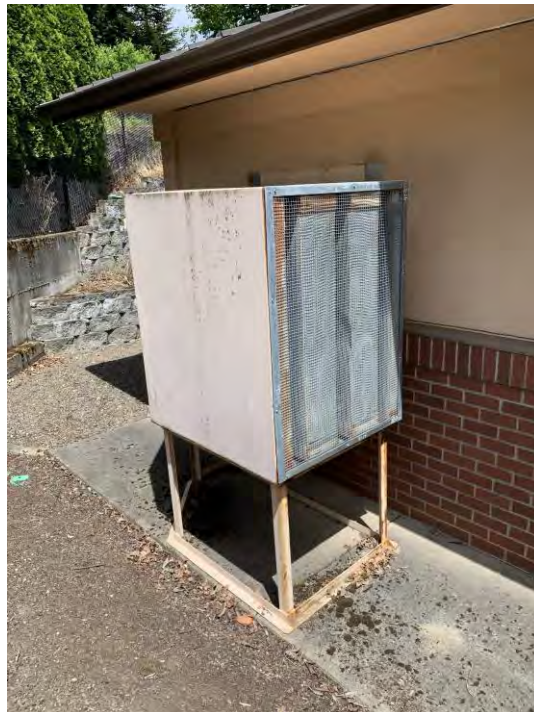
Figure 3.45 Unanchored Emergency Generator Air Intake Support Frame

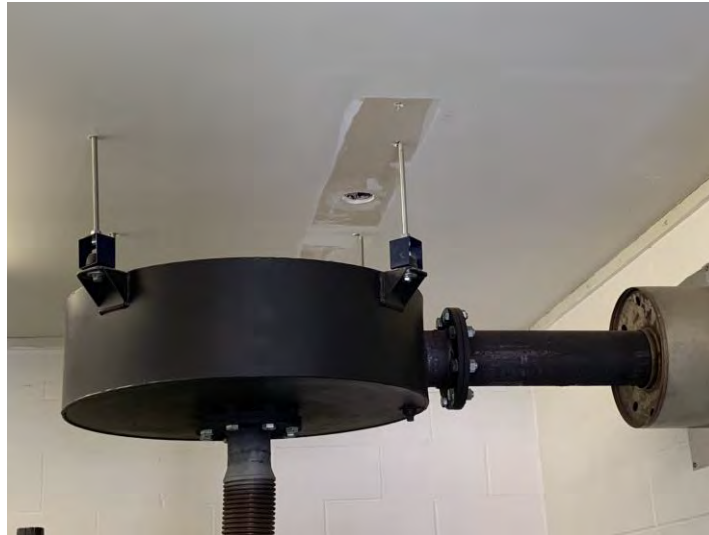
Figure 3.46 Unbraced Emergency Generator Muffler

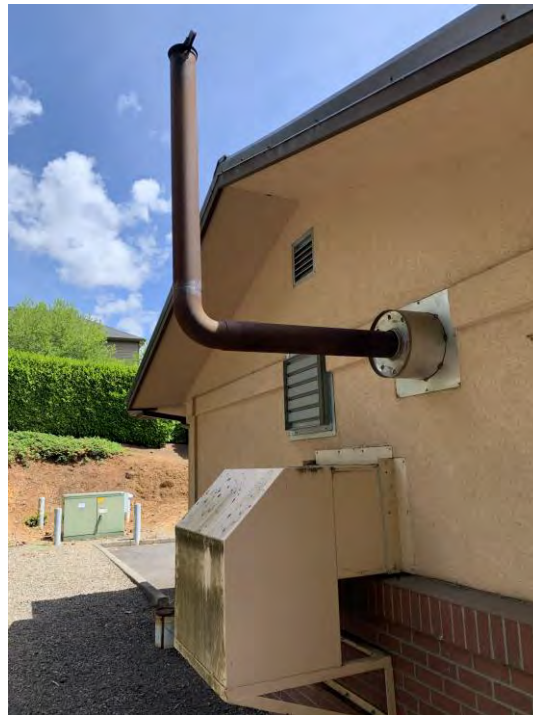
Figure 3.47 Unbraced Emergency Generator Exhaust Pipe

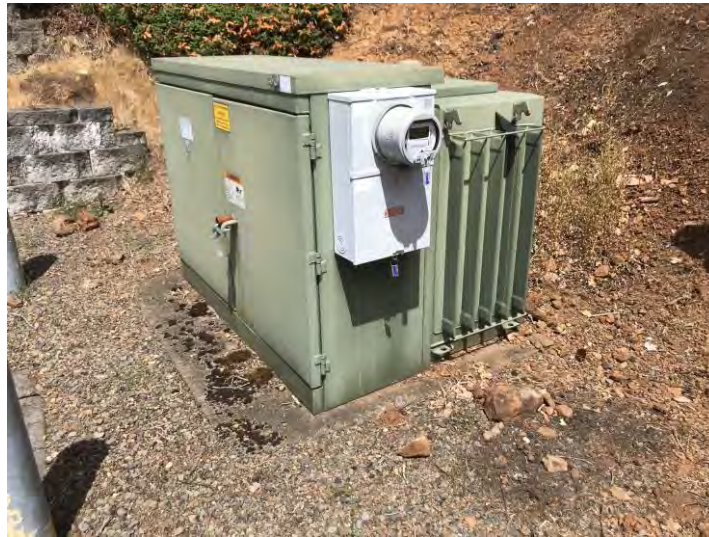
Figure 3.48 Unanchored Electrical Transformer

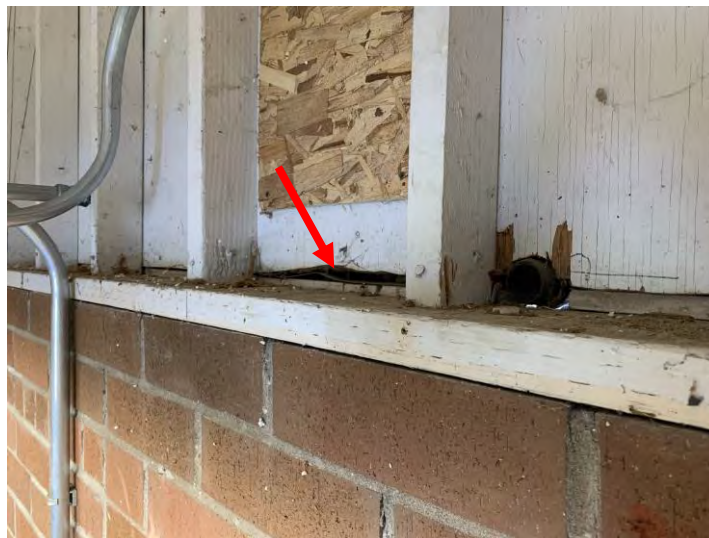
Figure 3.50 Sheathing Not Connected to Top Plate of Interior Masonry Wall

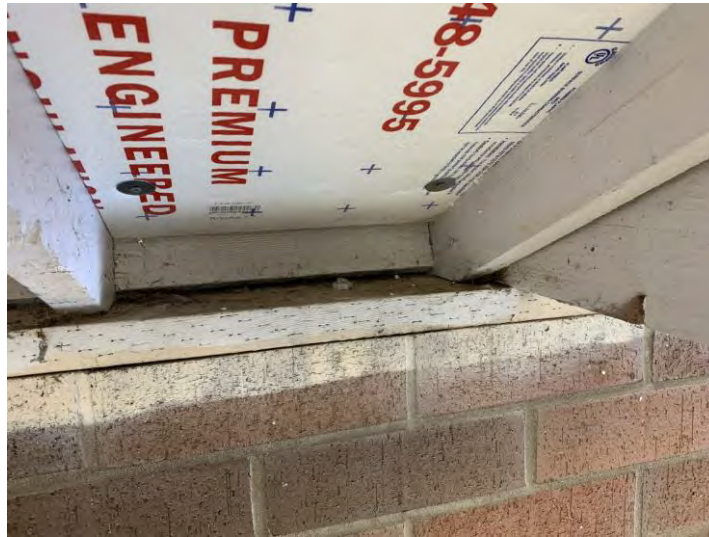
Figure 3.51 Inadequate Connection between Blocking and Masonry Wall Top Plate

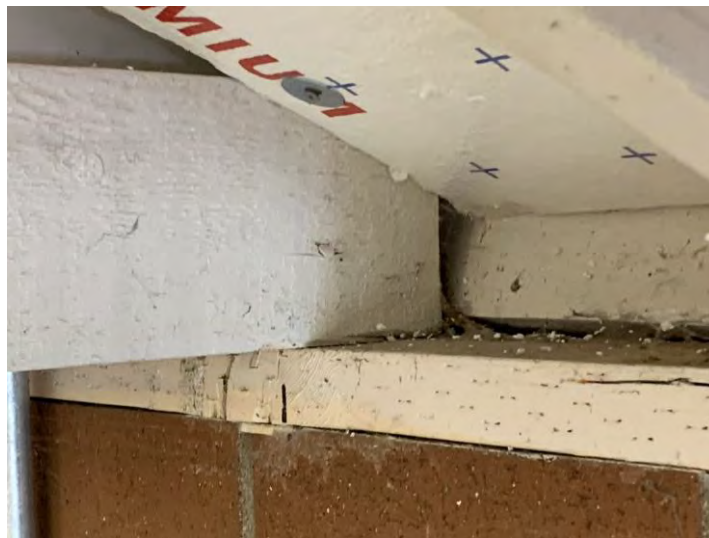
| Potential Deficiencies | Description |
|---|---|
| Structural | <ul style="list-style-type: none"> • No design drawings were available for the original construction of the pump station or the electrical room addition. The size, spacing, and detailing of the steel reinforcing for the masonry walls is unknown. Additionally, it is unknown how the masonry walls from the electrical room addition are connected to the walls of the original pump station. • The roof plywood sheathing to truss nail size and spacing are unknown. • The original south wall of the pump station (now an interior wall between the pump and electrical rooms) is not adequately engaged to resist seismic forces from the roof diaphragm (see Figure 3.50). Without engaging this interior wall, the roof diaphragm span for east-west oriented seismic forces exceeds the ASCE 41-17 Tier 1 limit for unblocked wood structural panel diaphragms. • A positive connection does not appear to be provided between the sloped truss blocking and masonry wall top plate in the original pump station (see Figure 3.51). In the electrical room addition, the view of the area where blocking would be installed was obstructed by insulation. Even if there is blocking installed, based on observation of similar construction, it is likely that blocking connections to the sheathing or masonry wall top plate are deficient. Therefore, the load path is likely inadequate to transfer in-plane shear forces from the roof diaphragm to the masonry walls. • The details of how the roof diaphragm is connected to the south gable end masonry wall are unknown. Therefore, the load path is potentially not adequate to transfer in-plane shear forces from the roof diaphragm to the masonry walls. • Out-of-plane bracing of perimeter and interior masonry walls is not adequate. The roof trusses are not attached to the top plate of the perimeter masonry walls with any metal connector hardware that is designed to resist wall out-of-plane demands (see Figure 3.52). • Adequate cross ties between diaphragm chords are not provided in both directions. |

Figure 3.52 Inadequate Connection between Truss Chord and Masonry Wall Top Plate

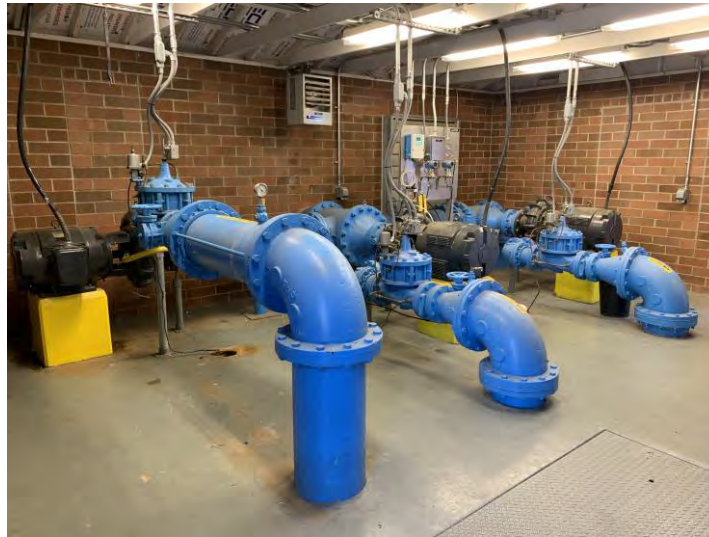
| Potential Deficiencies | Description |
|---|---|
| Nonstructural | <ul style="list-style-type: none"> • Water system piping within the pump station is not braced (see Figure 3.53) • Valves in line with the water system piping are not braced (see Figure 3.53). • It is unknown if adequate dowels are provided between the pump support concrete pedestal and the floor slab to resist the expected shear and overturning demands. • There does not appear to be adequate flexibility in the piping that is attached to the pumps to accommodate potential relative movement between the piping and the pump, and to prevent the piping from adding additional load to the pump anchorage. • The pipe support stanchion base plates are missing anchors into the concrete slab (see Figure 3.54). • Anchorage of electrical cabinets to the concrete slab on grade was not visible from the outside of the cabinets and may not be adequate. Additionally, electrical cabinets do not appear to be anchored or braced to the wall near the top of the cabinets to prevent them from tipping over during an earthquake (see Figure 3.55). • The emergency generator starter batteries may not be adequately restrained. A restrainer bracket (similar to the one that would be expected to be installed for the emergency generator starter batteries) was observed inside the pump station (see Figure 3.56). • The horizontal arm of the SCADA antenna may not be adequately connected to the supporting pole to prevent the antenna from being misaligned or damaged after an earthquake (see Figure 3.57). • The wood pole and anchorage of the pole-mounted transformer to the pole may not be adequately designed to resist the seismic forces generated by the transformer |

Figure 3.53 Unbraced Piping and Valves
