SEISMIC RESILIENCY ANALYSIS REPORT

B&V PROJECT NO. 406828

City of Salem

AUGUST 2023

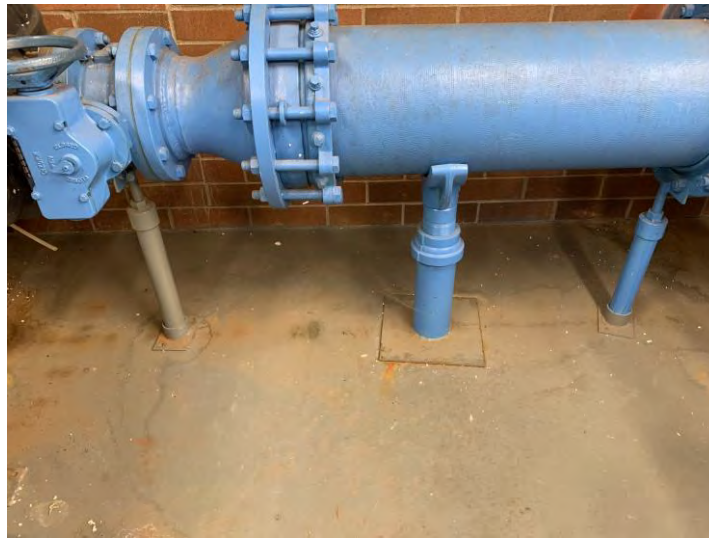
Figure 3.54 Pipe Support Stanchion Missing Anchors into Floor Slab

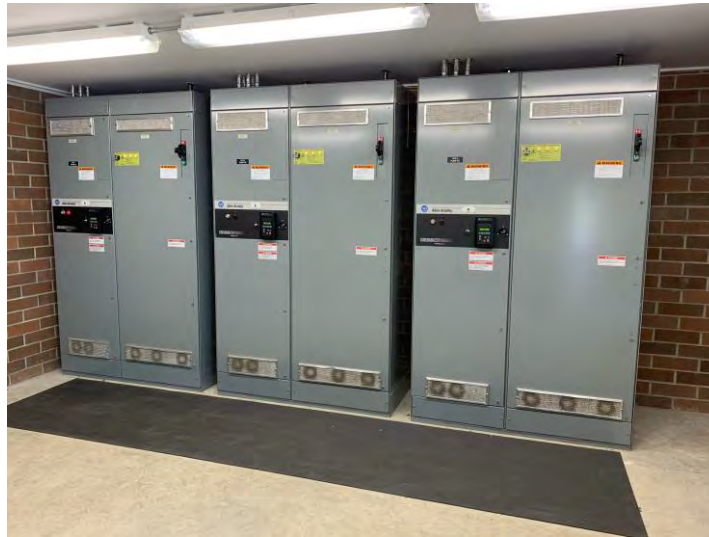
Figure 3.55 Electrical Cabinet with Unknown Anchorage Details

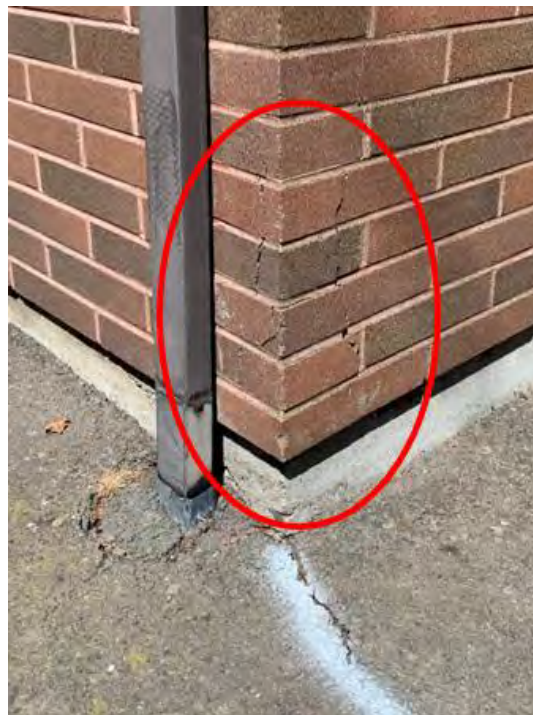
| Potential Deficiencies | Description |
|---|---|
| Structural | <ul style="list-style-type: none"> Per the Technical Memorandum “Seismic Geohazard Evaluation Report, City of Salem Seismic Resilience Study” by Shannon & Wilson, Inc., there is evidence of soil settlement resulting from past uncontrolled water releases at the pump stations and uncertainty associated with the liquefaction potential of the soil in the area around the pump station. Cracking of the masonry wall was observed at the southwest corner of the building near the base of the wall (see Figure 3.59). |

Figure 3.59 Cracking of Masonry Wall

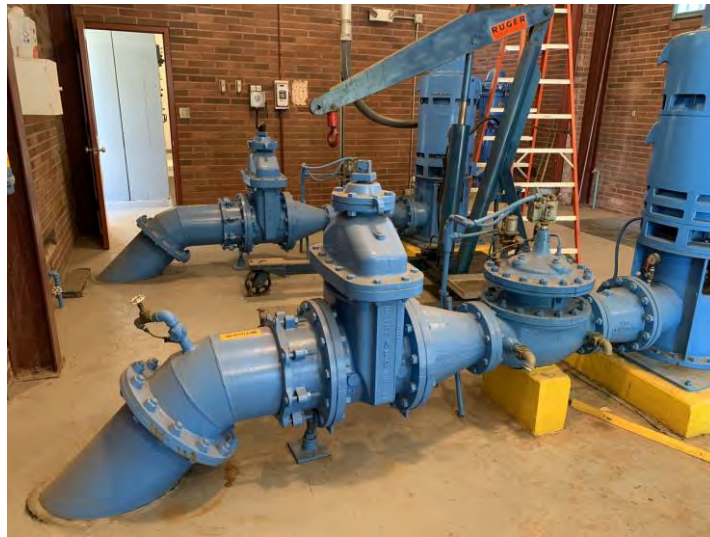
Figure 3.61 Unbraced Piping and Valves

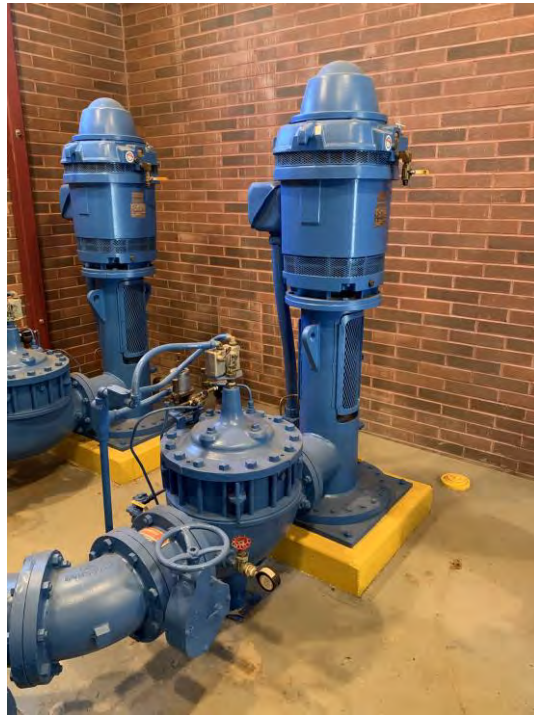
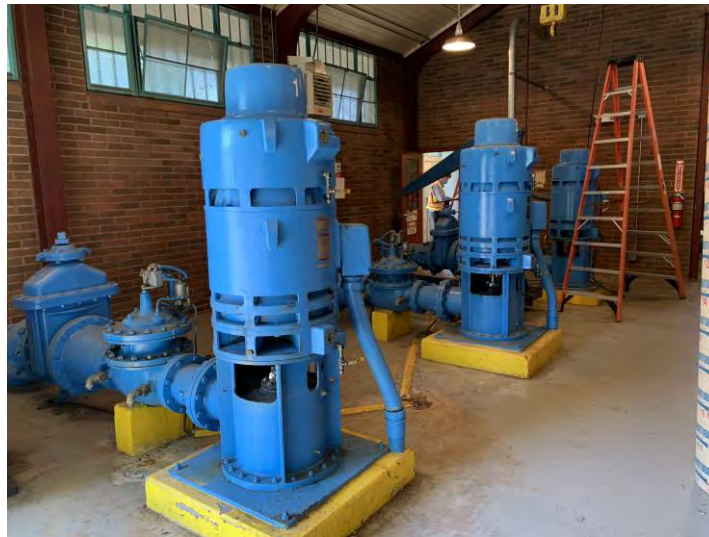
Figure 3.62 Unbraced Pump Motor

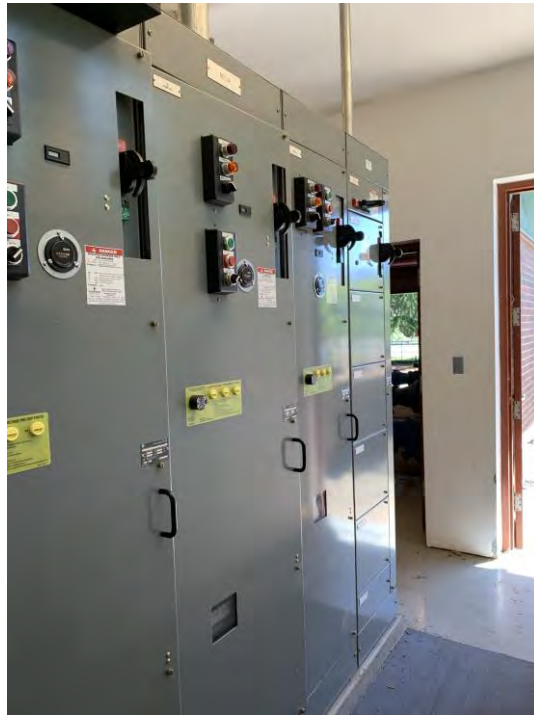
Figure 3.63 Electrical Cabinets with Unknown Anchorage Details

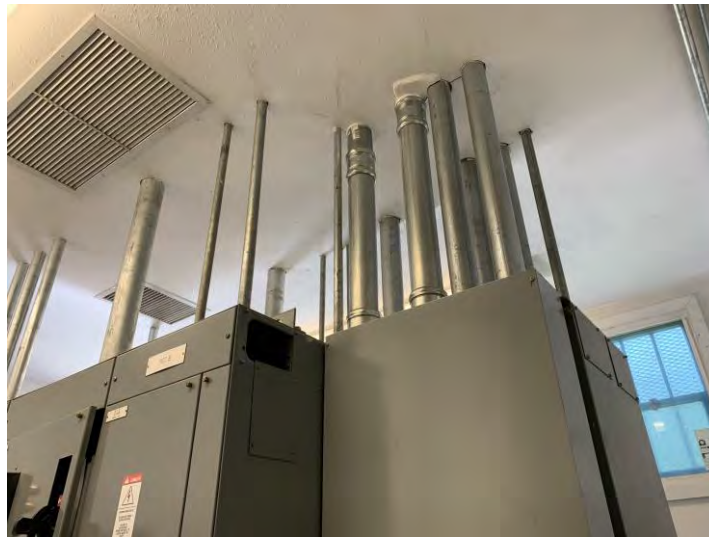
Figure 3.64 Conduits Connecting to Electrical Cabinets without Flexible Connections

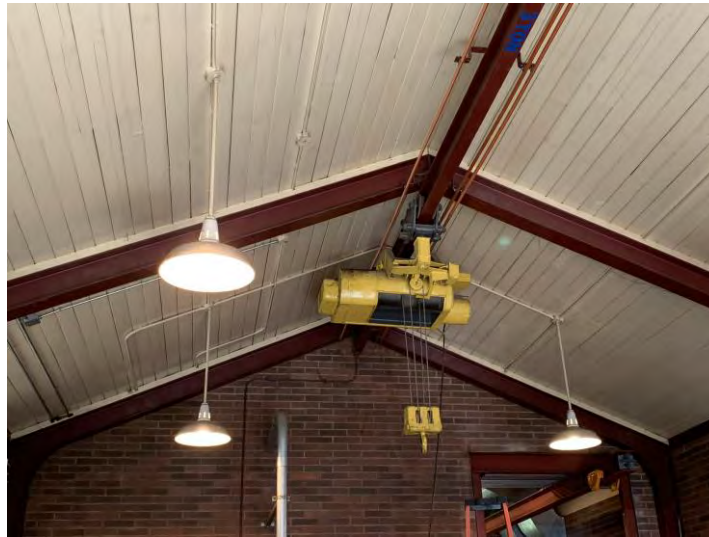
Figure 3.65 Pendant Lights without Lens Covers

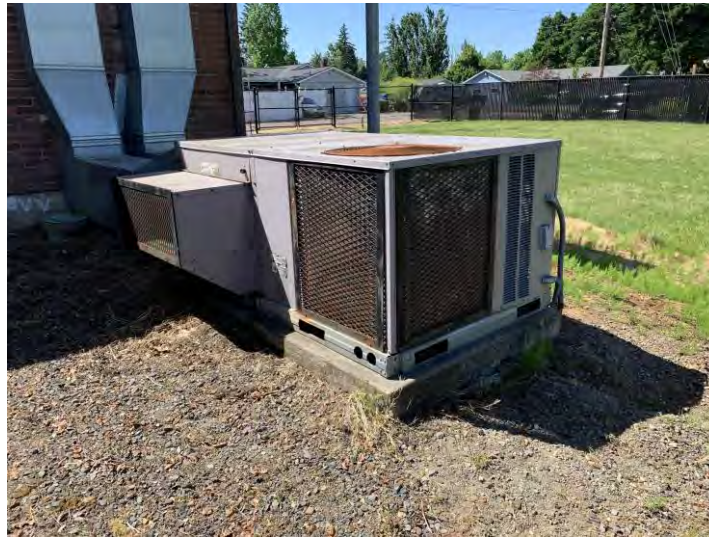
Figure 3.67 Unanchored HVAC Condenser Unit

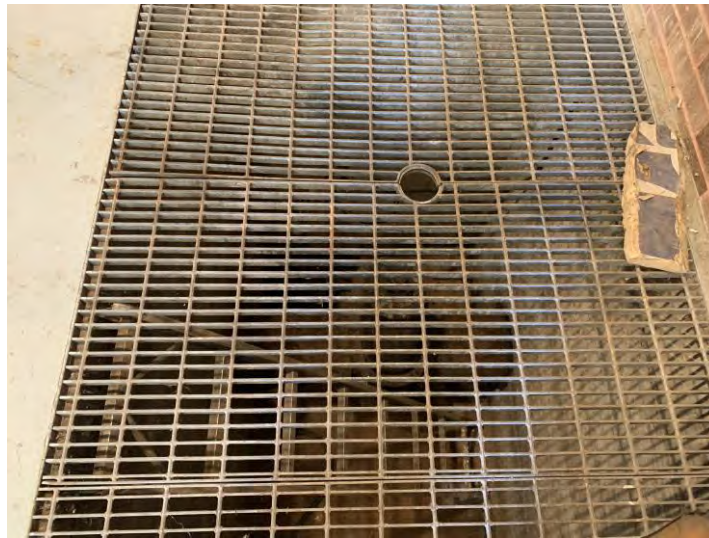
Figure 3.68 Grating without Clip Connection to Supporting Steel Framing

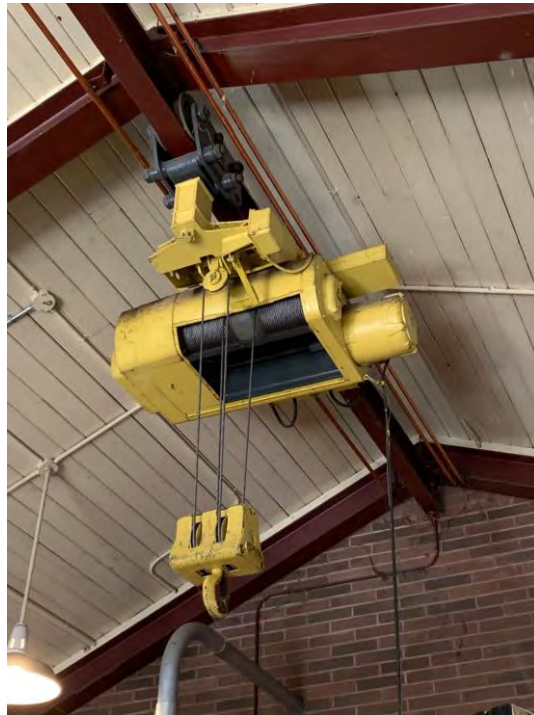
Figure 3.69 Unrestrained Overhead Bridge Crane

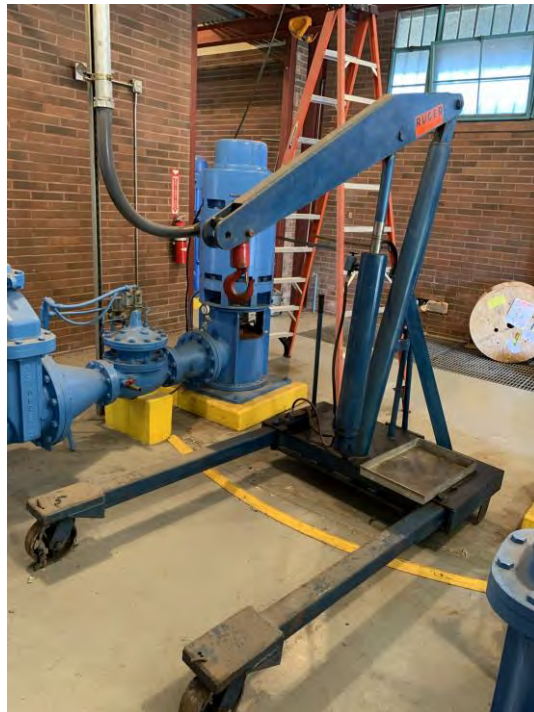
Figure 3.70 Unrestrained Ladder and Rolling Lift

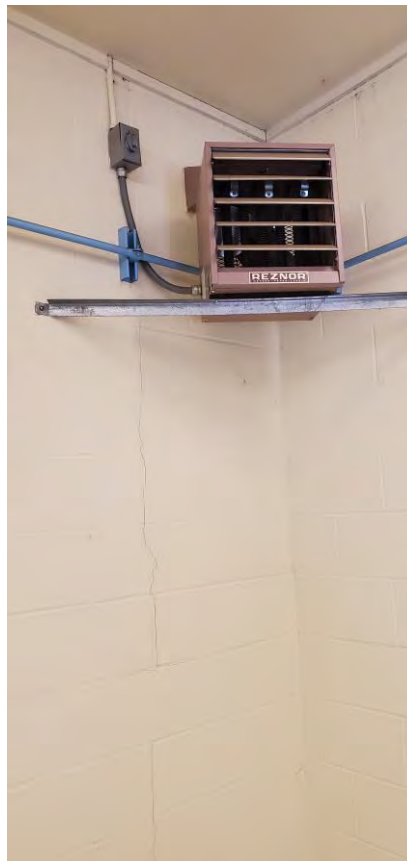
| Potential Deficiencies | Description |
|---|--|
| Structural | <ul style="list-style-type: none"> • Several vertical cracks were observed in all four exterior masonry walls of the pump station (see Figure 3.73). Also, deterioration of the plywood sheathing and support framing was observed adjacent to the pump station entrances (see Figure 3.74). • The roof plywood sheathing nailing schedule was not provided in the available original design drawings. • The roof diaphragm span for east-west oriented seismic forces exceeds the ASCE 41-17 Tier 1 limit for unblocked wood structural panel diaphragms. • A positive connection does not appear to be provided between the sloped truss blocking and masonry wall top plate. Therefore, the load path is incomplete to transfer in-plane shear forces from the roof diaphragm to the masonry walls. Additionally, blocking in approximately every other bay has a long vent slot that limits its capacity to transfer seismic forces from the roof diaphragm to the masonry wall (see Figure 3.75). |

Figure 3.73 Masonry Wall Cracking

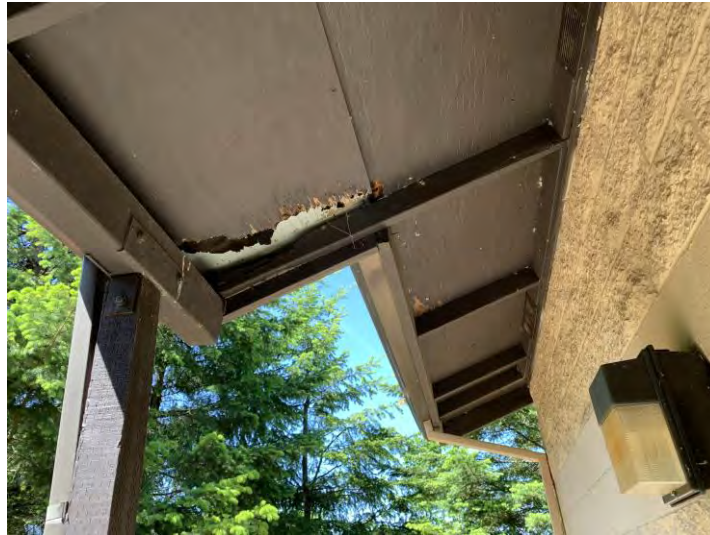
Figure 3.74 Sheathing and Framing Deterioration

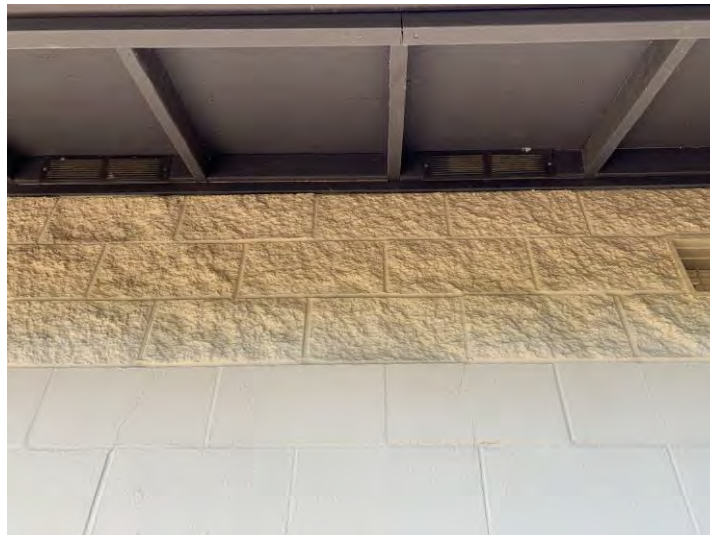
Figure 3.75 Sloped Blocking Between Wood Trusses

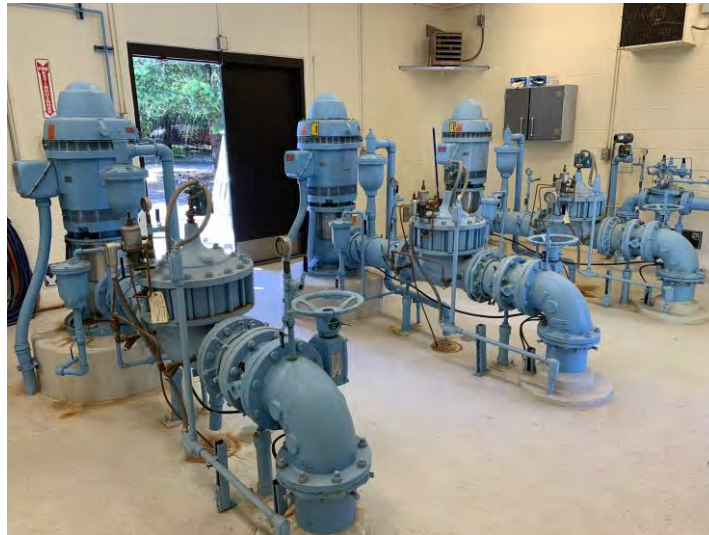
| Potential Deficiencies | Description |
|---|--|
| Nonstructural | <ul style="list-style-type: none"> • Water system piping within the pump station is not braced (see Figure 3.77). • Valves in line with the water system piping are not braced (see Figure 3.77). • Air relief valves are not braced and are only supported by rigid small diameter piping (see Figure 3.78). • Vertical pump motors are not braced above the center of gravity of the motor (see Figure 3.79). • There does not appear to be adequate flexibility in the piping that is attached to the pumps to accommodate potential relative movement between the piping and the pump, and to prevent the piping from adding additional load to the pump anchorage. • Anchorage of electrical cabinets to the housekeeping pads was not visible from the outside of the cabinets and may not be adequate. Details for how the housekeeping pad is reinforced and connected to the slab on grade are not provided in the available original design drawings and may not be adequate. Additionally, electrical cabinets do not appear to be anchored or braced to the wall near the top of the cabinets to prevent them from tipping over during an earthquake (see Figure 3.80). • The horizontal arm of the SCADA antenna may not be adequately connected to the supporting pole to prevent the antenna from being misaligned or damaged after an earthquake (see Figure 3.81). • No anchorage was observed between the electrical transformer and concrete support pad (see Figure 3.82). |

Figure 3.77 Unbraced Piping and Valves

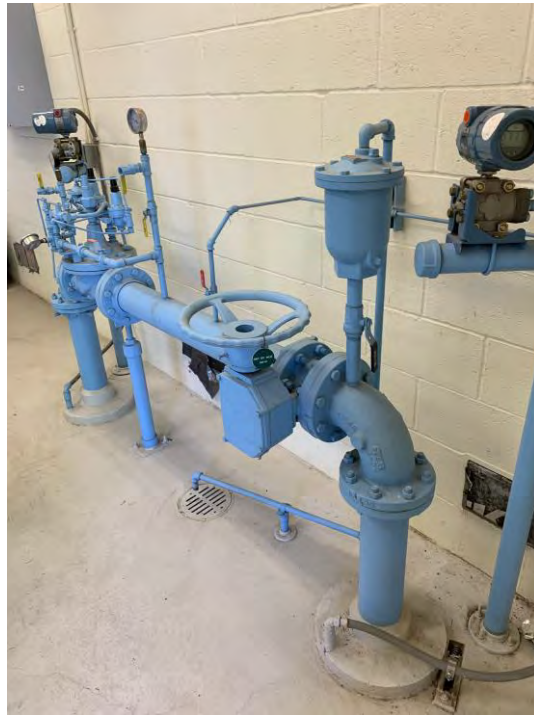
Figure 3.78 Unbraced Air Relief Valve

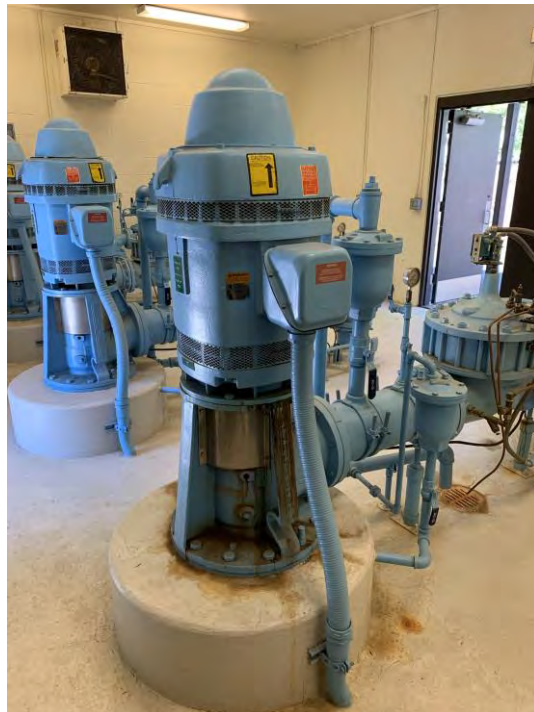
Figure 3.79 Unbraced Pump Motor

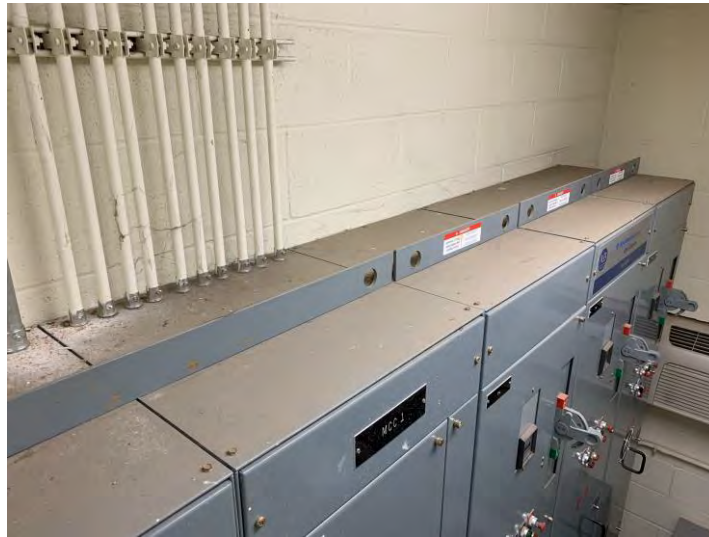
Figure 3.80 Electrical Cabinets with Unknown Anchorage Details

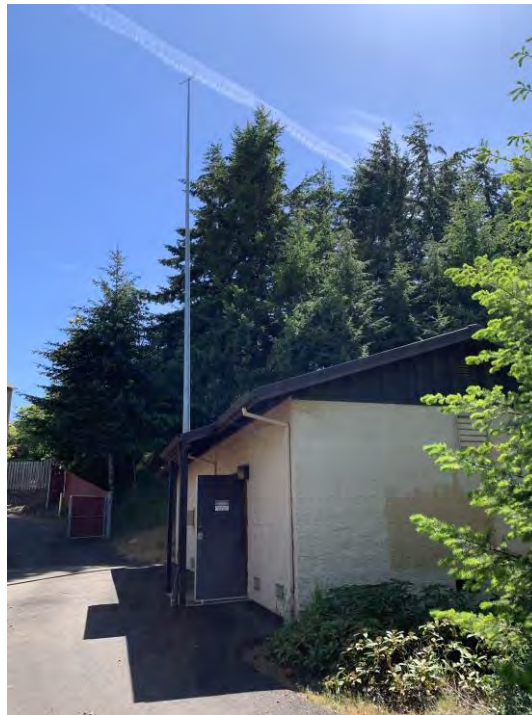
Figure 3.81 SCADA Antenna

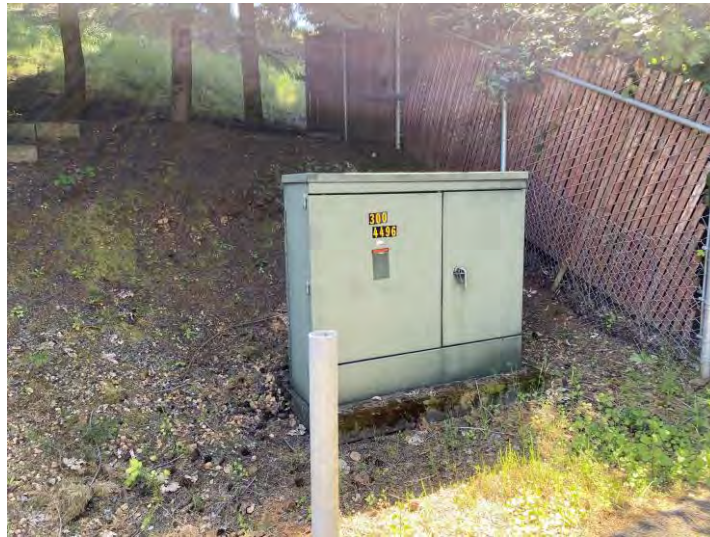
Figure 3.82 Unanchored Electrical Transformer

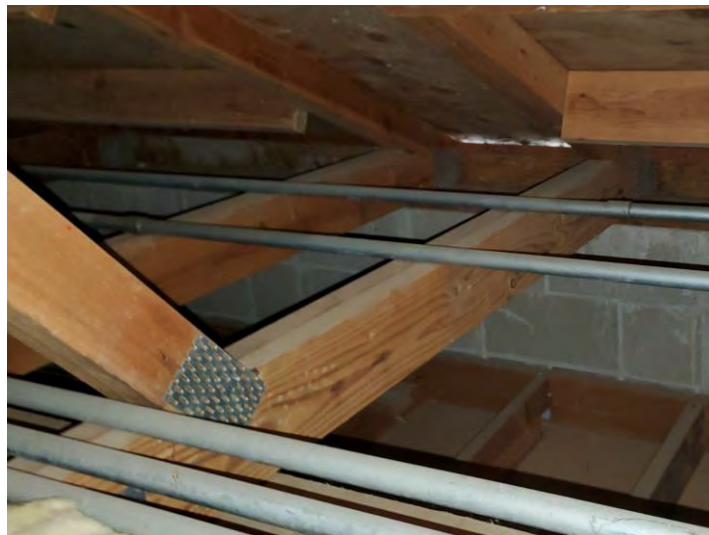
| Potential Deficiencies | Description |
|---|--|
| Structural | <ul style="list-style-type: none"> The load path is incomplete to deliver seismic forces from the roof diaphragm to the north masonry shear wall. Note that the observed as-built framing configuration is different than shown in the original design drawings (see Figure 3.84). Out-of-plane bracing of perimeter and interior masonry walls is not adequate. The roof trusses do not appear to be attached to the top plate of the perimeter masonry walls with metal connector hardware specifically designed to resist out-of-plane seismic forces. In the direction perpendicular to the roof trusses, the roof sheathing is used to provide out-of-plane bracing for the masonry walls (see Figure 3.85). Adequate cross ties between diaphragm chords are not provided in both directions. |

(a) Detail from Original Design Drawings
(Source: Detail 2 on Sheet S4 of 1994 design drawings by KMC, Inc.)

(b) As-built Framing Configuration Different than Shown on Original Design Drawings

Figure 3.84 Incomplete Load Path at North Wall

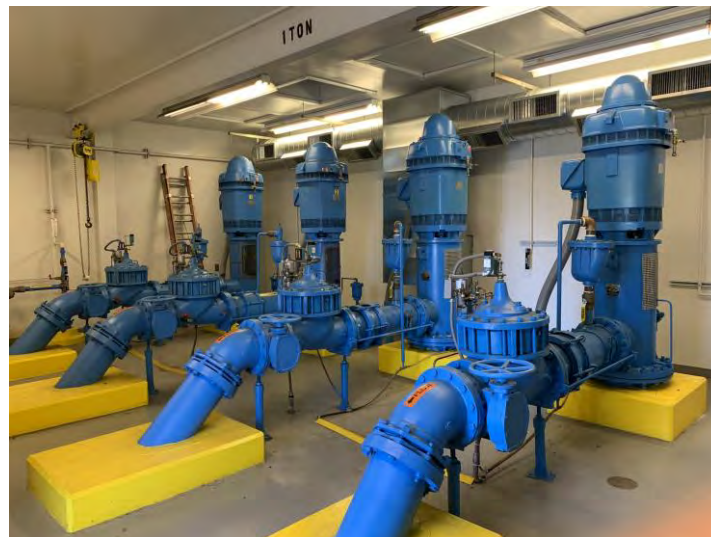
| Potential Deficiencies | Description |
|---|--|
| Nonstructural | <ul style="list-style-type: none"> • Water system piping within the pump station is not braced (see Figure 3.86) • Valves in line with the water system piping are not braced (see Figure 3.86). • Air relief valves are not braced and are only supported by rigid small diameter piping (see Figure 3.87). • Vertical pump motors are not braced above the center of gravity of the motor (see Figure 3.88). • There does not appear to be adequate flexibility in the piping that is attached to the pumps to accommodate potential relative movement between the piping and the pump, and to prevent the piping from adding additional load to the pump anchorage. • The piping gravity support stanchions are not anchored to the slab (see Figure 3.89). • The chlorination equipment is not adequately anchored, and the supporting concrete curb is severely damaged (see Figure 3.90 and Figure 3.91). • The fuse protection soft starter cabinets are restrained at the top by a wall mounted strut and spacers. The lag screw expansion shield anchors used to attach the strut to masonry wall are likely not seismically rated and may not provide adequate capacity (see Figure 3.92). Also, the short strut section spacers are not positively connected to the main strut. • The electrical transformer hung from the roof is not adequately braced (see Figure 3.93). • Anchorage of electrical cabinets to the concrete slab was not visible from the outside of the cabinets and may not be adequate. Additionally, electrical cabinets have only one clip angle bracket per cabinet that attaches between the top of the cabinet to the wall, which may not be adequate to prevent them from tipping over during an earthquake (see Figure 3.94). • Electrical conduits, hung from the roof and connected to the top of floor- and wall-mounted electrical panels and cabinets, may not have adequate flexibility to account for differential movement between the floor and the pump station roof (see Figure 3.95). • The emergency generator starter batteries are not adequately restrained, and the battery bins are not anchored (see Figure 3.96). • The emergency generator muffler is not adequately braced (see Figure 3.97). |

Figure 3.86 Unbraced Piping and Valves

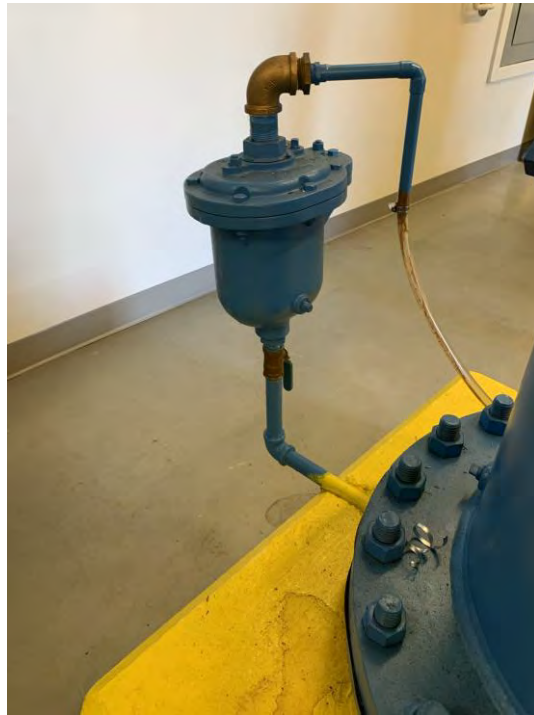
Figure 3.87 Unbraced Air Relief Valve

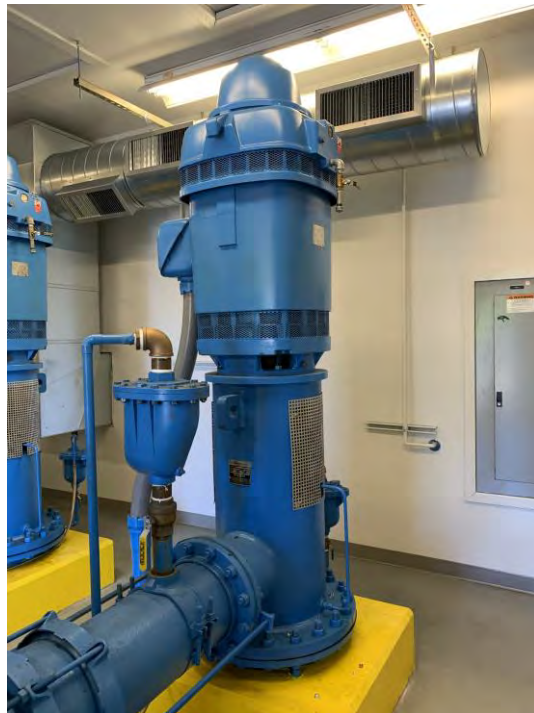
Figure 3.88 Unbraced Pump Motor

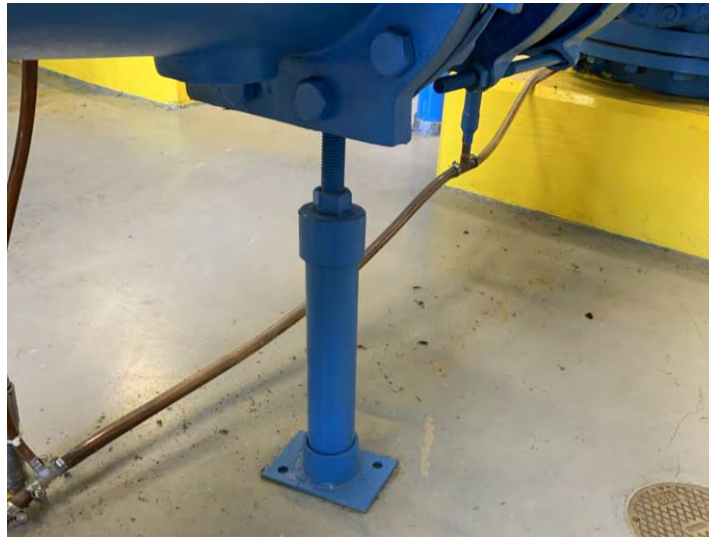
Figure 3.89 Pipe Support Stanchion Missing Anchors into Floor Slab

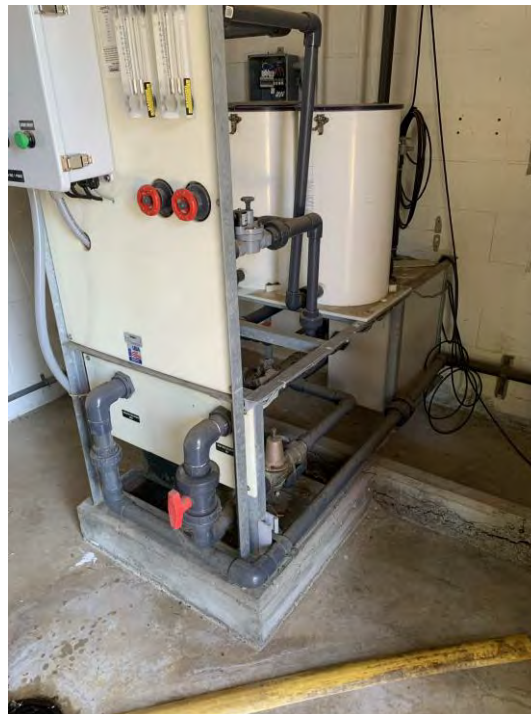
Figure 3.90 Chlorine System without Adequate Anchorage

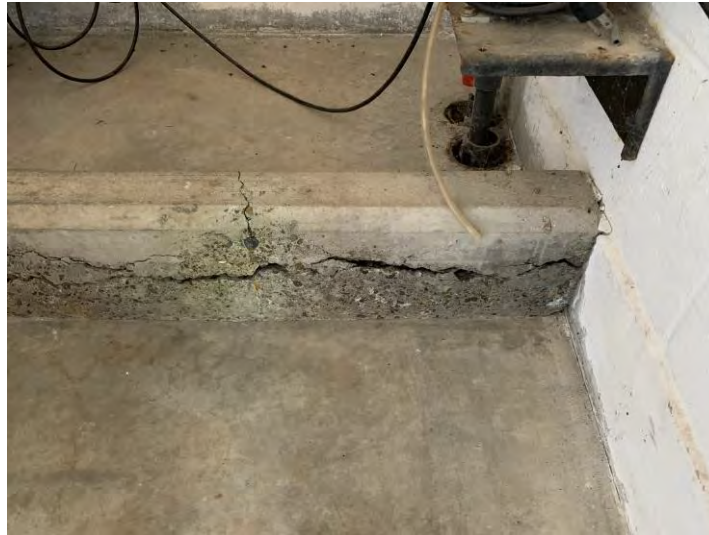
Figure 3.91 Deteriorated Concrete Curb

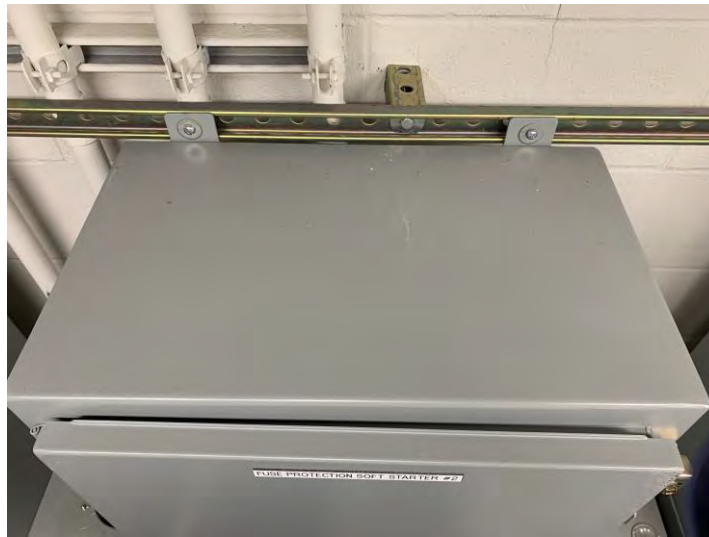
Figure 3.92 Inadequate Lag Screw and Spacer Strut Connection to Wall

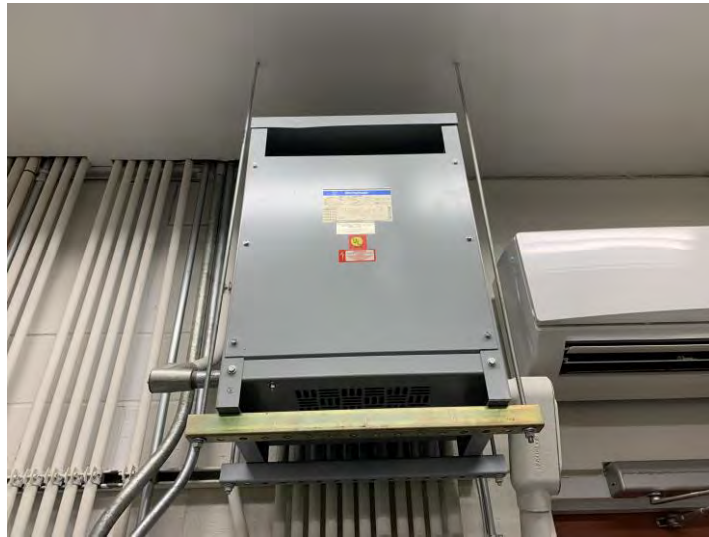
Figure 3.93 Unbraced Elevated Electrical Transformer

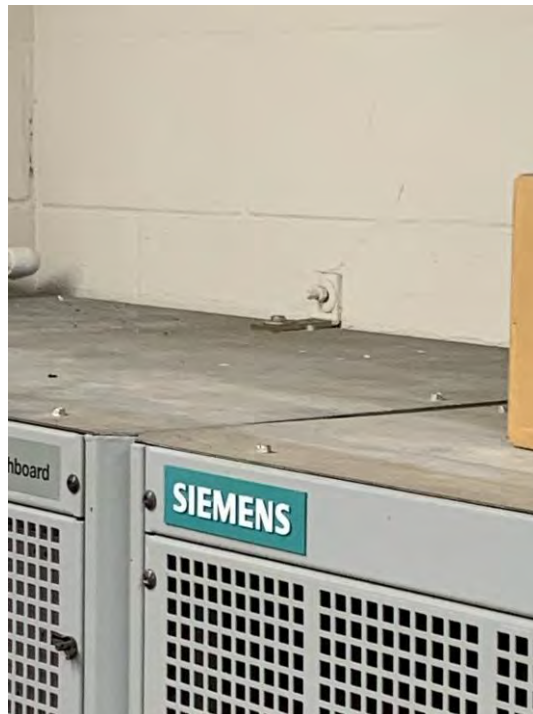
Figure 3.94 Electrical Cabinet with Single Anchor Bracket at Top of Cabinet

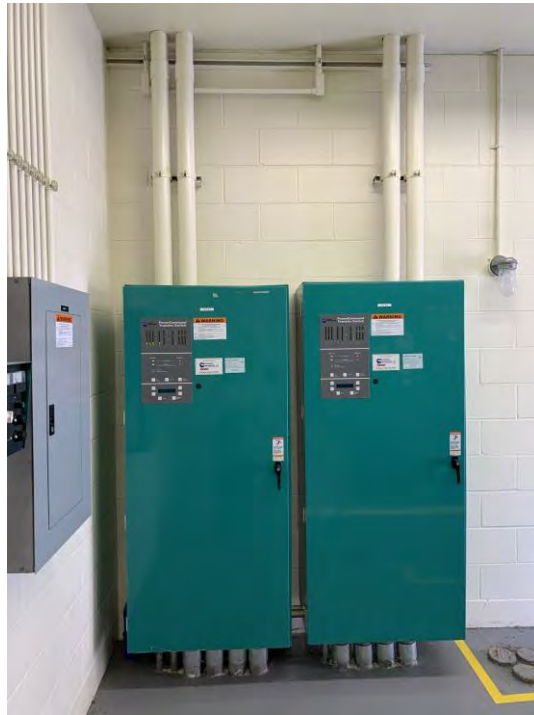
Figure 3.95 Conduits Connecting to Electrical Cabinets without Flexible Connections

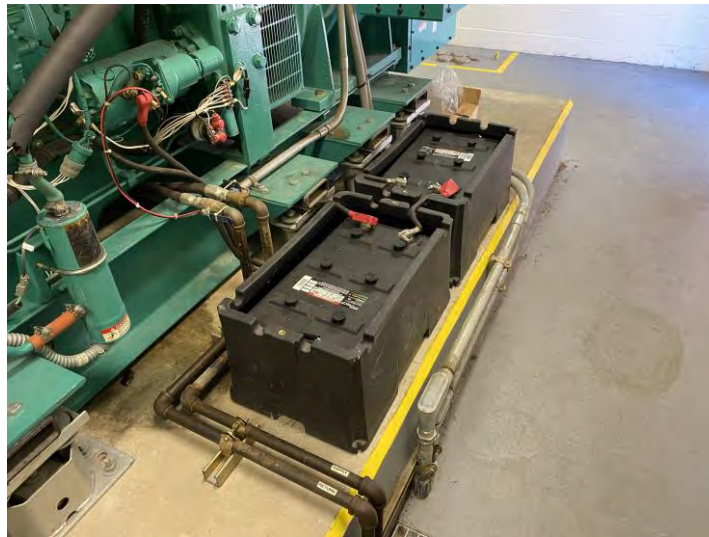
Figure 3.96 Unrestrained Emergency Generator Starter Batteries

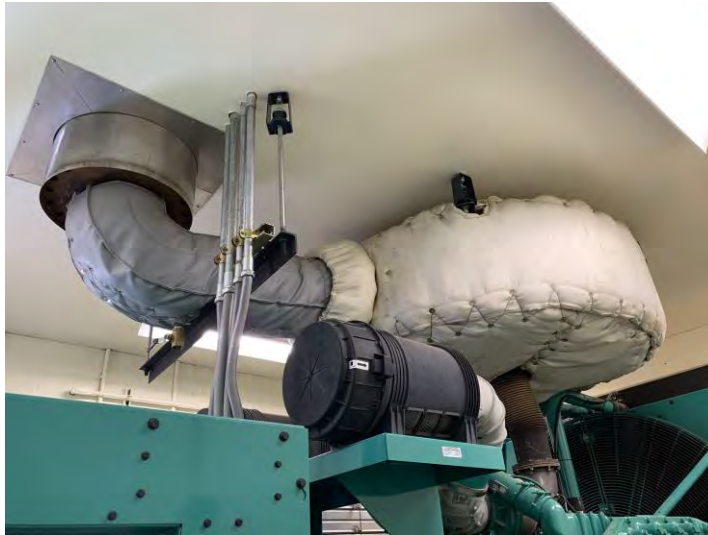
Figure 3.97 Unbraced Emergency Generator Muffler

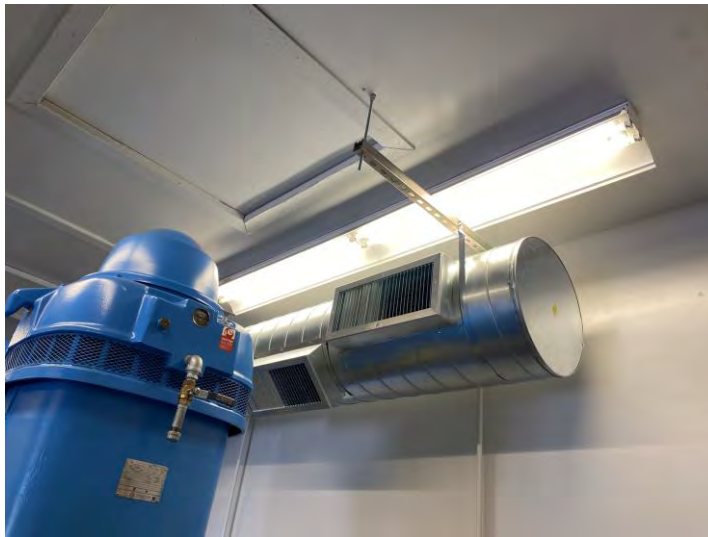
| Potential Deficiencies | Description |
|---|--|
| Nonstructural (cont.) | <ul style="list-style-type: none"> • Light fixtures in the pump station do not include lens covers (see Figure 3.98). • The horizontal arm of the SCADA antenna may not be adequately connected to the supporting pole to prevent the antenna from being misaligned or damaged after an earthquake (see Figure 3.99). • The overhead trolley chain hoist is not laterally braced and may damage other equipment during an earthquake (see Figure 3.100). • A ladder is unrestrained and may topple into and potentially damage the piping and valves during an earthquake (see Figure 3.100). • No anchorage was observed between the electrical transformer and concrete support pad (see Figure 3.101). |

Figure 3.98 Light Fixtures without Lens Covers

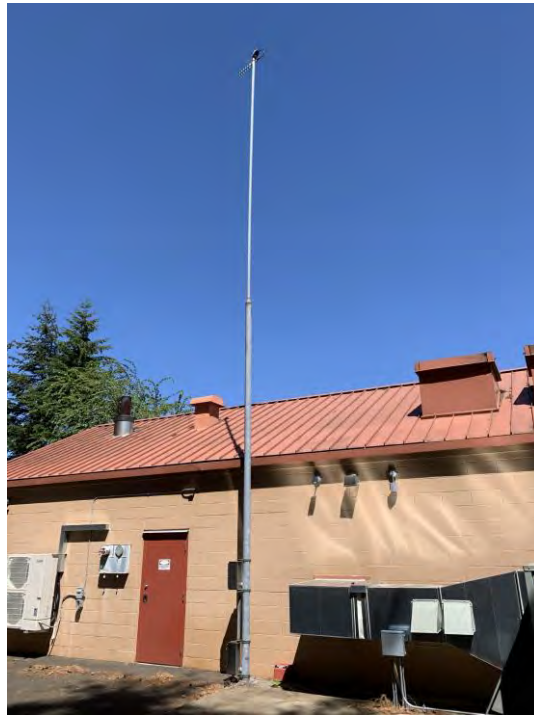
Figure 3.99 SCADA Antenna

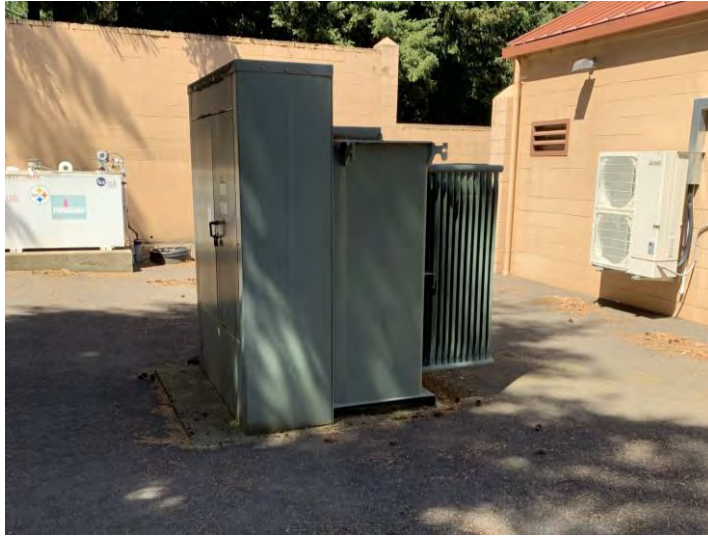
Figure 3.101 Unanchored Electrical Transformer

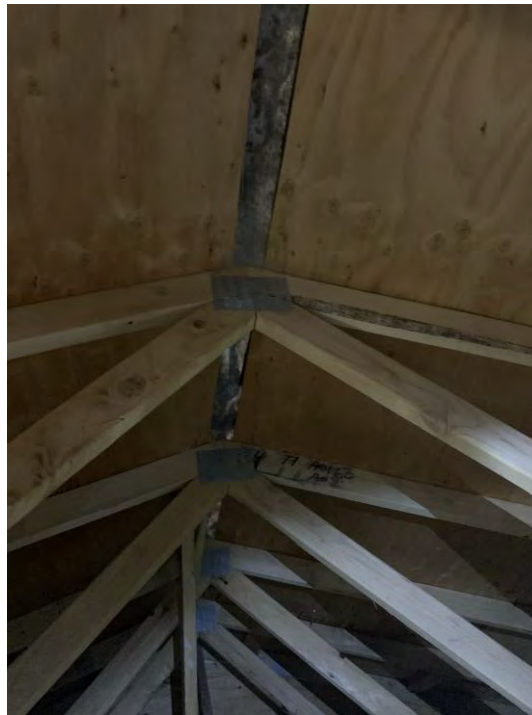
Figure 3.103 Roof Sheathing not Continuous to Ridge Line

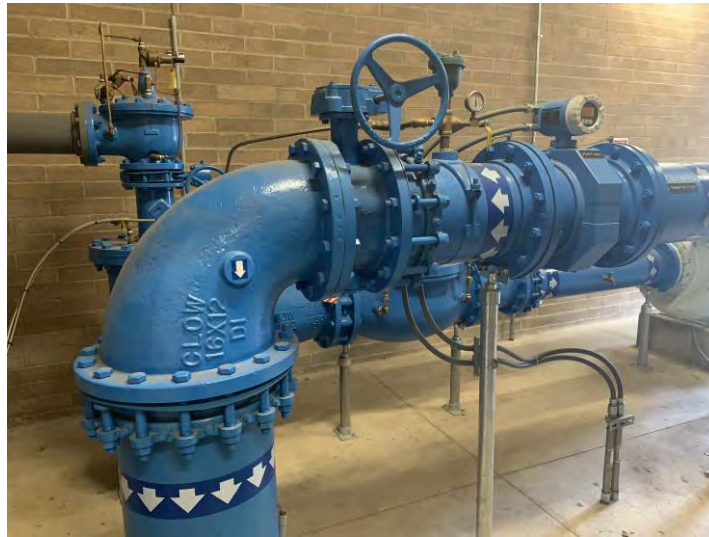
Figure 3.106 Unbraced Piping and Valves

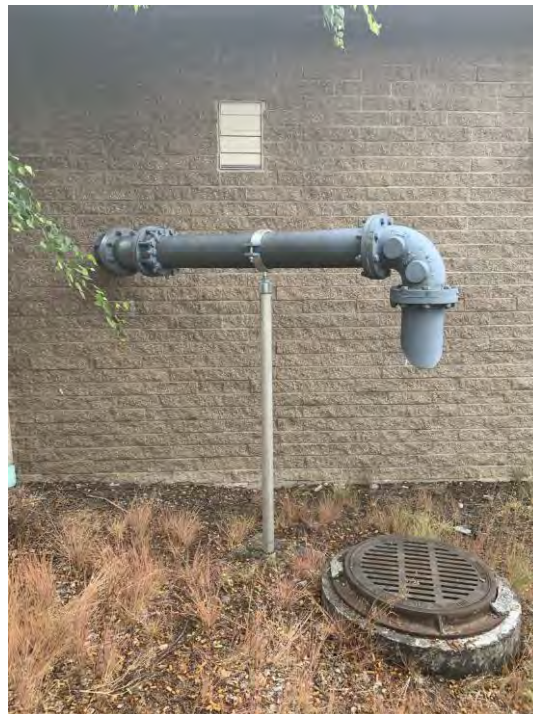
Figure 3.107 Unbraced Overflow Pipe on South Side of Pump Station

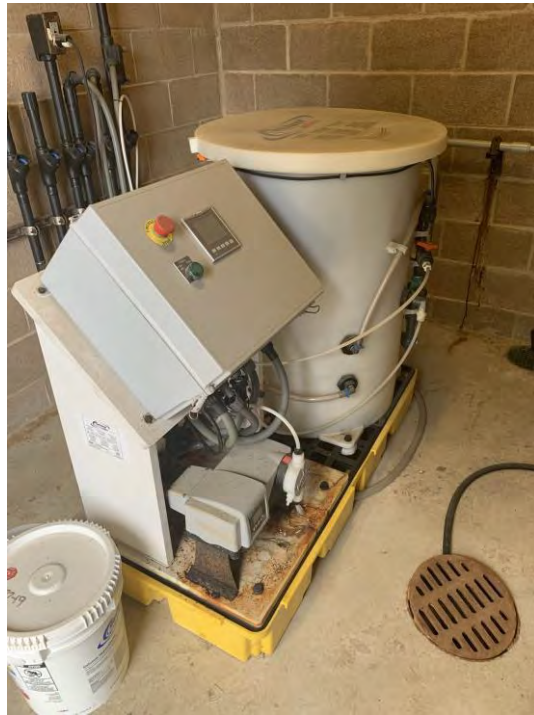
Figure 3.108 Unanchored Chlorination Skid

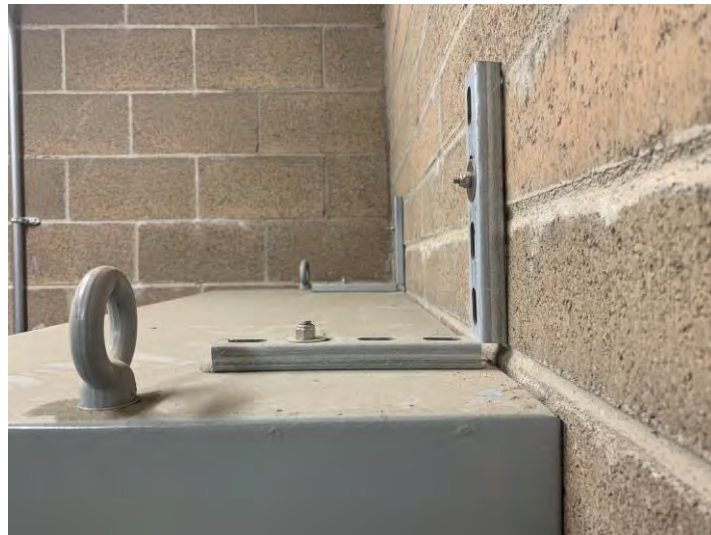
Figure 3.109 Anchorage at Electrical Cabinet with Bent Strut

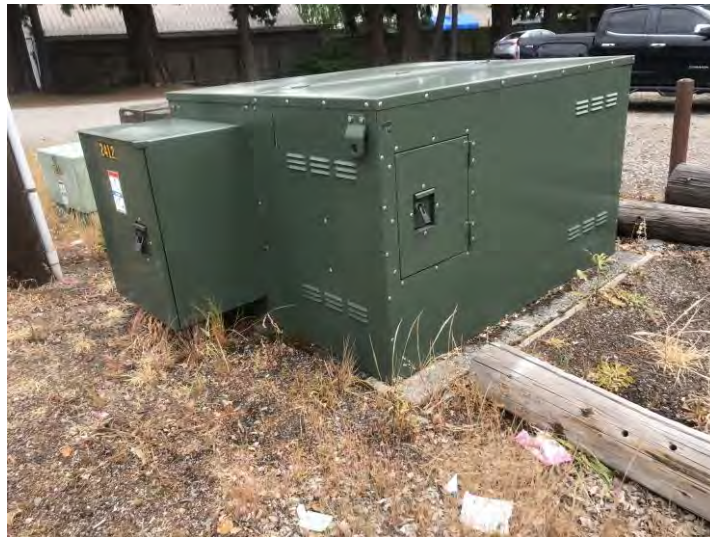
Figure 3.111 Unanchored Electrical Transformer

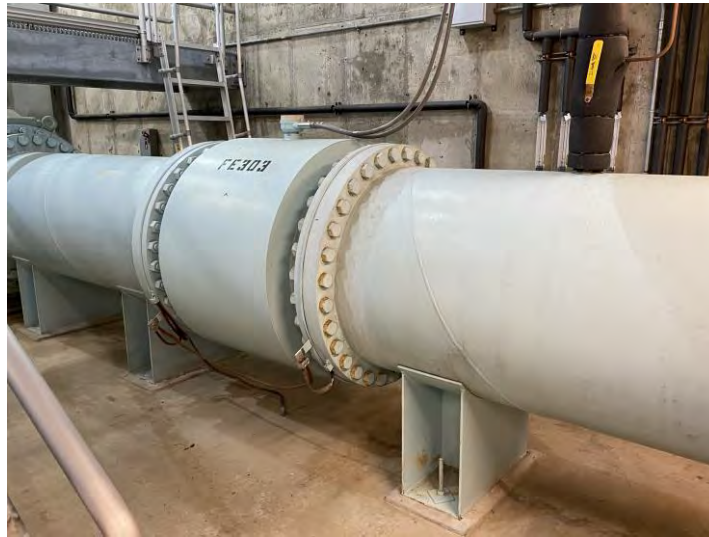
Figure 3.114 Unbraced Pipe

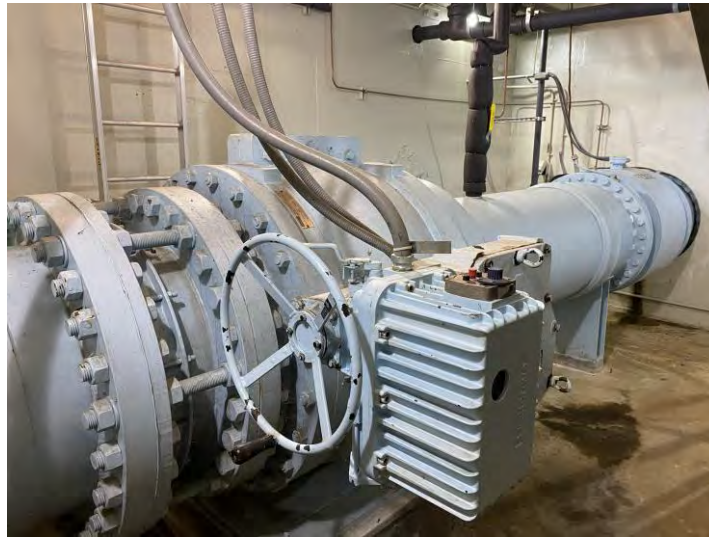
Figure 3.115 Unbraced Valve

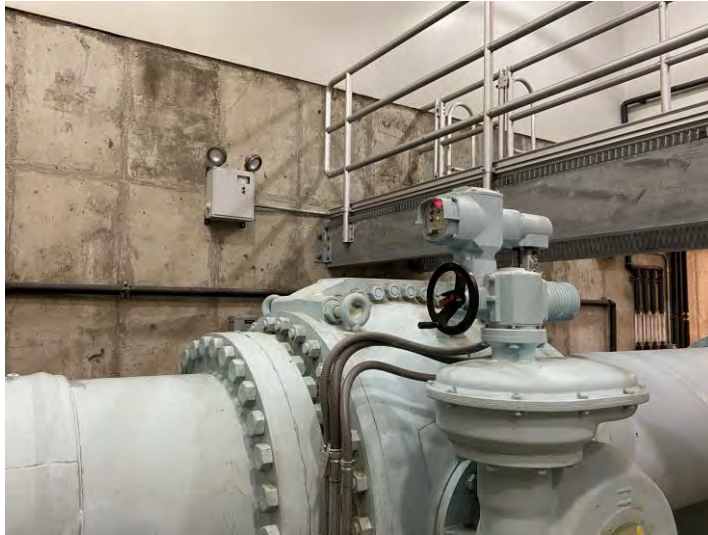
Figure 3.116 Unbraced Valve Actuator

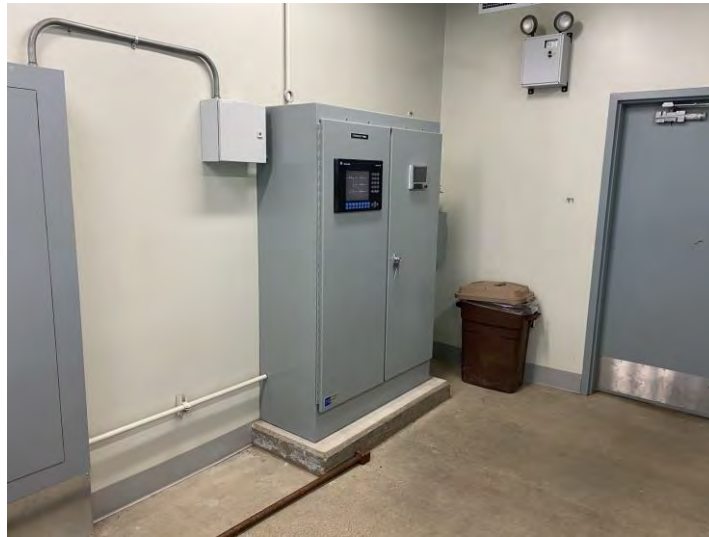
Figure 3.117 Unanchored Control Cabinet

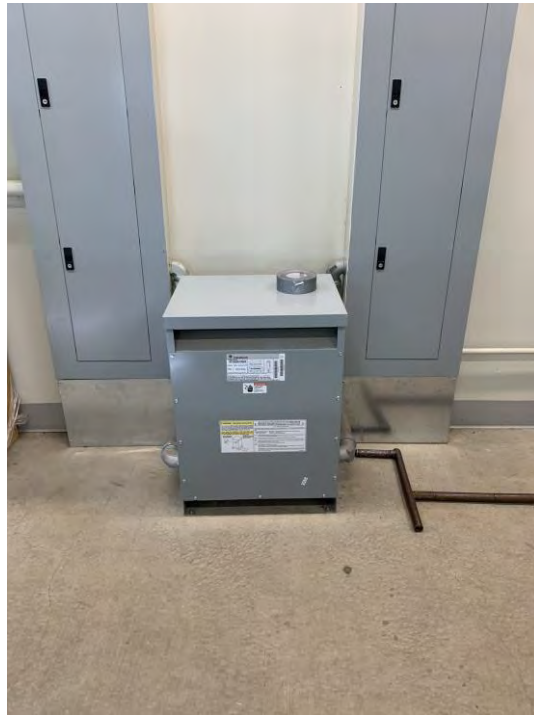
Figure 3.118 Electrical Transformer Missing Anchors into Floor Slab

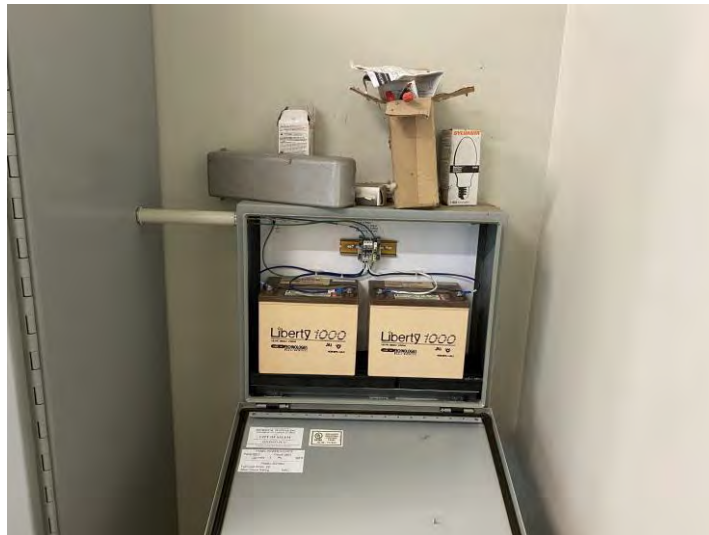
Figure 3.119 Unrestrained Backup Batteries in Battery Cabinet

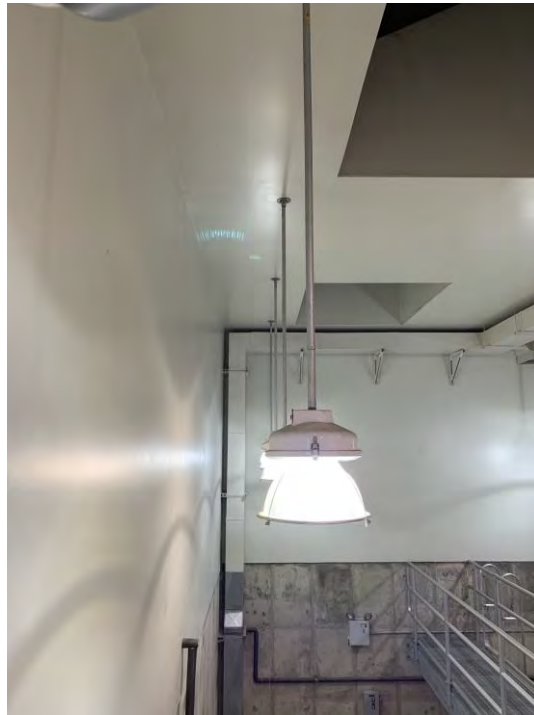
Figure 3.120 Unrestrained Pendant Light Fixtures

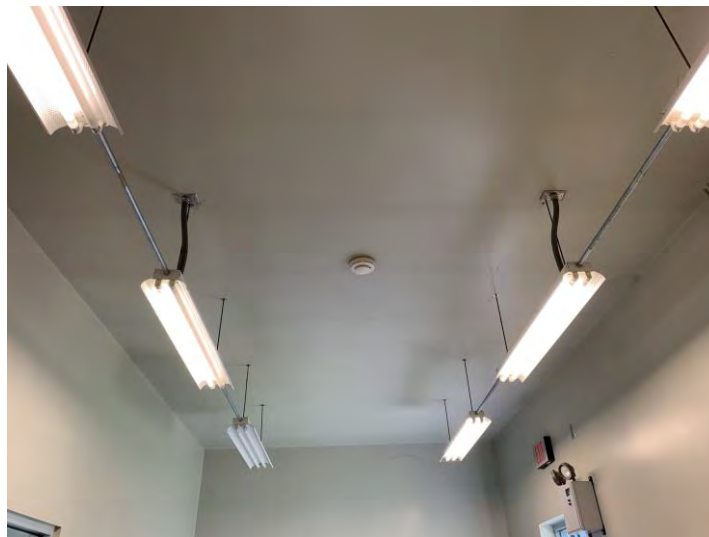
Figure 3.121 Light Fixtures without Lens Covers

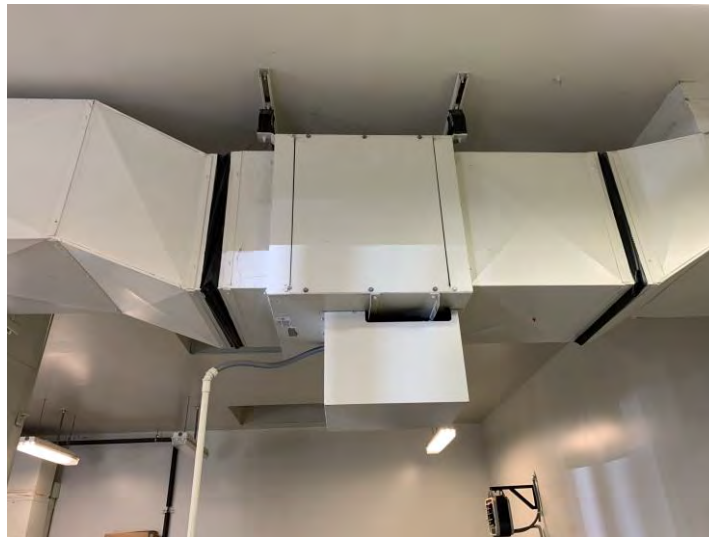
Figure 3.123 Unbraced Inline Fan Unit
