SEISMIC RESILIENCY ANALYSIS REPORT

B&V PROJECT NO. 406828

City of Salem

AUGUST 2023

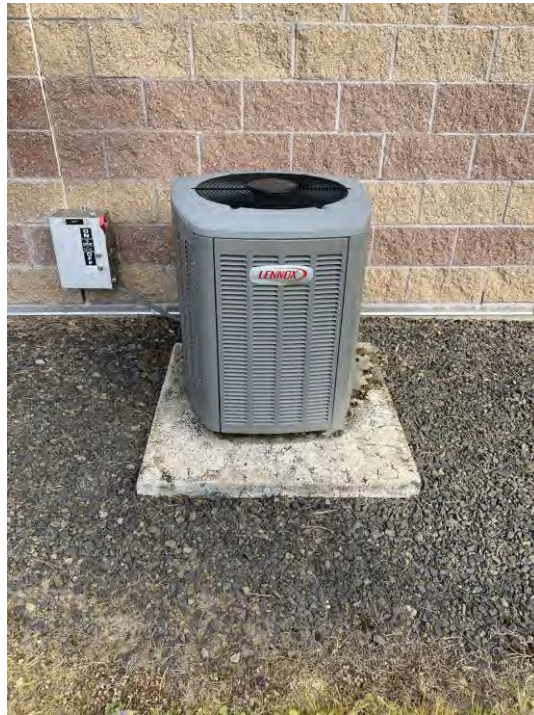
Figure 3.124 Unanchored HVAC Condenser Unit

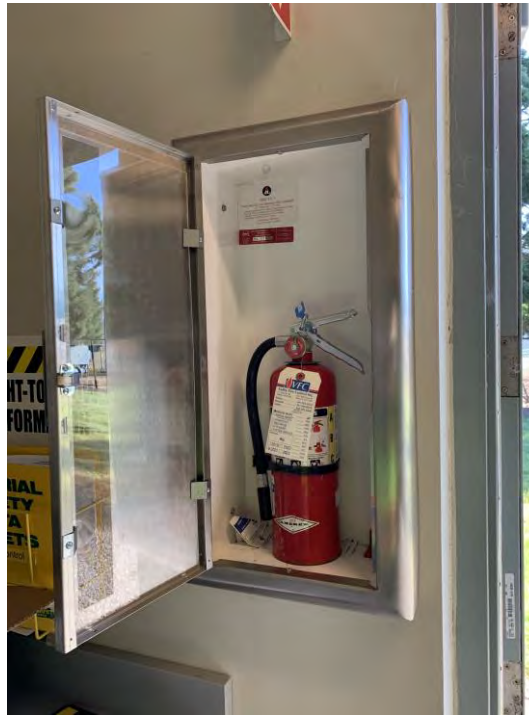
| Potential Deficiencies | Description |
|---|--|
| Nonstructural | <ul style="list-style-type: none"> • Water system piping that penetrates through the control facility walls may not have adequate flexibility to accommodate the potential differential movement between the control facility and the surrounding soil at the pipe penetration. • Water system piping within the control facility does not appear to be adequately braced (see Figure 3.114) • Valves in line with the water system piping are not braced (see Figure 3.115). • The valve actuators are not braced (see Figure 3.116). • The control cabinet did not appear to be anchored to the housekeeping pad or wall (see Figure 3.117). • The electrical transformer is only anchored with two anchors at the front of the unit. It is missing two anchors into the concrete slab at the back of the unit (see Figure 3.118). • Backup batteries in the battery cabinet are not adequately restrained (see Figure 3.119). • Pendant lights are not restrained to prevent them from hitting the wall (see Figure 3.120). • Light fixtures in the control facility do not include lens covers (see Figure 3.121). • The horizontal arm of the SCADA antenna may not be adequately connected to the supporting pole to prevent the antenna from being misaligned or damaged after an earthquake (see Figure 3.122). • The ceiling hung inline HVAC fan is not laterally braced (see Figure 3.123). • No anchorage was observed between the HVAC condenser unit and concrete support pad (see Figure 3.124). • Two storage shelving units are not anchored to the floor and/or the wall (see Figure 3.125). • The fire extinguisher is not adequately restrained in its cabinet (see Figure 3.126). |

Figure 3.126 Unrestrained Fire Extinguisher

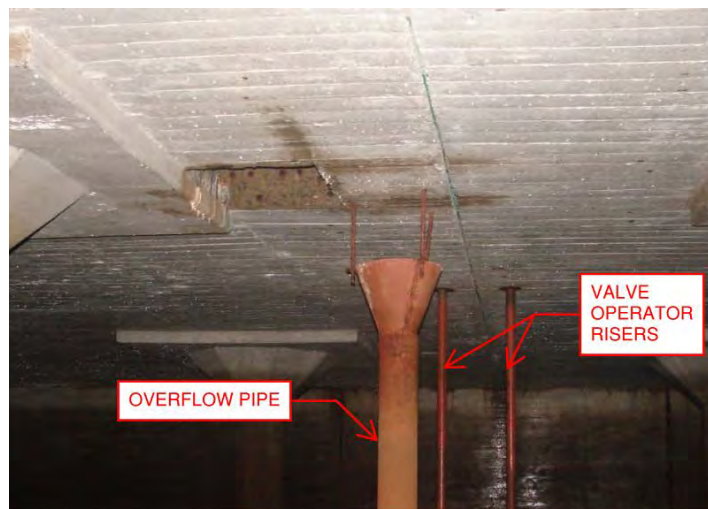
| Potential Deficiencies | Description |
|---|--|
| Nonstructural | <p><u>Reservoir</u></p> <ul style="list-style-type: none"> Some piping and fittings within the reservoir may be cast-iron, which is a brittle material that may crack when subjected to earthquake shaking-induced forces and/or ground deformation. The overflow pipe and valve operator riser shafts may not be adequately braced to resist seismic forces (see Figure 3.128). Note that the 2011 condition assessment also indicated that these elements were observed to have significant corrosion deterioration. <p><u>Valve Vault</u></p> <ul style="list-style-type: none"> Per the 2006 design drawings, the piping and valve inside the valve vault are not independently braced. Backup batteries in the battery cabinet (for operation of the seismic valve) may not be adequately restrained. |

Figure 3.128 Overflow Pipe and Valve Operator Risers Not Adequately Braced
(Source: 2011 Reservoir Condition Assessment by Murray, Smith & Associates)

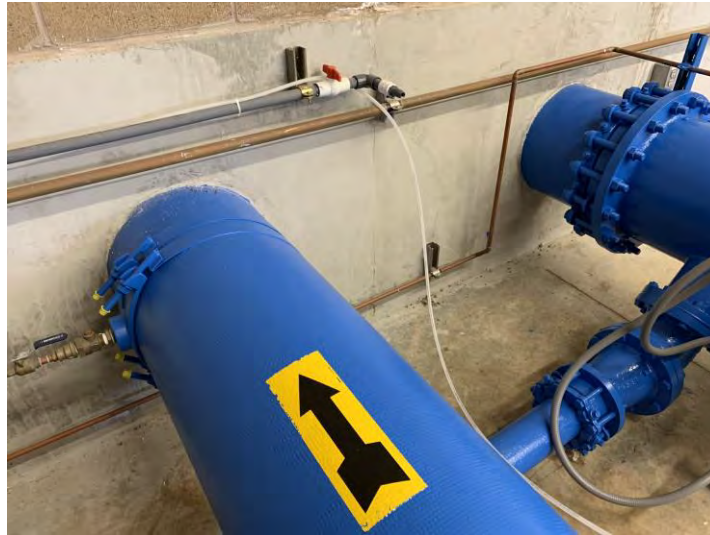
| Potential Deficiencies | Description |
|---|--|
| Nonstructural | <ul style="list-style-type: none"> • Water system piping that penetrates through the control building walls may not have adequate flexibility to accommodate the potential differential movement between the control facility and the surrounding soil at the pipe penetration (see Figure 3.135). • Water system piping within the control building is not adequately seismically braced (see Figure 3.136). • Valves in line with the water system piping are not braced (see Figure 3.137). • The motor for the reservoir recirculation pump is not anchored at the base (see Figure 3.138) and the associated piping is not braced. • The pressure tank for the irrigation system appears to be missing an anchor at the base (see Figure 3.139). • Backup batteries in the battery cabinet (for operation of the seismic valves) are not adequately restrained (see Figure 3.140). • The horizontal arm of the SCADA antenna may not be adequately connected to the supporting pole to prevent the antenna from being misaligned or damaged after an earthquake (see Figure 3.141). • The ceiling framing of the chlorine room inside the control building does not appear to provide adequate connections to transfer seismic forces from the ceiling to the masonry walls below. Also, the wood ledger attachment to the masonry wall is not detailed to avoid cross-grain bending (see Figure 3.142). • The temporarily stored electrical cabinets are not anchored and may tip over during an earthquake and potentially damage valves or other components (see Figure 3.143). • The wood pole and anchorage of the pole-mounted transformer to the pole may not be adequately designed to resist the seismic forces generated by the transformer (see Figure 3.144). |

Figure 3.135 Rigid Pipe Connection Through Wall

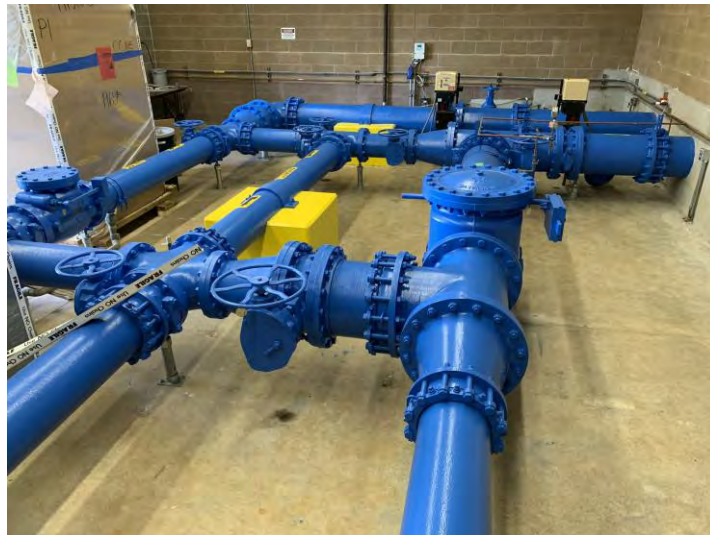
Figure 3.136 Unbraced Piping and Valves

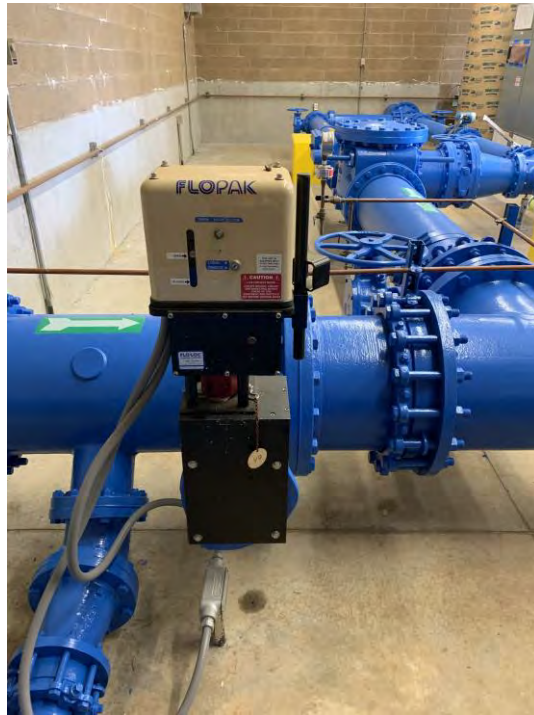
Figure 3.137 Unbraced Seismic Valve

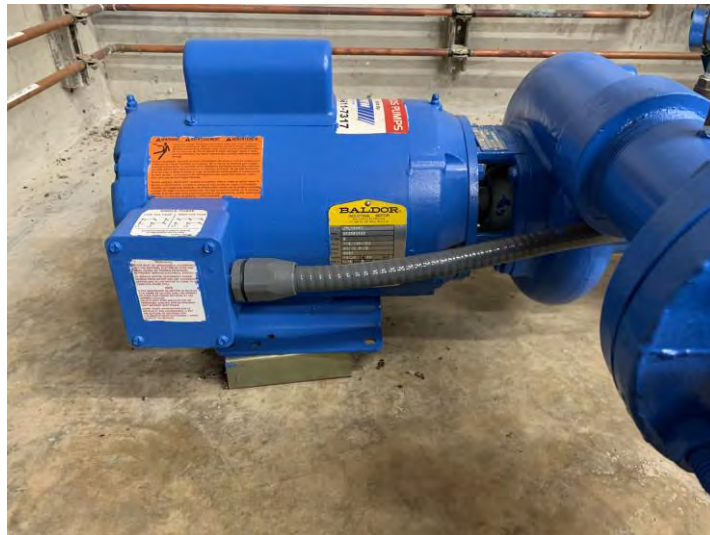
Figure 3.138 Unanchored Recirculation Pump Motor

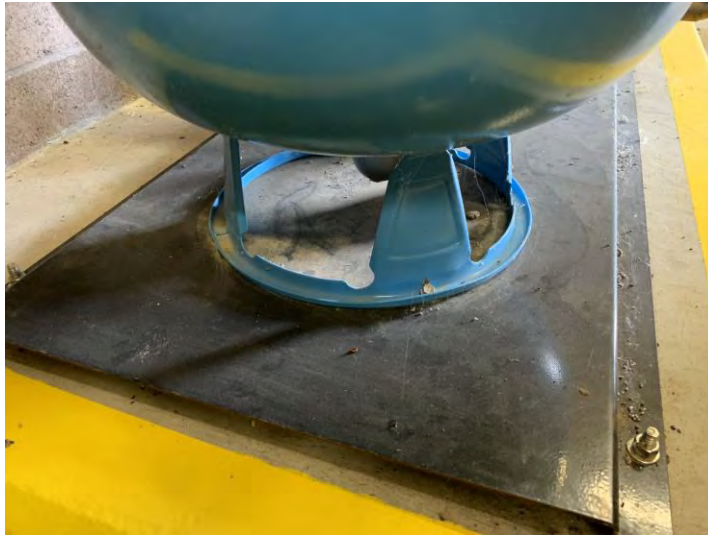
Figure 3.139 Irrigation Pressure Tank Missing Anchor

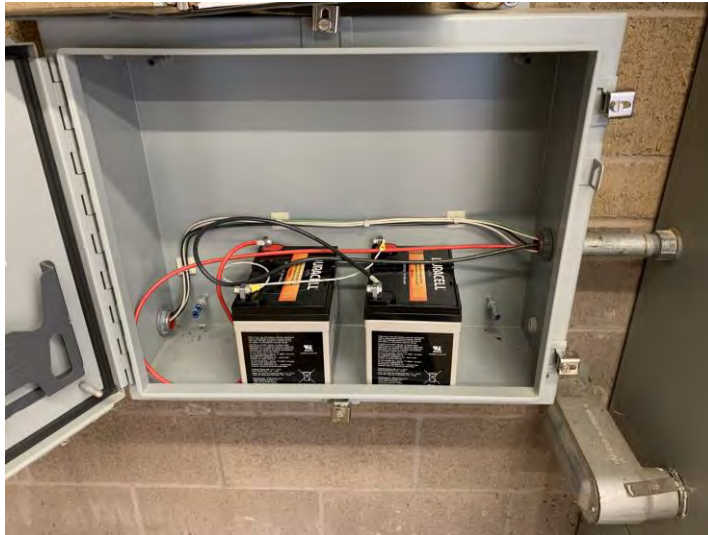
Figure 3.140 Unrestrained Backup Batteries

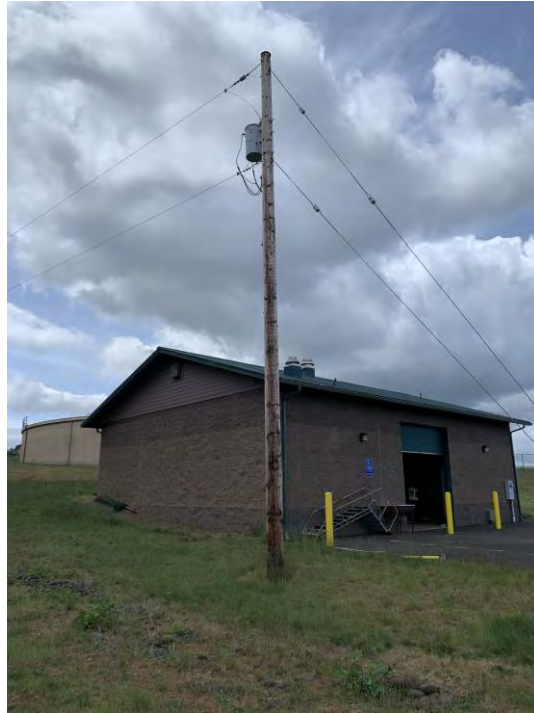
Figure 3.144 Pole-mounted Electrical Transformer

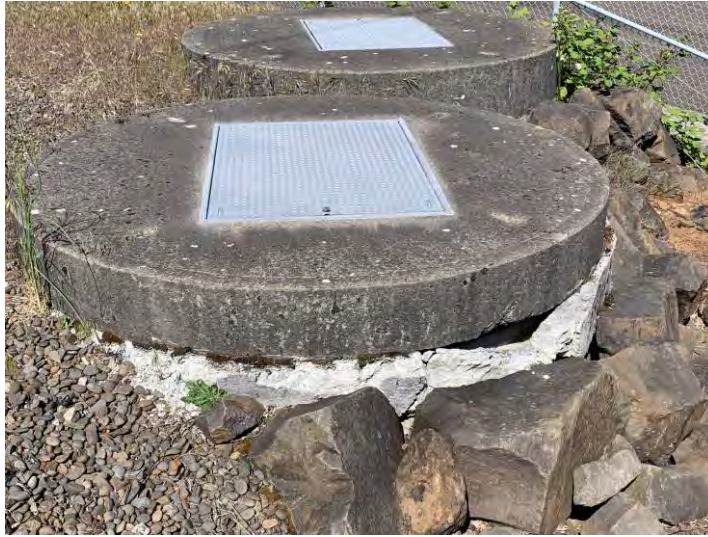
| Potential Deficiencies | Description |
|---|--|
| | <u>Valve Vaults</u> <ul style="list-style-type: none"> • Concrete deterioration was observed near the top of South Valve Vault wall to lid interface (see Figure 3.146) that may impact the seismic performance of the valve vault. • Valve vaults are constructed from precast concrete components. The riser joints of stacked precast components may separate and shift due to seismic lateral earth pressures of the face of the valve vault. • Sand, silt, or groundwater may infiltrate and leak into the valve vaults at the precast concrete construction joints. |

Figure 3.146 Concrete Deterioration at Lid to Wall Connection of South Valve Vault

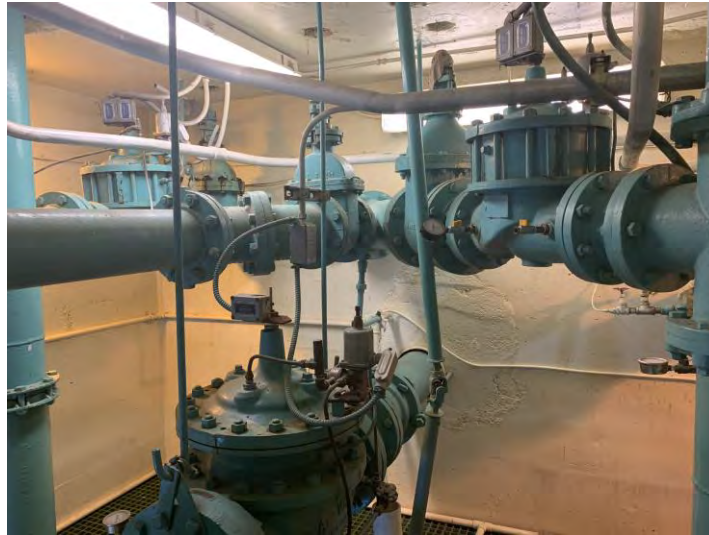
| Potential Deficiencies | Description |
|---|--|
| Nonstructural | <ul style="list-style-type: none"> • Water system piping within the control building is not seismically braced (see Figure 3.155). • Valves and valve actuators in line with the water system piping are not braced (see Figure 3.156). • The vertical pump bells and valve operator riser shafts are not braced (see Figure 3.157). • Per the original drawings and site visit observations, piping and valves within the control building are cast-iron (see Figure 3.158), which is a brittle material that may crack when subjected to earthquake shaking-induced forces and/or ground deformation. • Significant corrosion-induced deterioration was observed for some piping, valves, and pipe connection bolts in the control building (see Figure 3.159). • Pumps do not appear to be anchored at the base (see Figure 3.160). • Vertical pump motors are not braced above the center of gravity of the motor (see Figure 3.160). • There does not appear to be adequate flexibility in the piping that is attached to the pumps to accommodate potential relative movement between the piping and the pump, and to prevent the piping from adding additional load to the pump anchorage. • The air vent vertical pipe adjacent to the east reservoir access stair does not appear to be braced (see Figure 3.161). |

Figure 3.155 Unbraced Piping and Valves

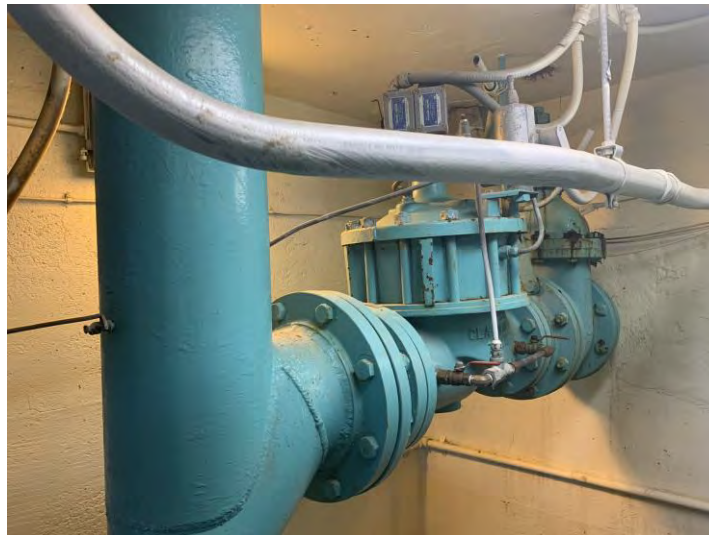
Figure 3.156 Unbraced Valve

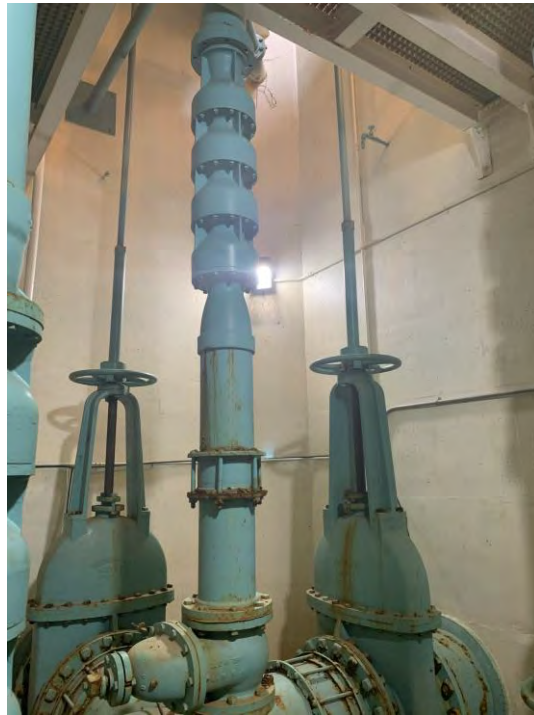
Figure 3.157 Unbraced Pump Bells and Valve Operator Riser Shafts

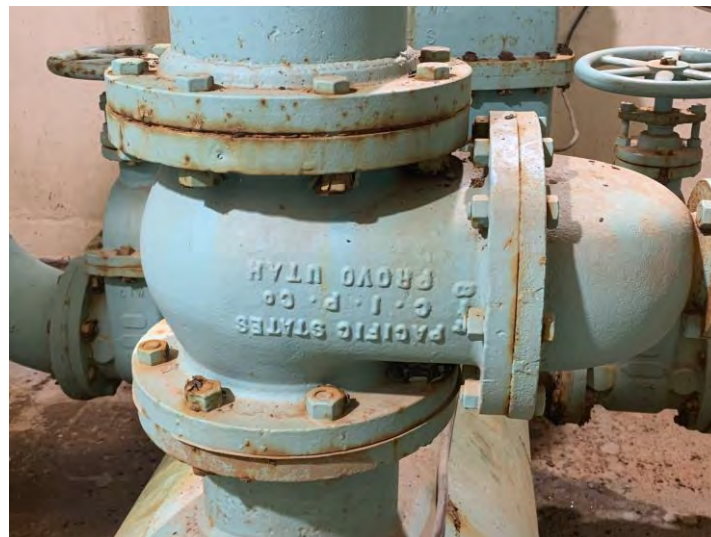
Figure 3.158 Cast Iron Valve

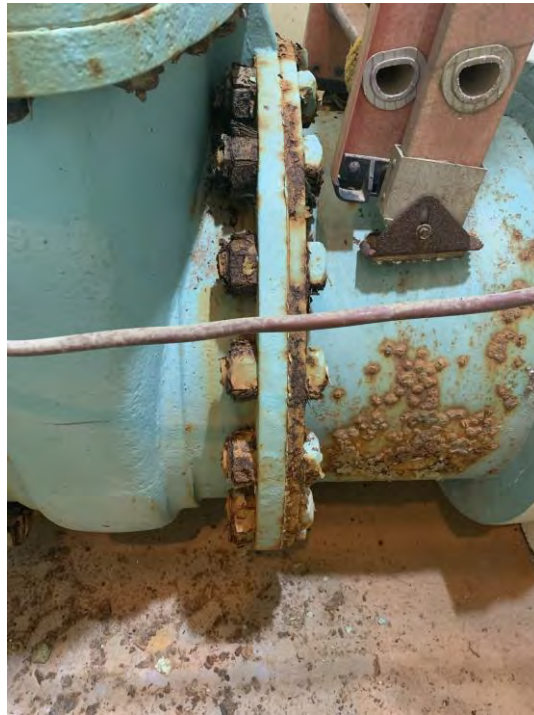
Figure 3.159 Corroded Bolts and Pipe

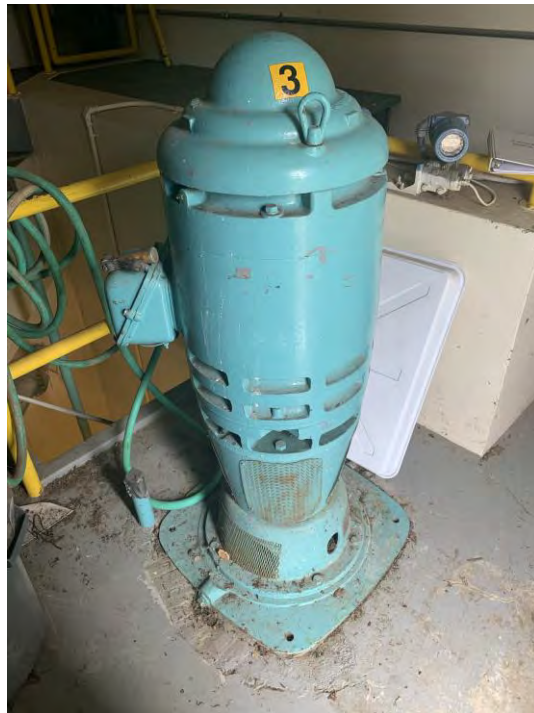
Figure 3.160 Unanchored Pump

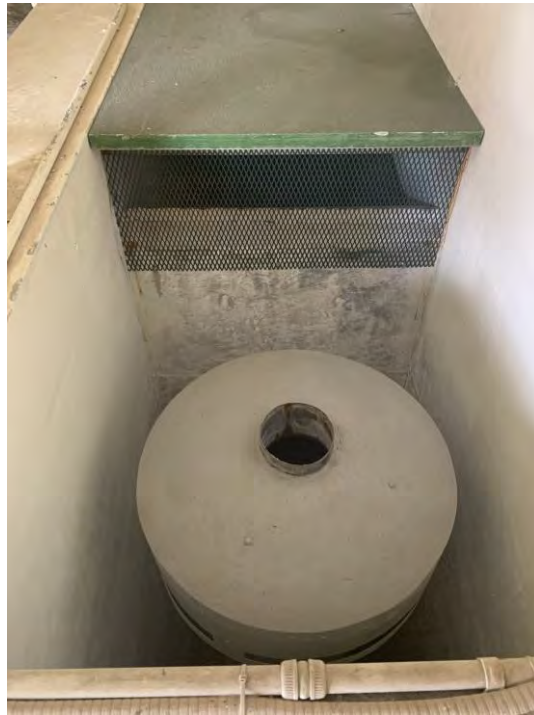
Figure 3.161 Unbraced Vent Pipe

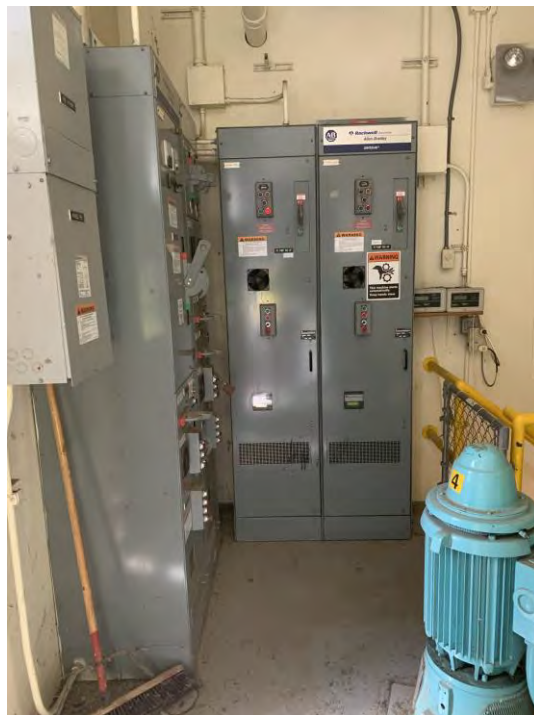
| Potential Deficiencies | Description |
|---|---|
| Nonstructural (cont.) | <ul style="list-style-type: none"> • Anchorage of electrical cabinets to the concrete slab was not visible from the outside of the cabinets and may not be adequate. Additionally, electrical cabinets do not appear to be anchored or braced to the wall near the top of the cabinets to prevent them from tipping over during an earthquake (see Figure 3.162) • Electrical conduits, hung from the roof, penetrating the wall and connected to the top of floor-mounted electrical cabinets, may not have adequate flexibility to account for differential movement between the floor, walls, and roof (see Figure 3.163). • The horizontal arm of the SCADA antenna may not be adequately connected to the supporting pole to prevent the antenna from being misaligned or damaged after an earthquake (see Figure 3.164). • The wood pole and anchorage of the pole-mounted transformer to the pole may not be adequately designed to resist the seismic forces generated by the transformer (see Figure 3.165). |

Figure 3.162 Electrical Cabinets with Unknown Anchorage Details

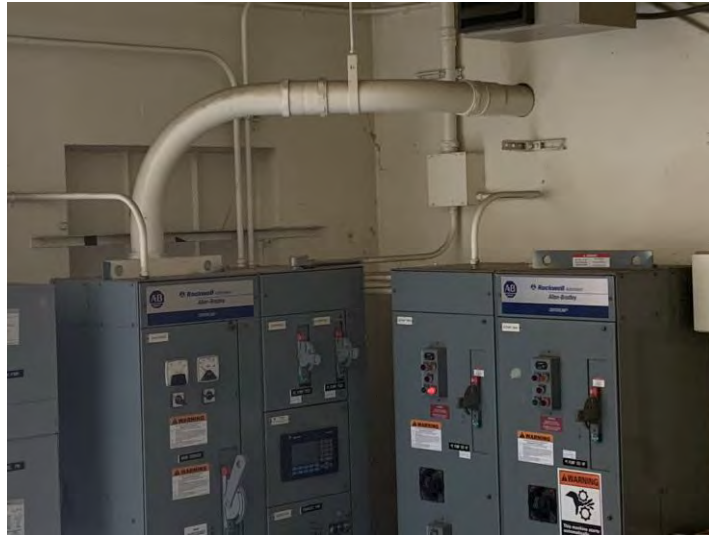
Figure 3.163 Conduits Connecting to Electrical Cabinets without Flexible Connections

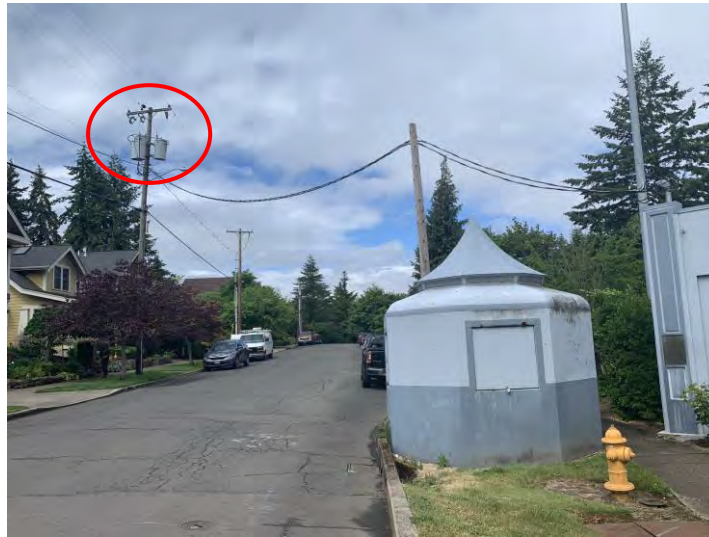
Figure 3.165 Pole-mounted Electrical Transformers

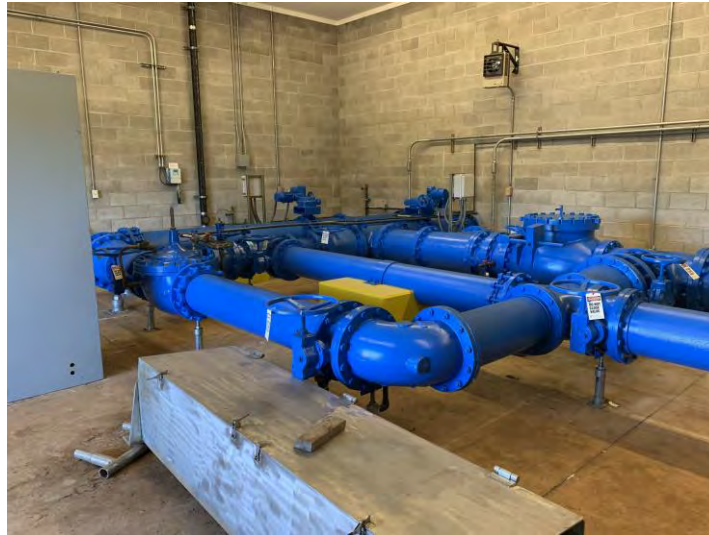
| Potential Deficiencies | Description |
|---|---|
| Nonstructural | <ul style="list-style-type: none"> • Water system piping within the control building is not adequately seismically braced (see Figure 3.172). • Valves in line with the water system piping are not braced (see Figure 3.173). • One of the seismic valves has a note attached indicating that the valve is out of service (see Figure 3.174). • The pressure tank for the irrigation system is not anchored at the base (see Figure 3.175). • Backup batteries in the battery cabinet (for operation of the seismic valves) are not adequately restrained (see Figure 3.176). • The ceiling framing of the chlorine room inside the control building does not appear to provide adequate connections to transfer seismic forces from the ceiling to the masonry walls below (see Figure 3.177). • The temporarily stored electrical cabinet (see Figure 3.178), emergency generator, etc. may tip over or slide during an earthquake and potentially damage valves or other components. • A ladder is unrestrained (see Figure 3.179) and may topple into and potentially damage valves or other components during an earthquake. • No anchorage was observed between the electrical transformer and concrete support pad (see Figure 3.180). |

Figure 3.172 Unbraced Piping and Valves

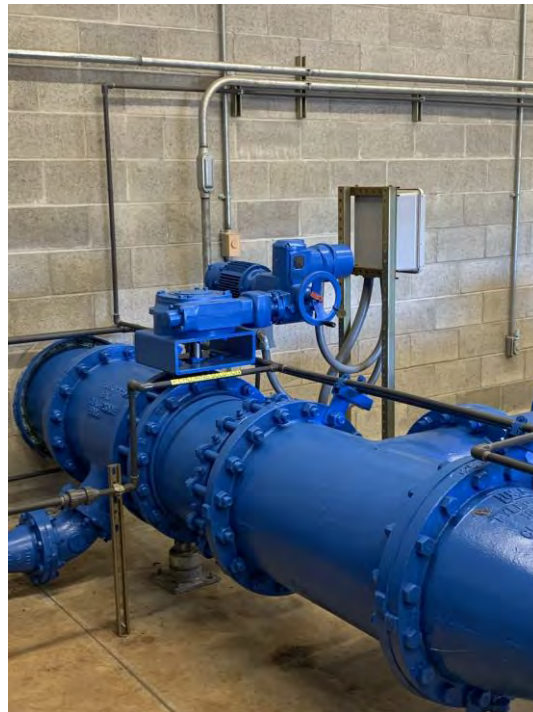
Figure 3.173 Unbraced Seismic Valve

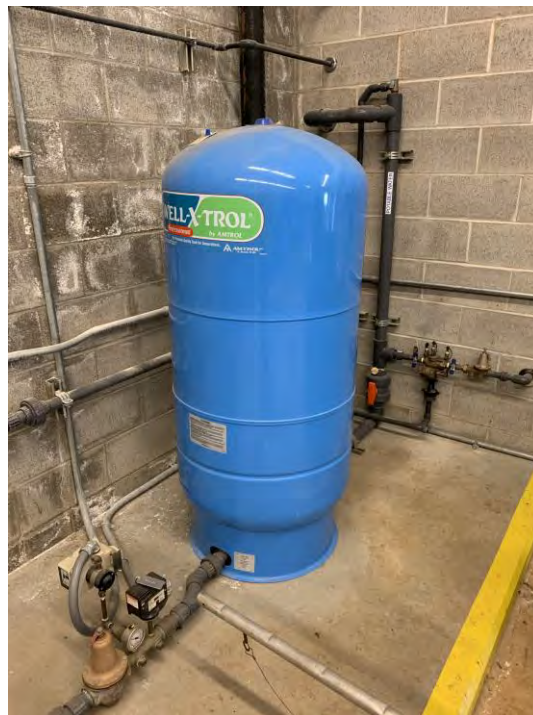
Figure 3.175 Unanchored Irrigation Pressure Tank

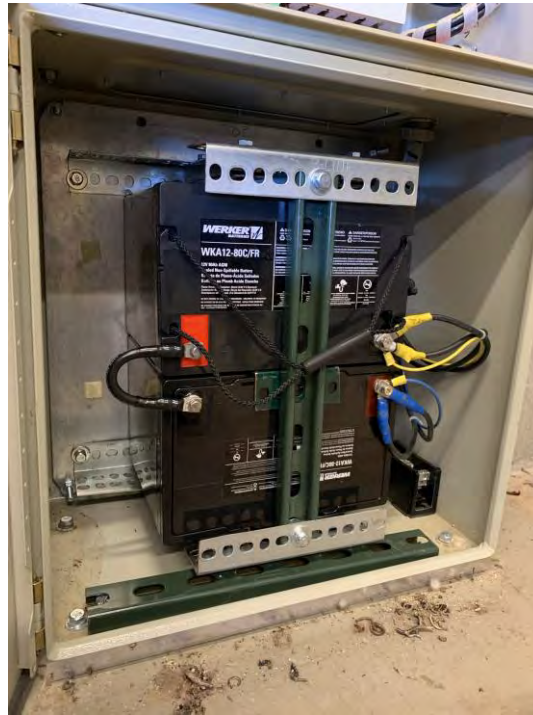
Figure 3.176 Backup Batteries without Adequate Restraint

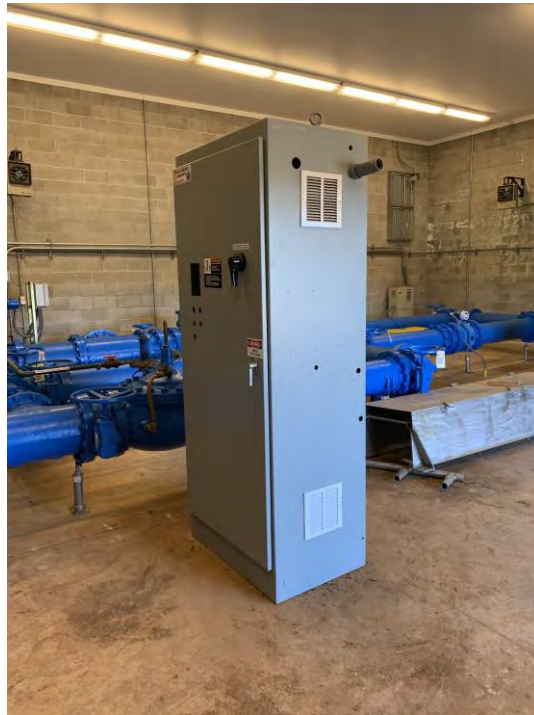
Figure 3.178 Temporarily Stored Electrical Cabinet

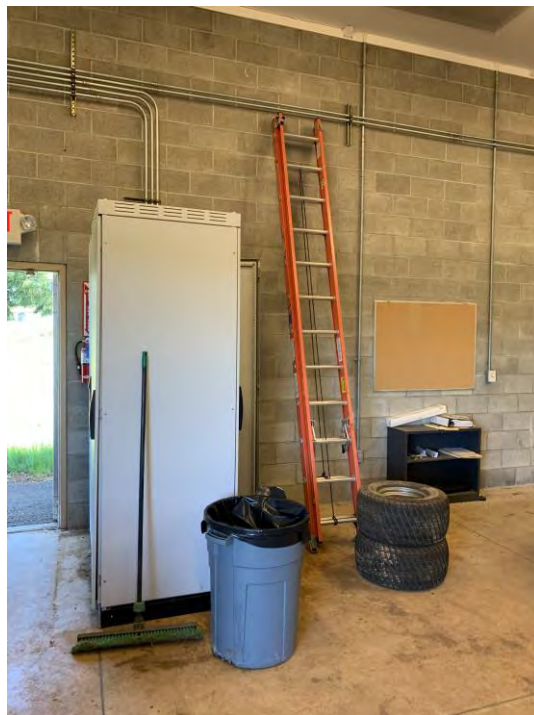
Figure 3.179 Unrestrained Ladder

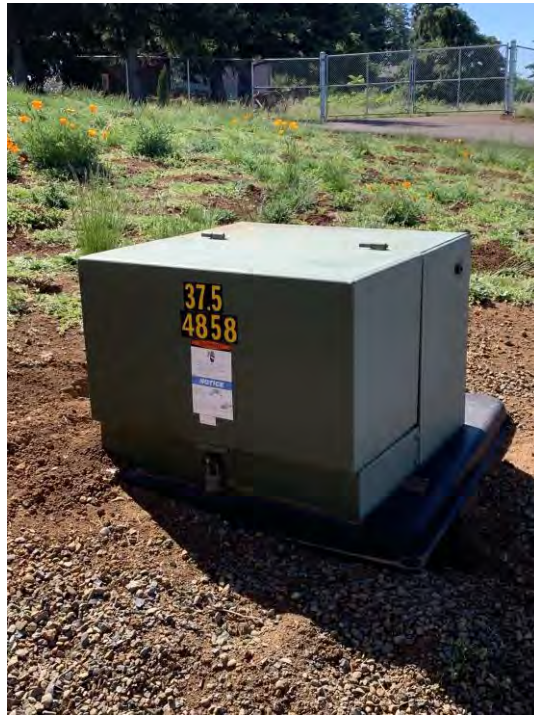
Figure 3.180 Unanchored Electrical Transformer

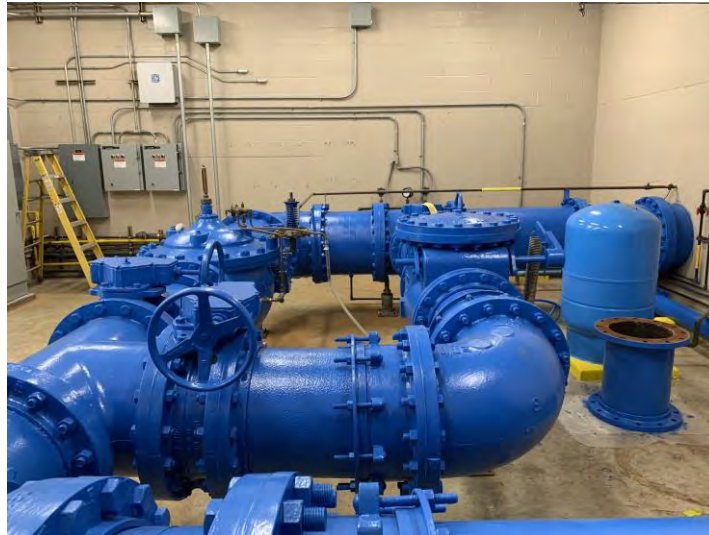
| Potential Deficiencies | Description |
|---|--|
| Nonstructural | <ul style="list-style-type: none"> • Water system piping within the control building is not seismically braced (see Figure 3.184). • Valves in line with the water system piping are not braced (see Figure 3.185). • The pressure tank for the irrigation system is not anchored at the base (see Figure 3.186). • Anchorage of the control cabinet to the housekeeping pads was not visible from the outside of the cabinets and may not be adequate. Additionally, the control cabinet does not appear to be anchored or braced to the wall near the top of the cabinet to prevent it from tipping over during an earthquake (see Figure 3.187). • Anchorage of the battery cabinet to the top of the control cabinet (see Figure 3.187) was not visible from the outside of the cabinet and may not be adequate. Also, backup batteries in the battery cabinet may not be adequately restrained. • The horizontal arm of the SCADA antenna may not be adequately connected to the supporting pole to prevent the antenna from being misaligned or damaged after an earthquake (see Figure 3.188). • The suspended HVAC unit may not be adequately braced (see Figure 3.189). Potential bracing deficiencies include the bracing angle for one pair of cable braces is near vertical (resulting in a significant decrease in the capacity of the braces to resist horizontal seismic forces), some braces appear to load the bottom chord of the roof truss in the out-of-plane direction (blocking or other detailing to deliver these seismic forces to the roof diaphragm are unknown) and only a single cable clamp is used for the braces (no redundancy if the single clamp were to loosen) • The base skid for the large water heater and safety shower in the chlorine room does not appear to be adequately anchored (see Figure 3.190). |

Figure 3.184 Unbraced Piping and Valves

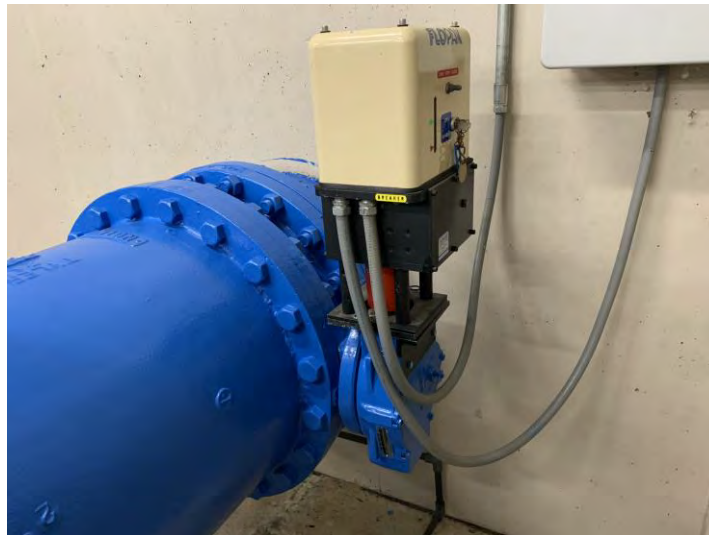
Figure 3.185 Unbraced Seismic Valve

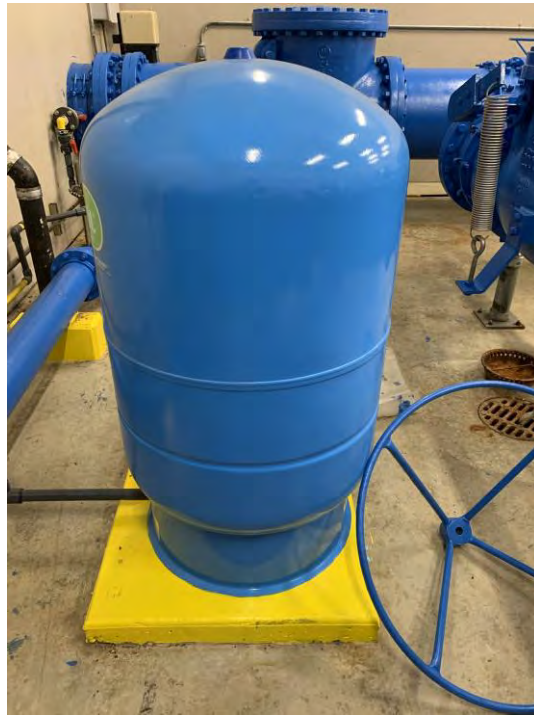
Figure 3.186 Unanchored Pressure Tank

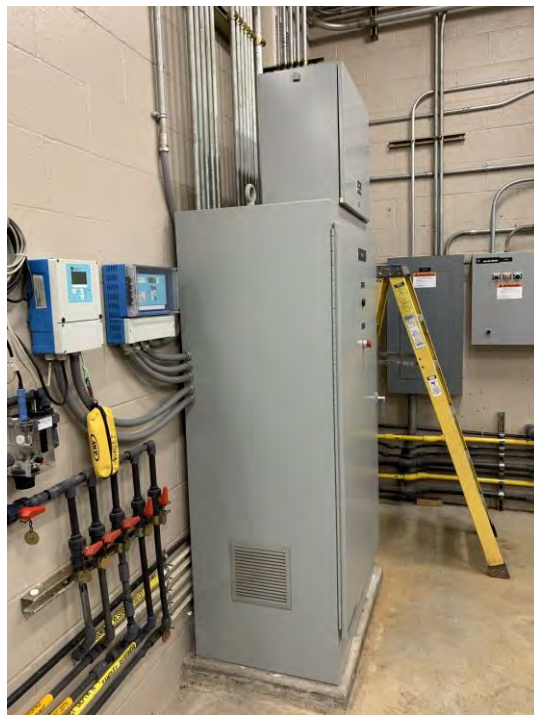
Figure 3.187 Control Cabinet with Unknown Anchorage Details

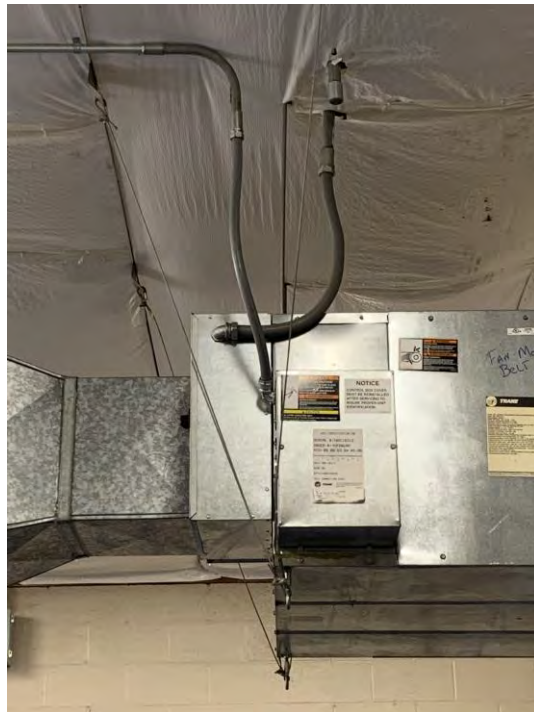
Figure 3.189 Suspended HVAC Unit

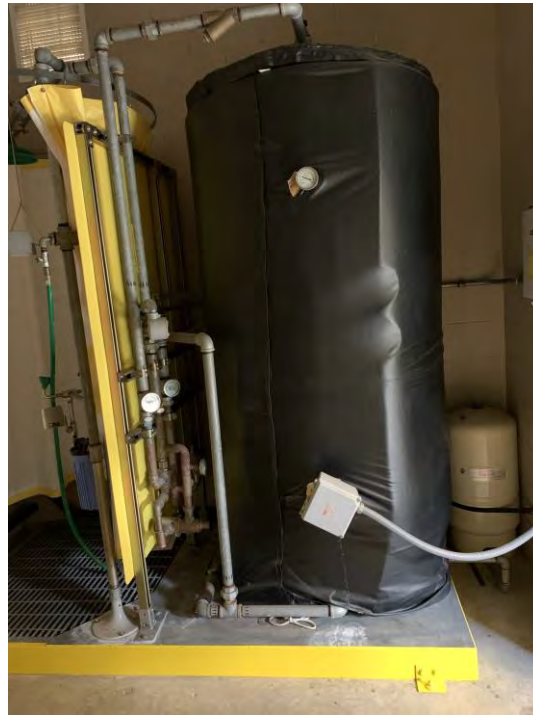
Figure 3.190 Inadequate Overturning Anchorage of Water Heater

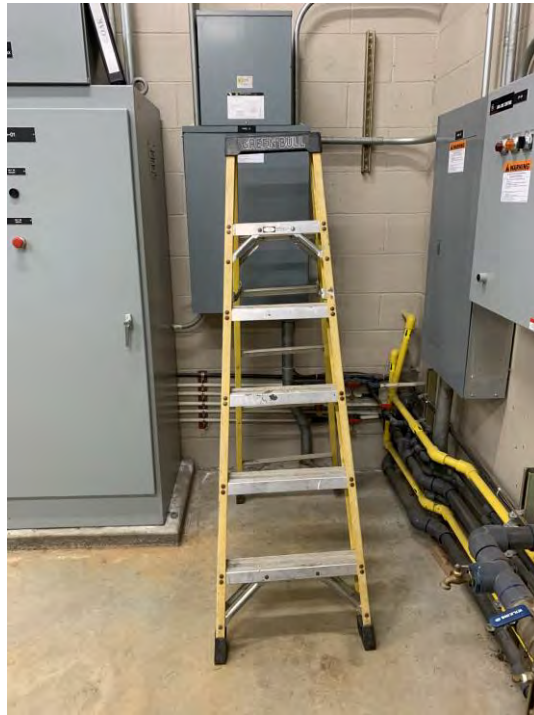
Figure 3.192 Unrestrained Step Ladder

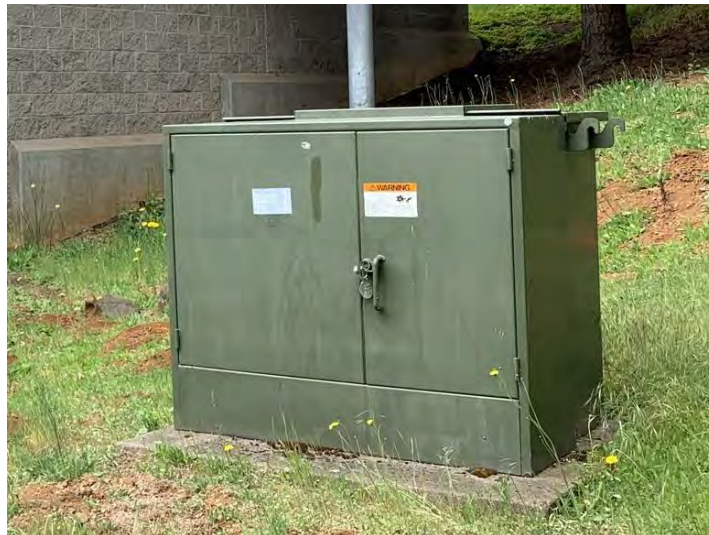
| Potential Deficiencies | Description |
|---|---|
| Nonstructural (cont.) | <ul style="list-style-type: none"> The original design drawings indicate that the design of the chlorine room masonry walls and top of wall bracing was a deferred submittal item (see Figure 3.191). The deferred submittal drawings/calculations were not available for review as part of this project and the bracing at the top of these masonry walls was not visible during SEFT's site visit. Therefore, the adequacy of the masonry wall bracing is unknown. A ladder is unrestrained (see Figure 3.192) and may topple into and potentially damage valves or other components during an earthquake. No anchorage was observed between the electrical transformer and concrete support pad (see Figure 3.193). |

Figure 3.193 Unanchored Electrical Transformer

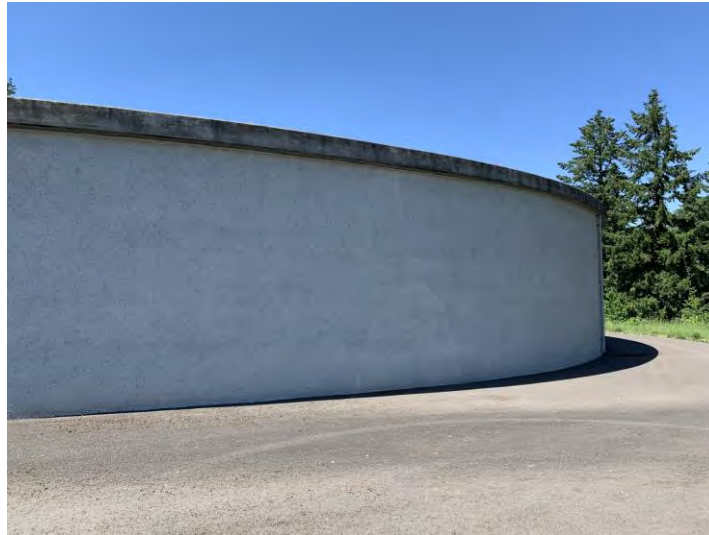
Figure 3.194 Mill Creek #1 Reservoir

The Mill Creek #1 Reservoir (see Figure 3.194) is a 2.2 MG tank built in 2013 at the Mill Creek #1 site off Deer Park Drive SE. This reservoir is a strand-wound, circular, prestressed concrete reservoir with a nearly flat roof, an approximate diameter of 140 feet and a maximum height of retained water of 20 feet. The Mill Creek #1 Reservoir serves the City's S1 Level and is supplied by the Deer Park Pump Station.

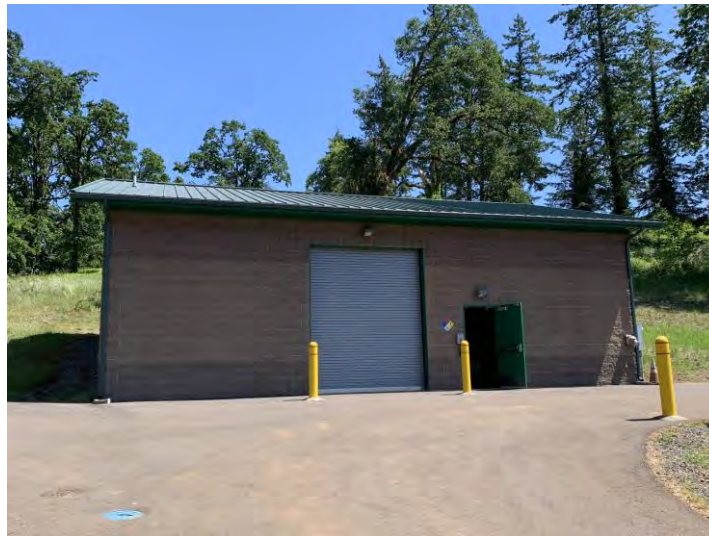
Figure 3.195 Mill Creek #1 Reservoir Control Building

The Mill Creek #1 Reservoir Control Building (see Figure 3.195) is located southwest of the reservoir. The control building is a single-story building with reinforced concrete walls below grade, reinforced masonry walls above grade, and a plywood sheathed wood truss roof. The building is rectangular in plan, with approximate dimensions of 46 feet in north-south direction by 42 feet in east-west direction. The building houses piping and valves (including seismic shutoff valves) that support the operation of the reservoir and a small pump station that supports the City's College Reservoir (steel tank). The original design of the control building included a chlorination room and associated equipment, but the chlorination system is not currently used. Therefore, the chlorination system has not been included in the scope of the nonstructural assessment.

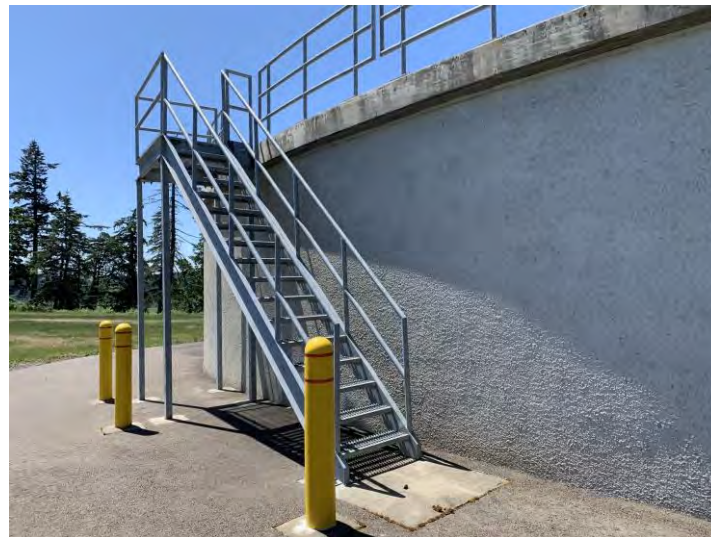
| Potential Deficiencies | Description |
|---|--|
| Nonstructural | <ul style="list-style-type: none"> The pipe support concrete pedestals within the reservoir do not appear to be positively connected to the reservoir floor. Original design drawings show that the vertical reinforcing at the corners of the pedestal terminates at the top of the reservoir floor (see Figure 3.196). The steel framed roof access stair located on the southeast side of the reservoir is relatively flexible (see Figure 3.197). During an earthquake, the stair will likely pound against the reservoir and may damage the stair or locally damage the concrete reservoir. |

Figure 3.197 Mill Creek #1 Reservoir Roof Access Stair

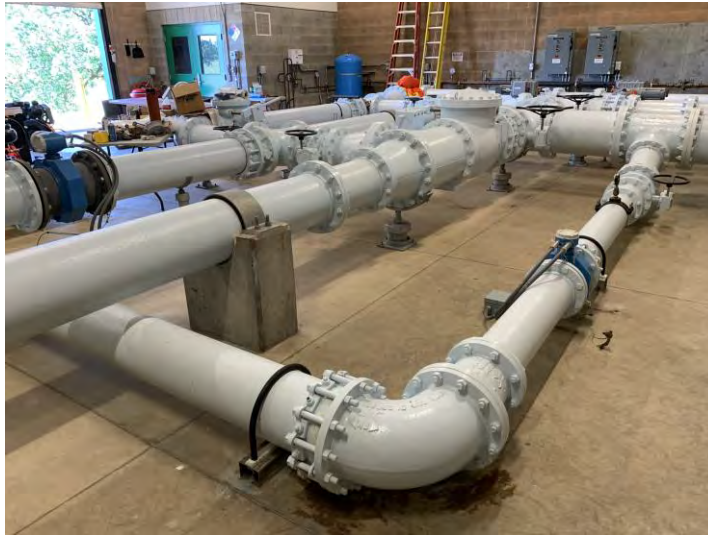
| Potential Deficiencies | Description |
|---|---|
| Nonstructural | <ul style="list-style-type: none"> • Water system piping within the control building is not adequately seismically braced (see Figure 3.200). • Valves in line with the water system piping are not braced (see Figure 3.201). • The pressure tank for the irrigation system is not anchored at the base (see Figure 3.202). • Vertical pump motors are not braced above the center of gravity of the motors (see Figure 3.203). • There does not appear to be adequate flexibility in the piping that is attached to the pumps to accommodate potential relative movement between the piping and the pump, and to prevent the piping from adding additional load to the pump anchorage. • Backup batteries in the battery cabinet (for operation of the seismic valves) may not be adequately restrained. • The horizontal arm of the SCADA antenna may not be adequately connected to the supporting pole to prevent the antenna from being misaligned or damaged after an earthquake (see Figure 3.204). • The ceiling framing of the chlorine room inside the control building does not appear to provide adequate connections to transfer seismic forces from the ceiling to the masonry walls below. Also, the wood ledger attachment to the masonry wall is not detailed to avoid cross-grain bending (see Figure 3.205). • The electrical “room” partial height masonry walls are not laterally braced (see Figure 3.206). • Two ladders are unrestrained (see Figure 3.207) and may topple into and potentially damage valves or other components during an earthquake. • No anchorage was observed between the electrical transformer and concrete support pad (see Figure 3.208). |

Figure 3.200 Unbraced Piping and Valves

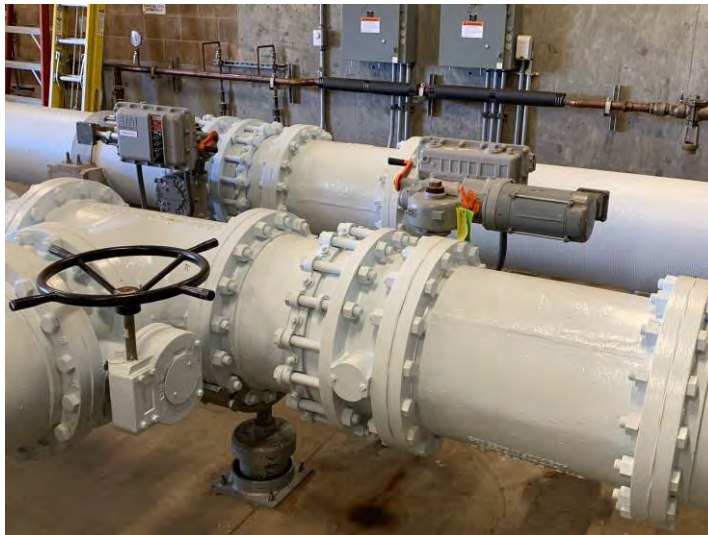
Figure 3.201 Unbraced Seismic Valves

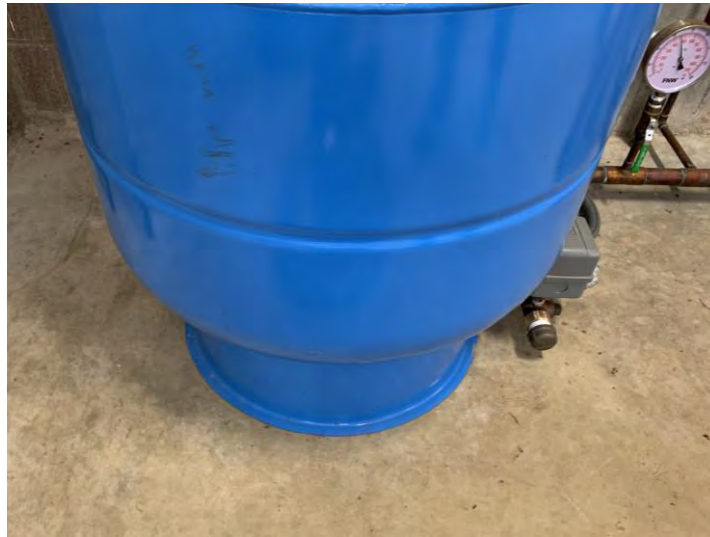
Figure 3.202 Unanchored Pressure Tank

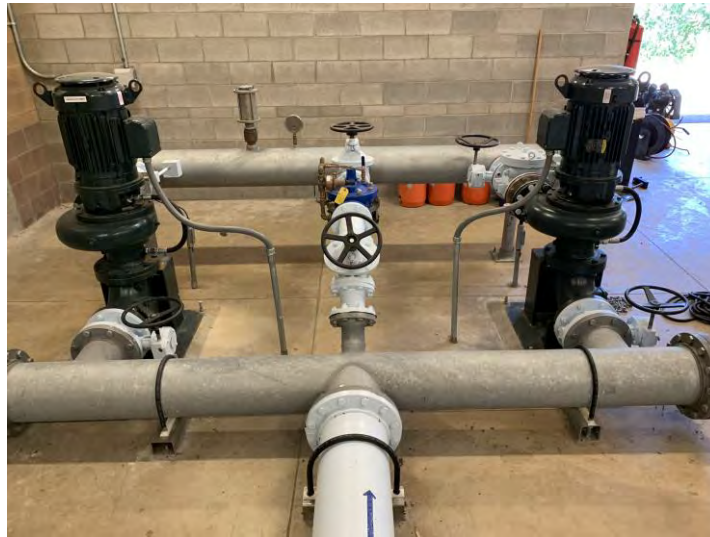
Figure 3.203 Unanchored Pump Motor

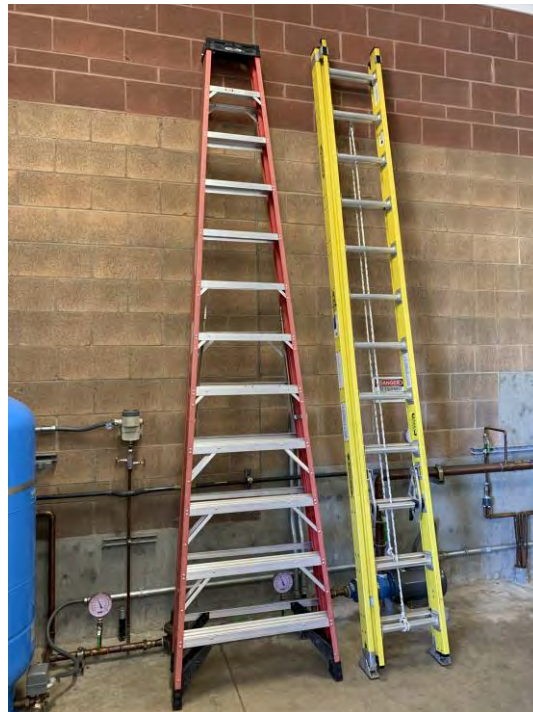
Figure 3.207 Unrestrained Ladders

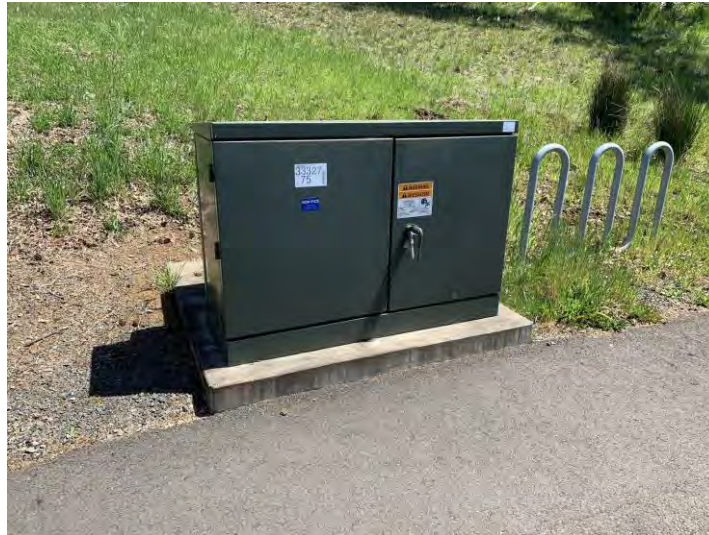
Figure 3.208 Unanchored Electrical Transformer

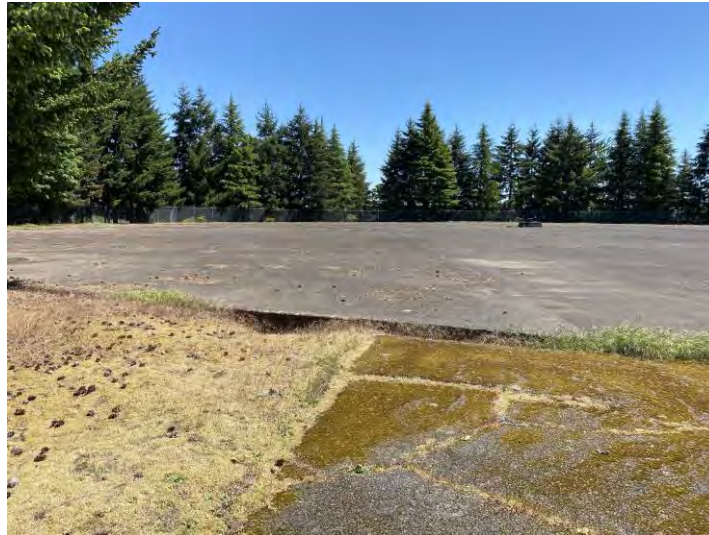
Figure 3.209 Mountain View Reservoir

The Mountain View Reservoir (see Figure 3.209) is a 10 MG tank built in 1971 near the intersection of Wallowa Avenue NW and Orchard Heights Road NW. This reservoir is a completely buried strand-wound, circular, prestressed concrete reservoir with a nearly flat roof, an approximate diameter of 292 feet and a maximum height of retained water of 20 feet. The Mountain View Reservoir serves the City's G0 Level and is hydraulically connected to both Franzen and Fairmount Reservoirs.
